## IOWA DEPARTMENT OF TRANSPORTATION

| Attention | Wes Mayberry, PE | Ref No. | Pottawattamie County<br>BRFN-092-1(081)--39-78 |
| Subject | Final Concept for <b>Bridge Replacement</b> of 183'-0 x 28'-0 Continuous I-Beam Bridge<br>Bridge Maintenance No. 7834.9S092 | | |

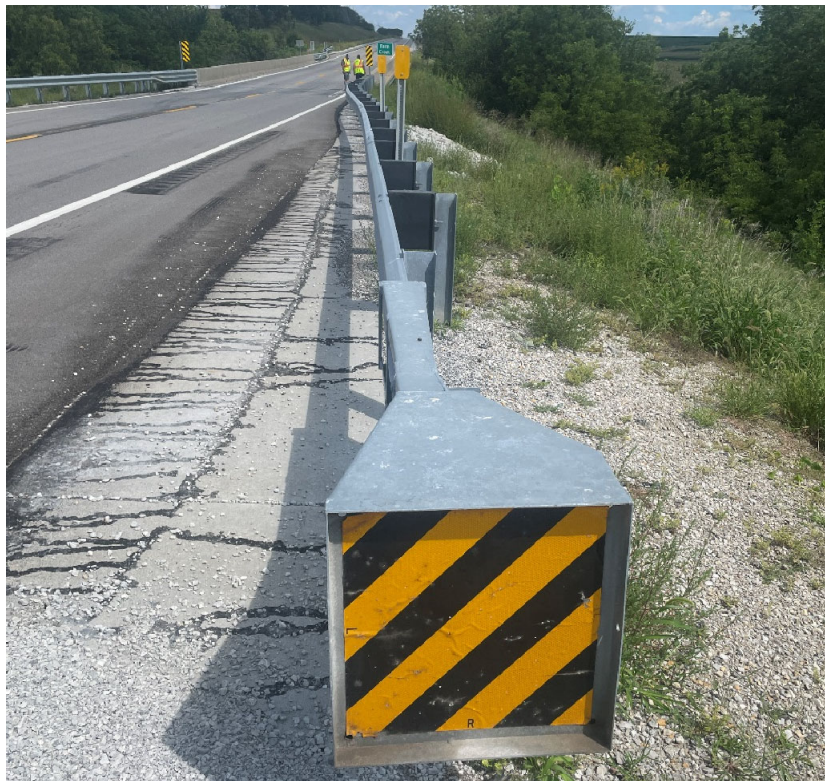
Image 1: Near Approach Guardrail (South Side)

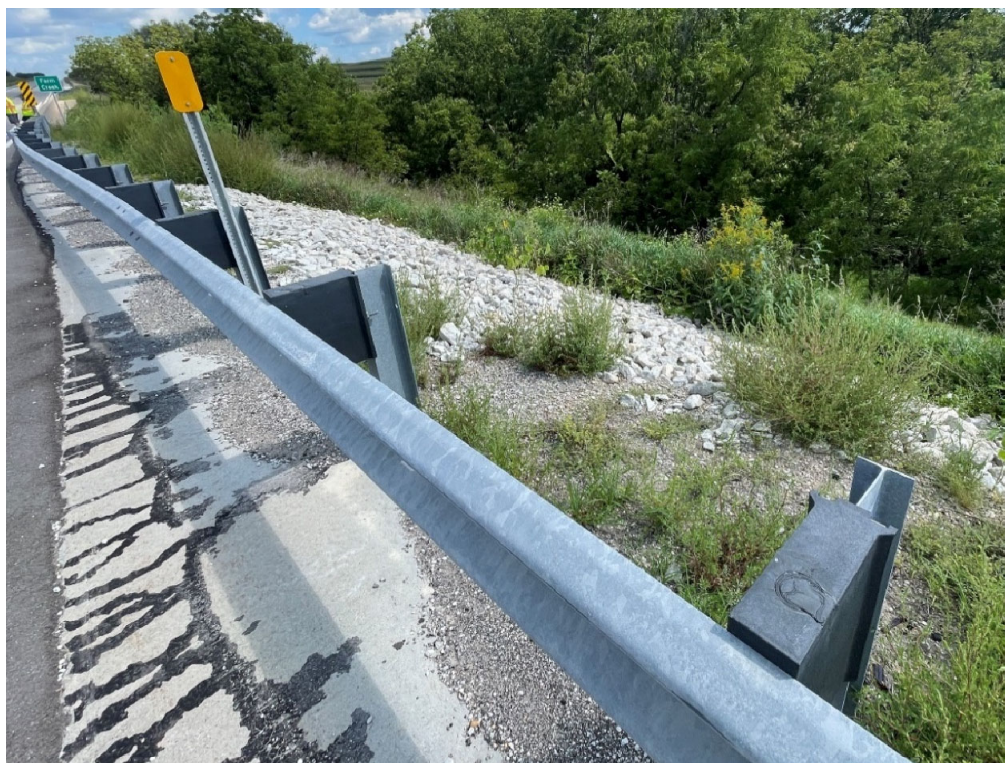
Image 2: Near Approach Slope Protection (South Side)

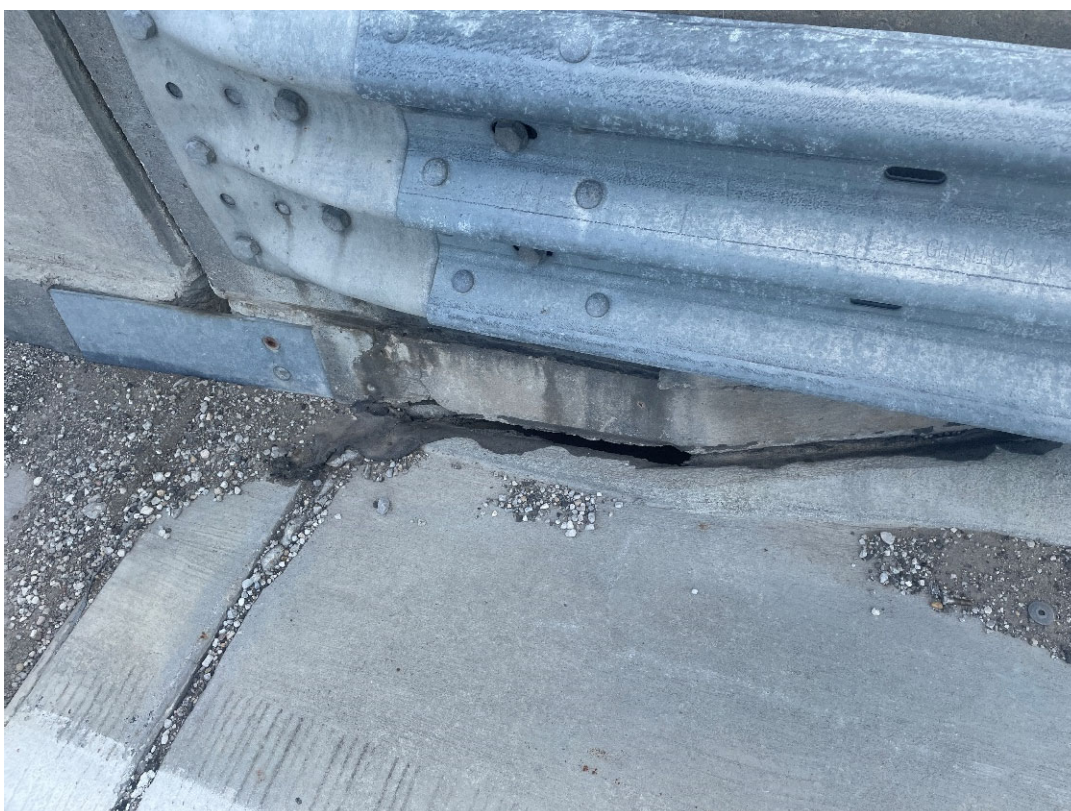
Image 4: Near End Barrier Seal (South Side)

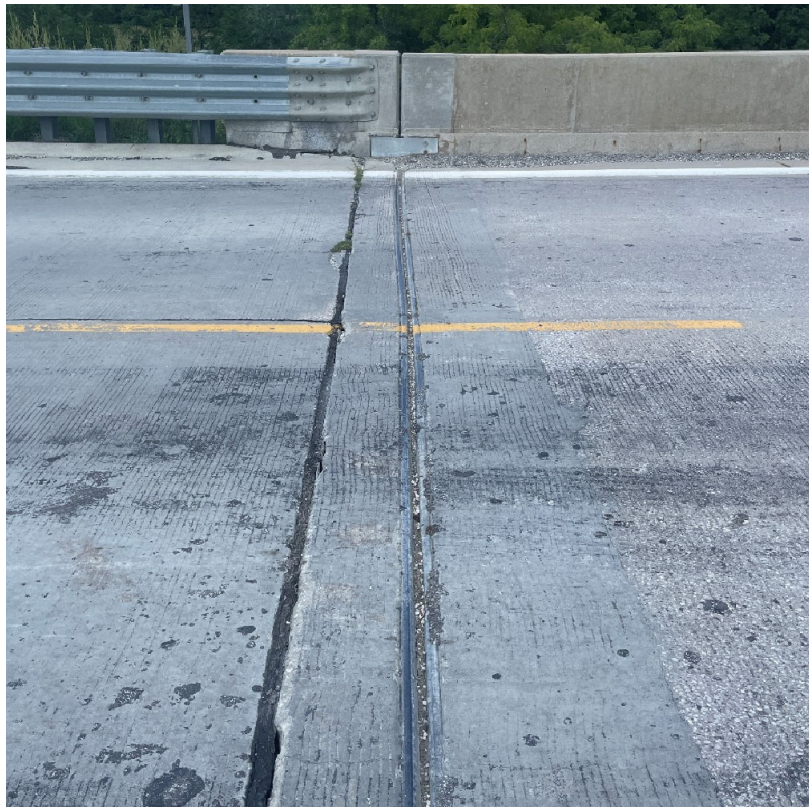
Image 5: Near Abutment Joint (Looking North)

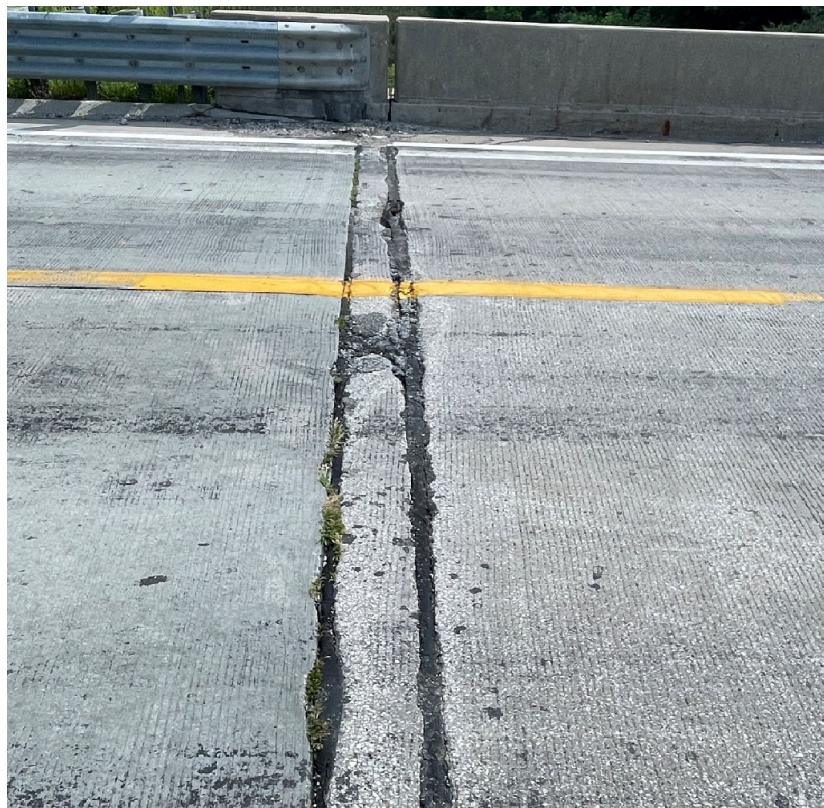
Image 6: Far Abutment Joint (Looking South)

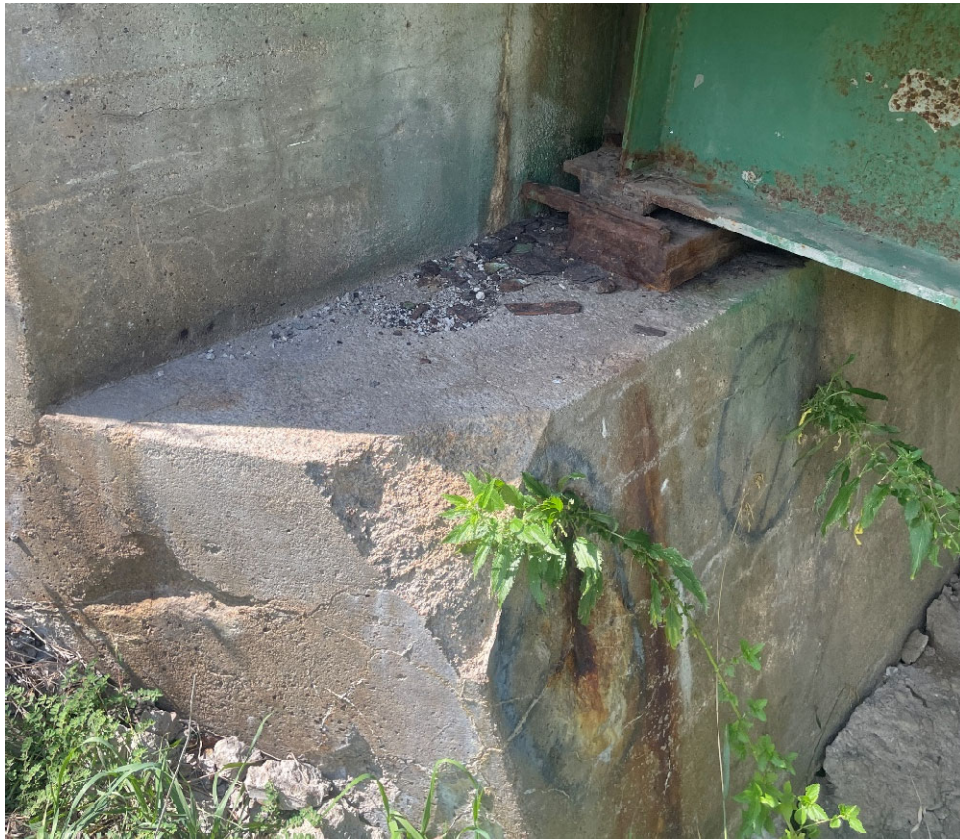
Image 7: Near Abutment Spalling (South Side)

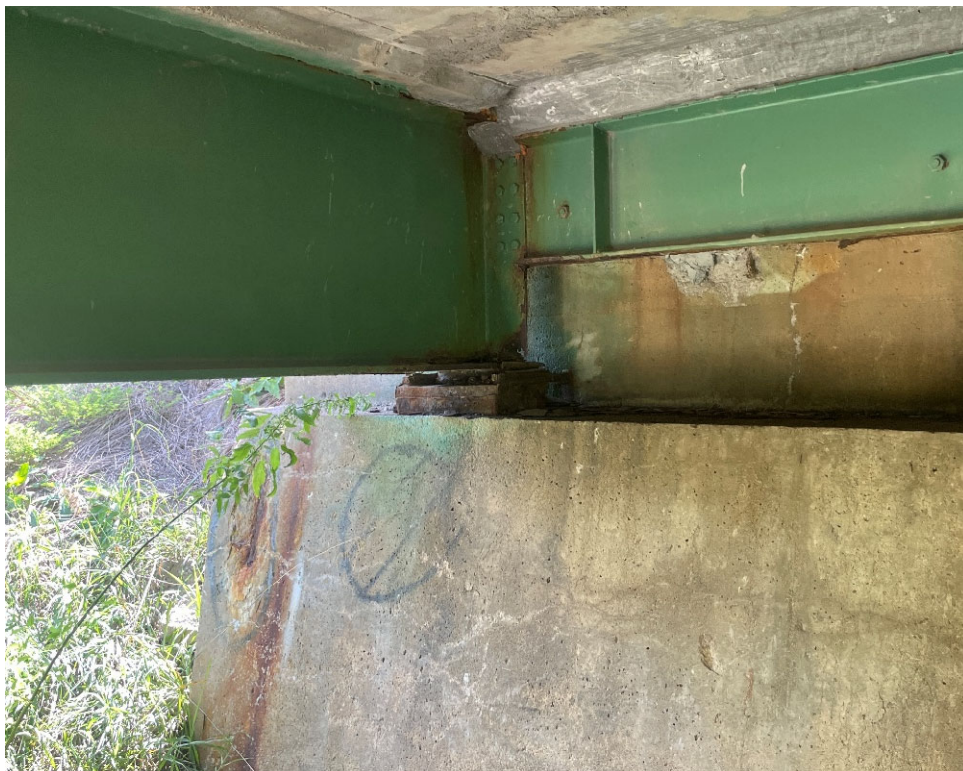
Image 8: Near Abutment Spalling (Looking Northwest)

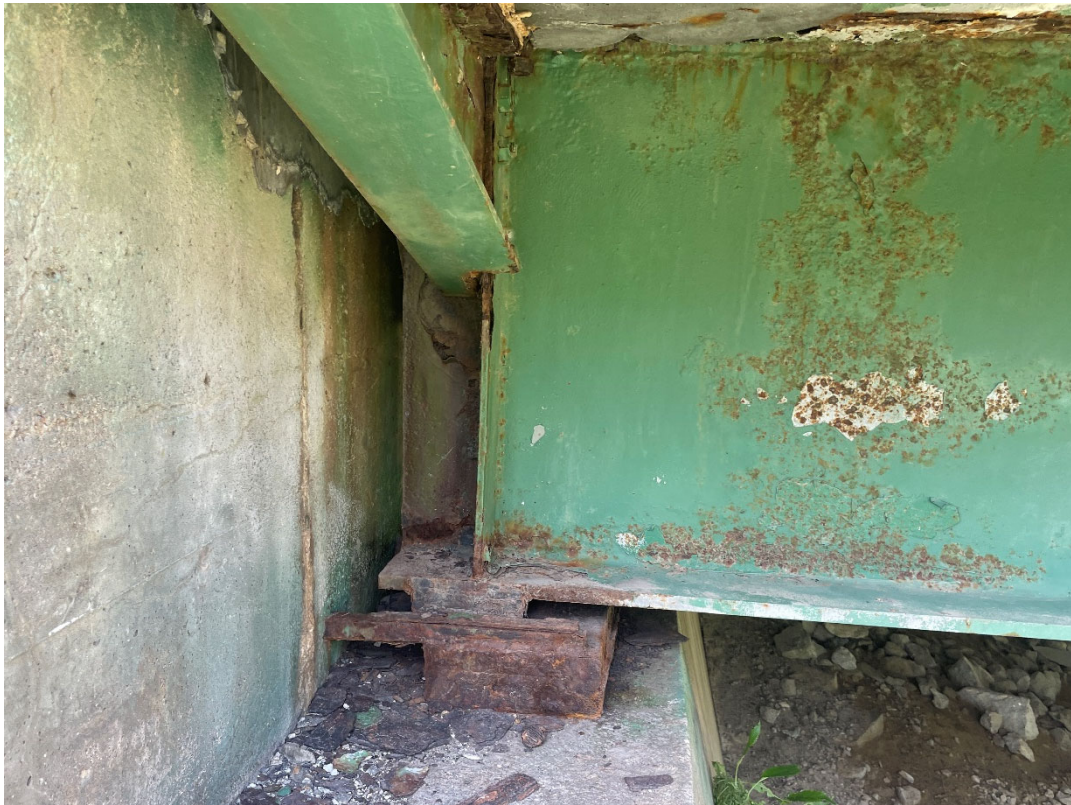
Image 9: Near Abutment Bearing Rusting, Typ.

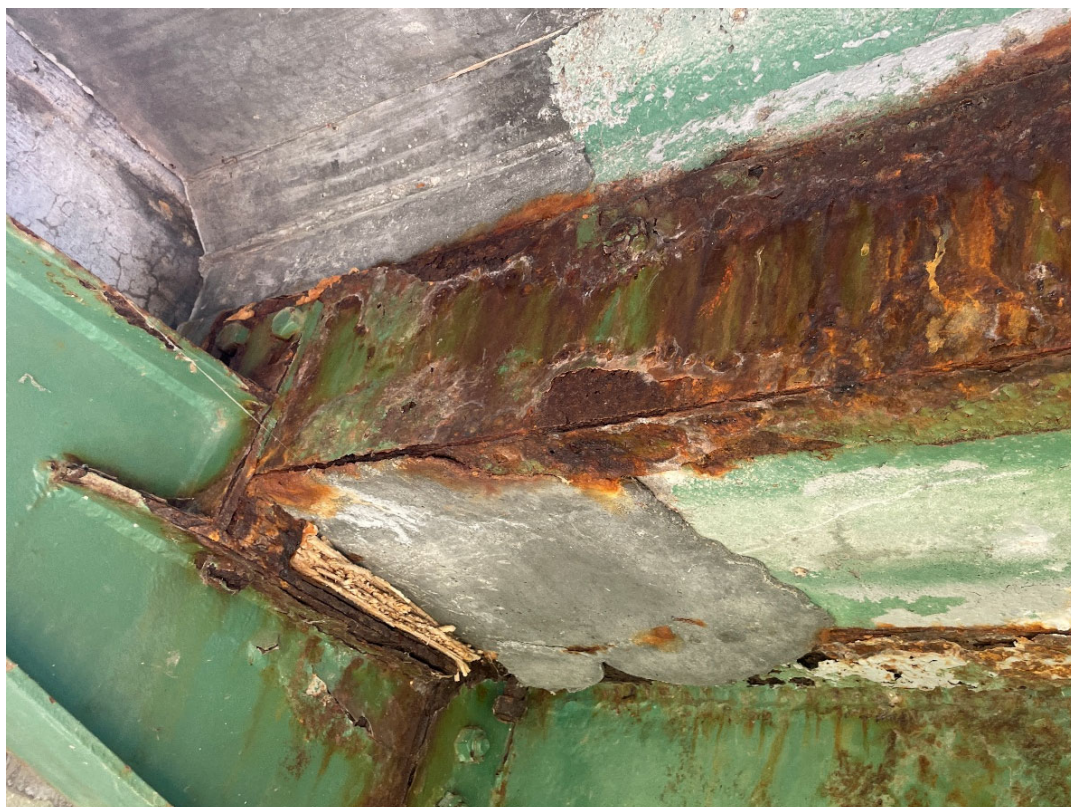
Image 10: Section Loss at Near Abutment Exterior Girder

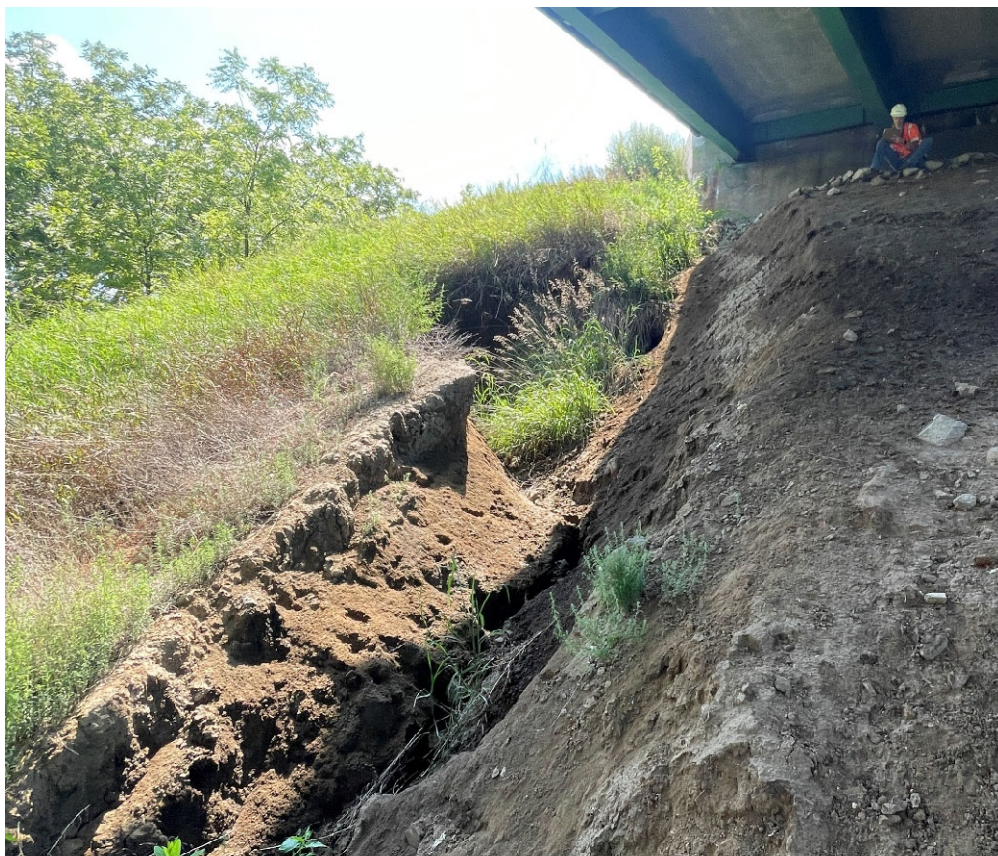
Image 11: Near Berm Erosion (South Side)

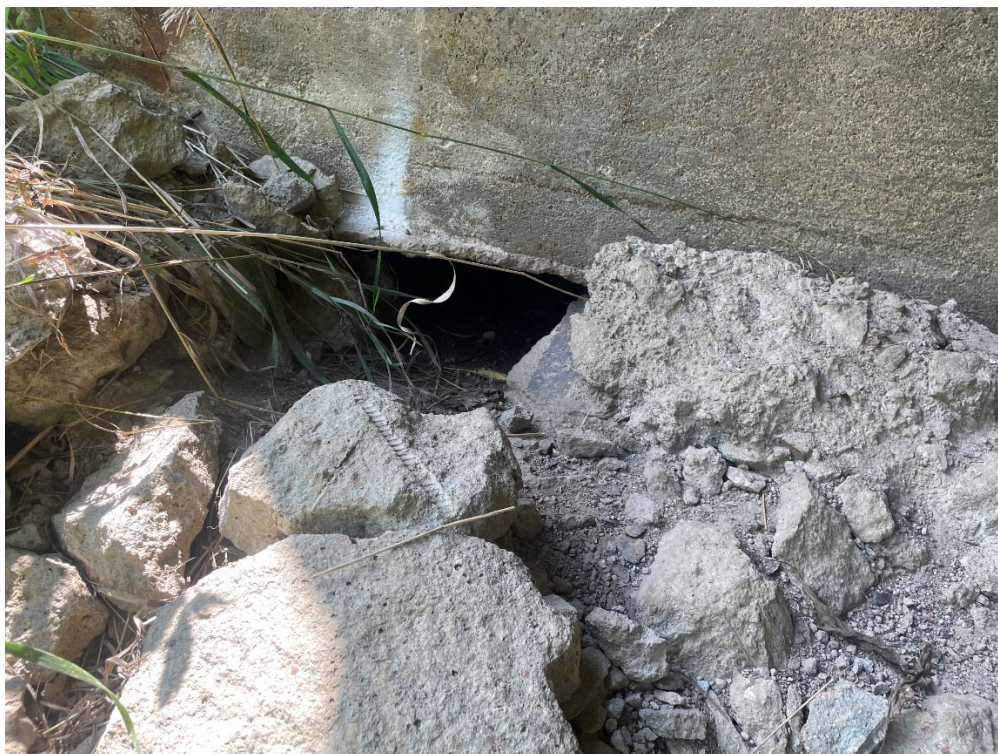
Image 12: Near Abutment Undermining (South Side)

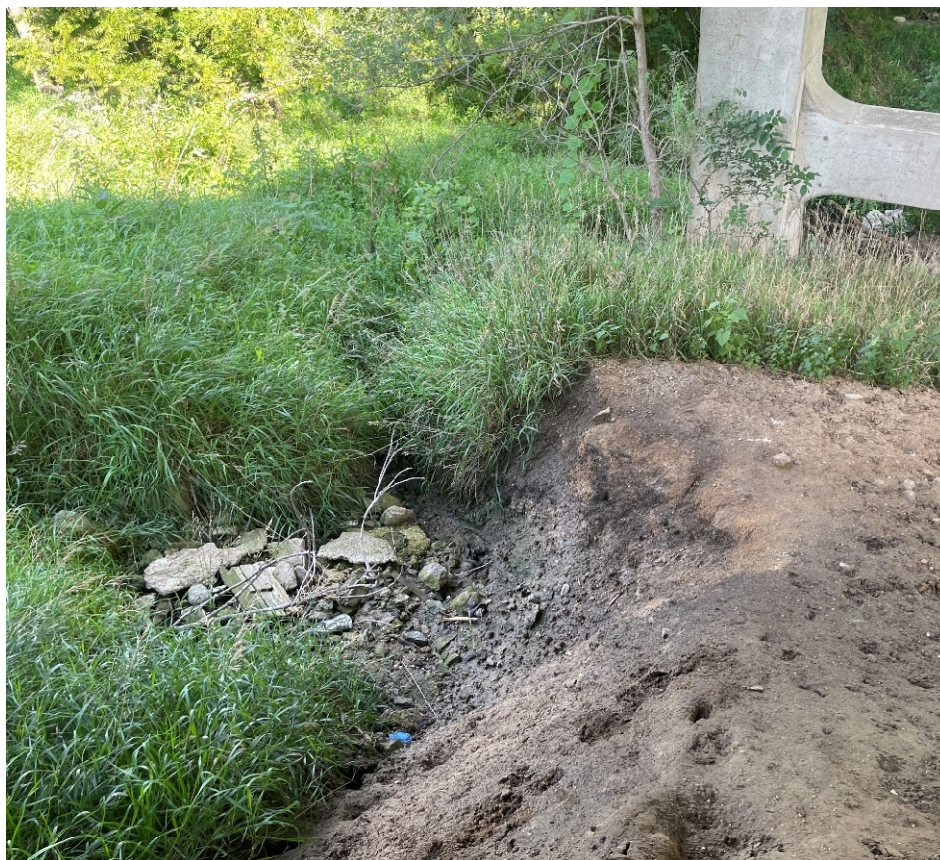
Image 13: Near Berm Erosion below Drain (North Side)

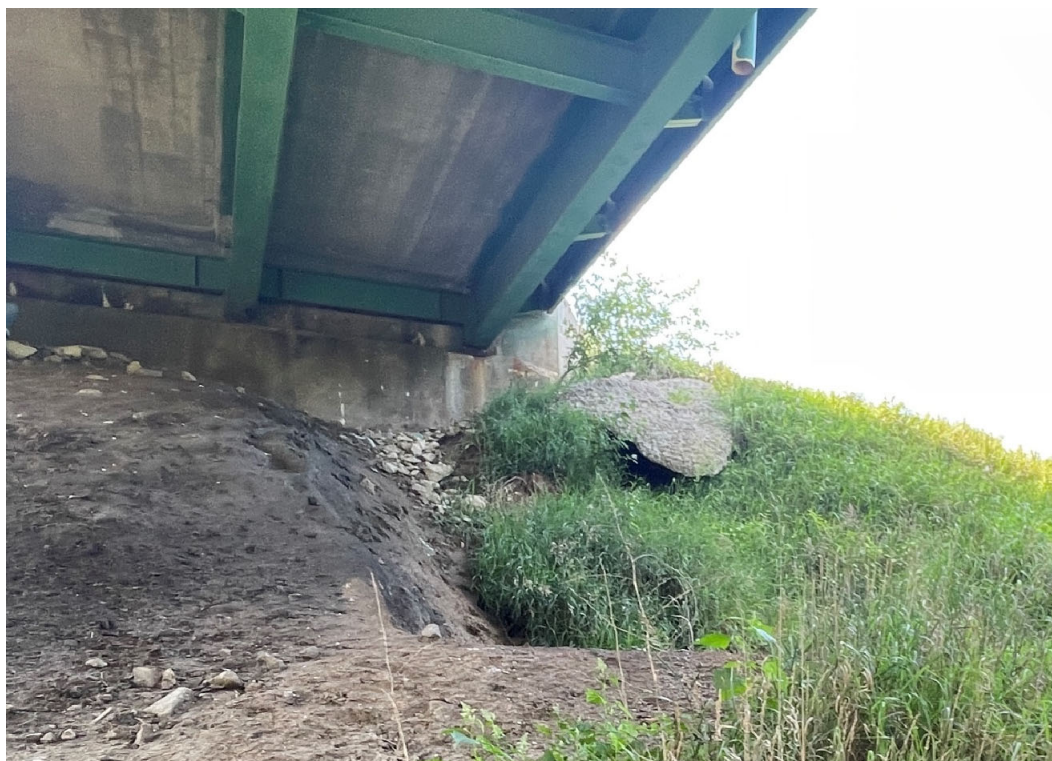
Image 14: Near Berm Erosion (North Side)

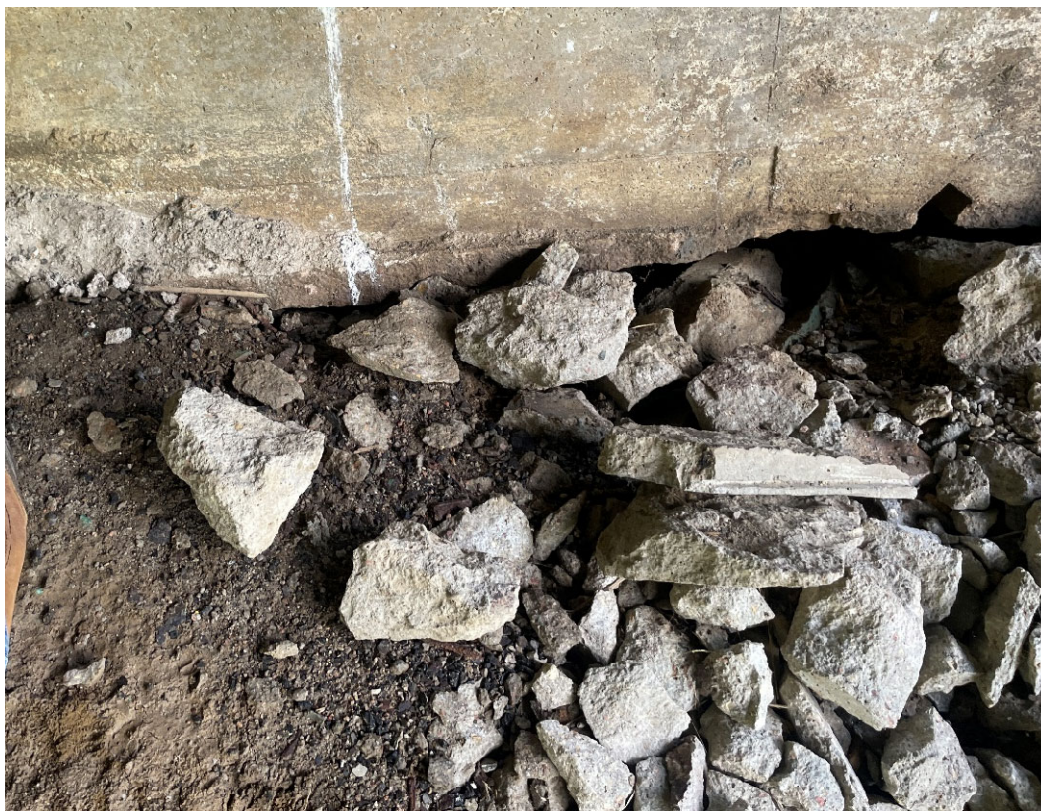
Image 15: Near Abutment Undermining (North Side)

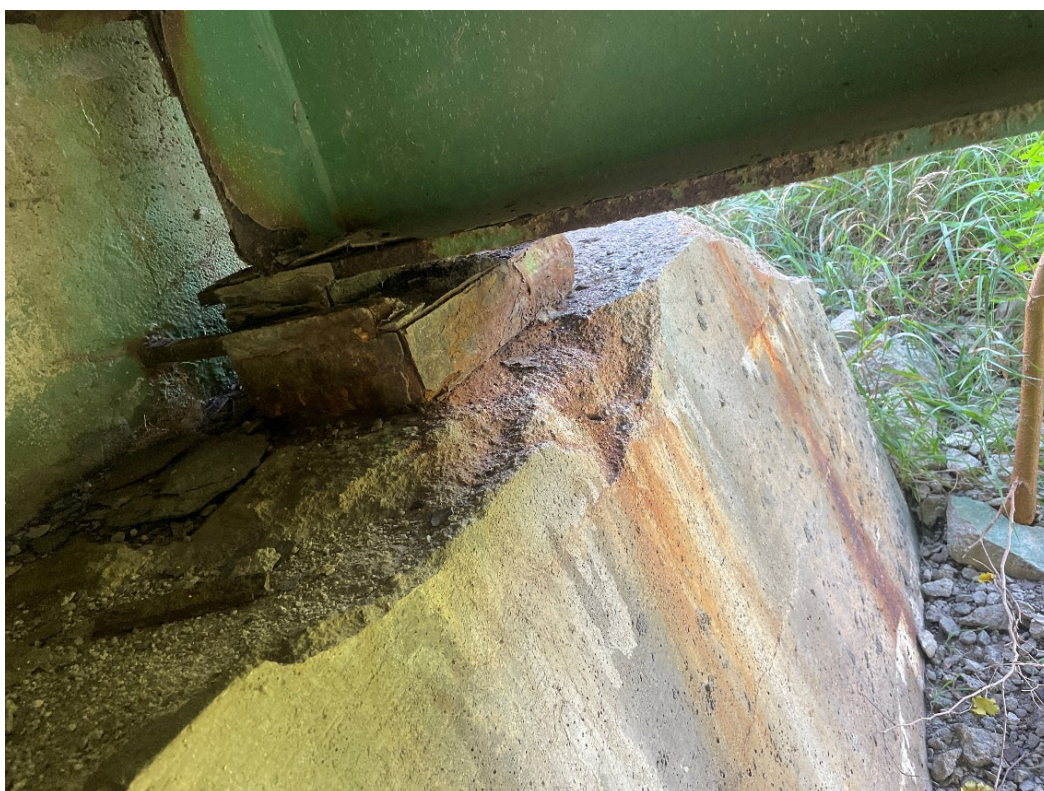
Image 16: Near Abutment Spalling (North Side)

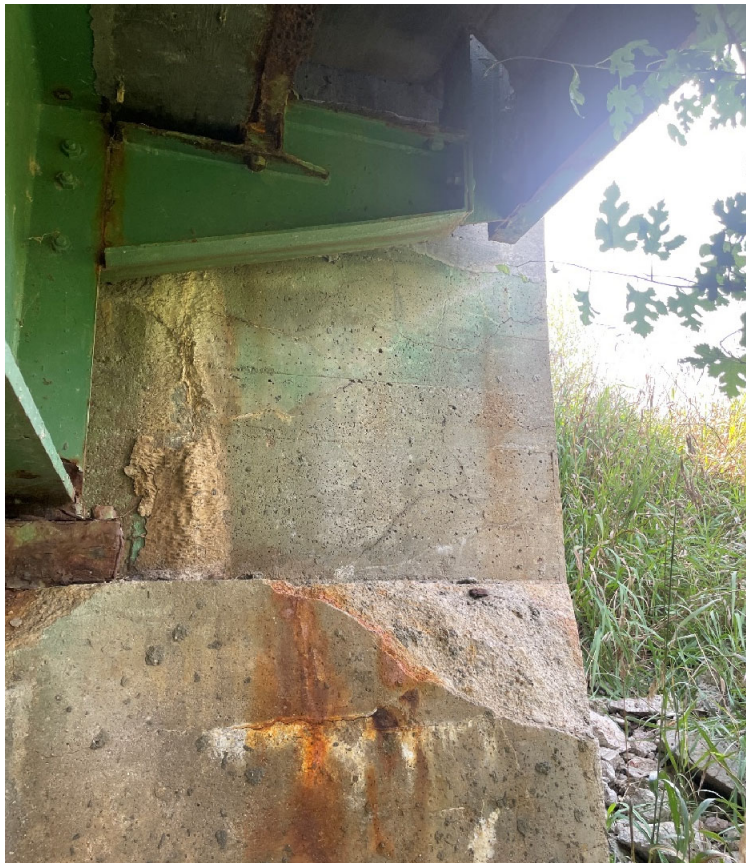
Image 17: Near Abutment Spalling (North Side)

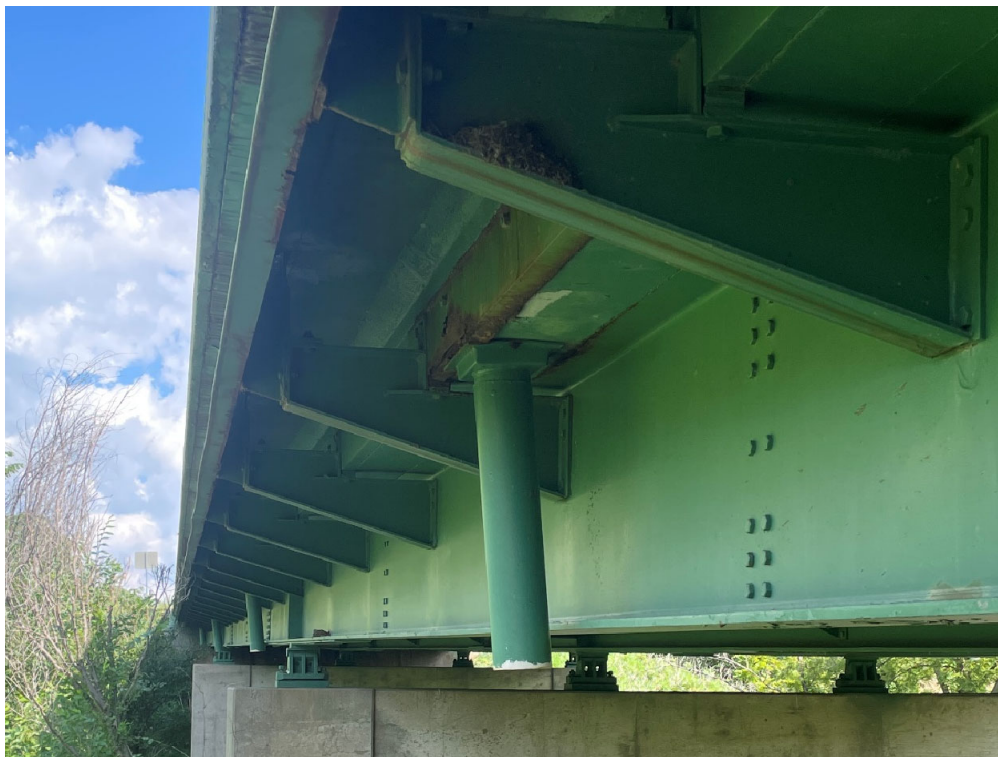
Image 18: Drain Leakage (North Side)

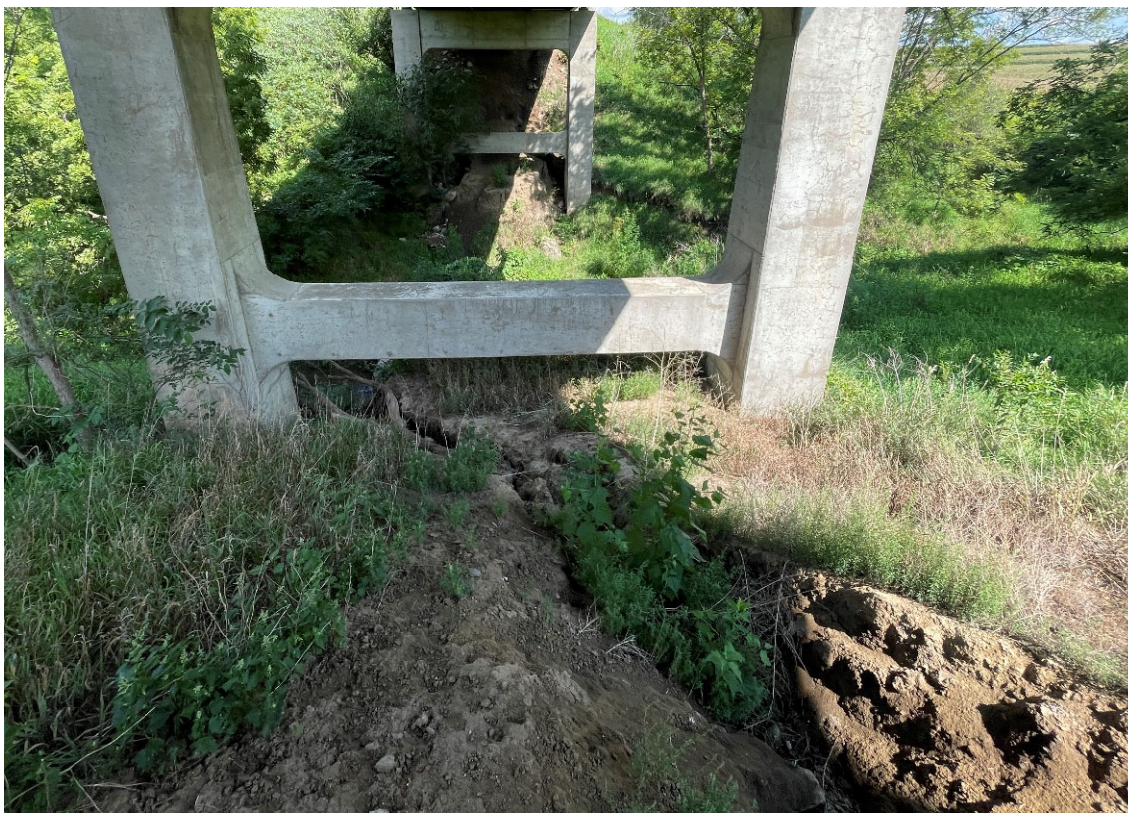
Image 19: Near Berm Erosion (Looking East)

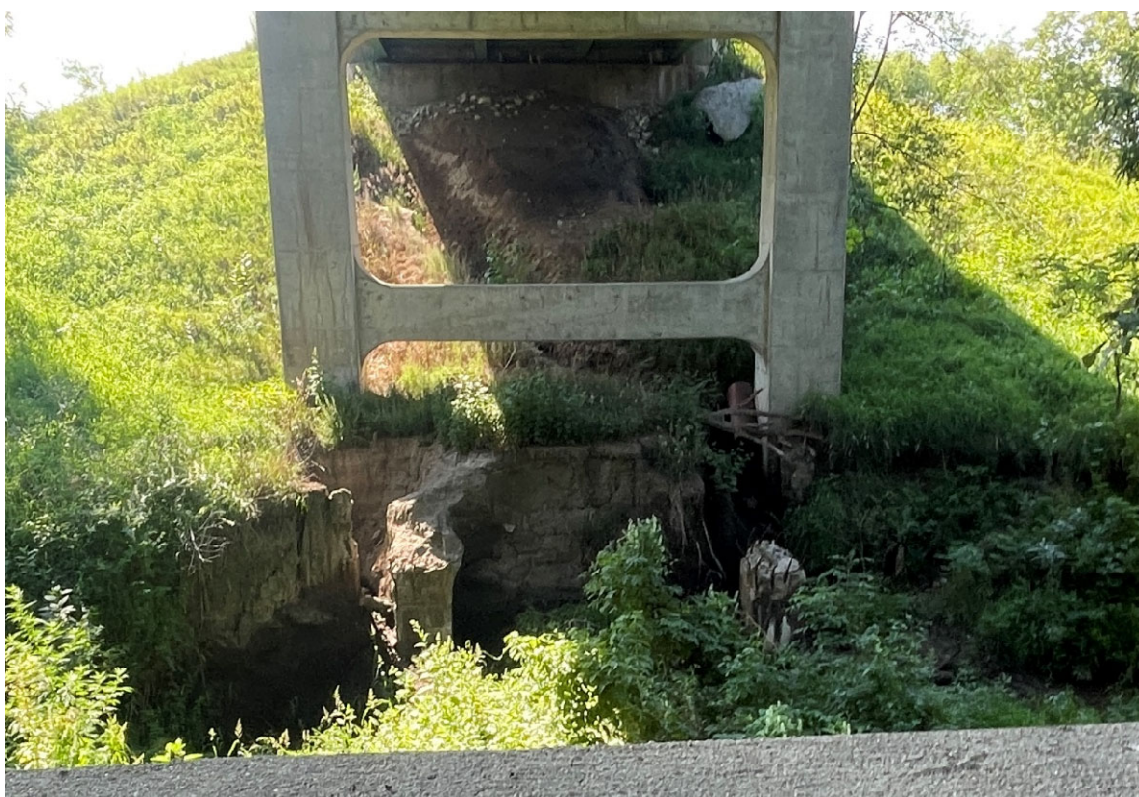
Image 20: Near Berm Erosion (Looking West)

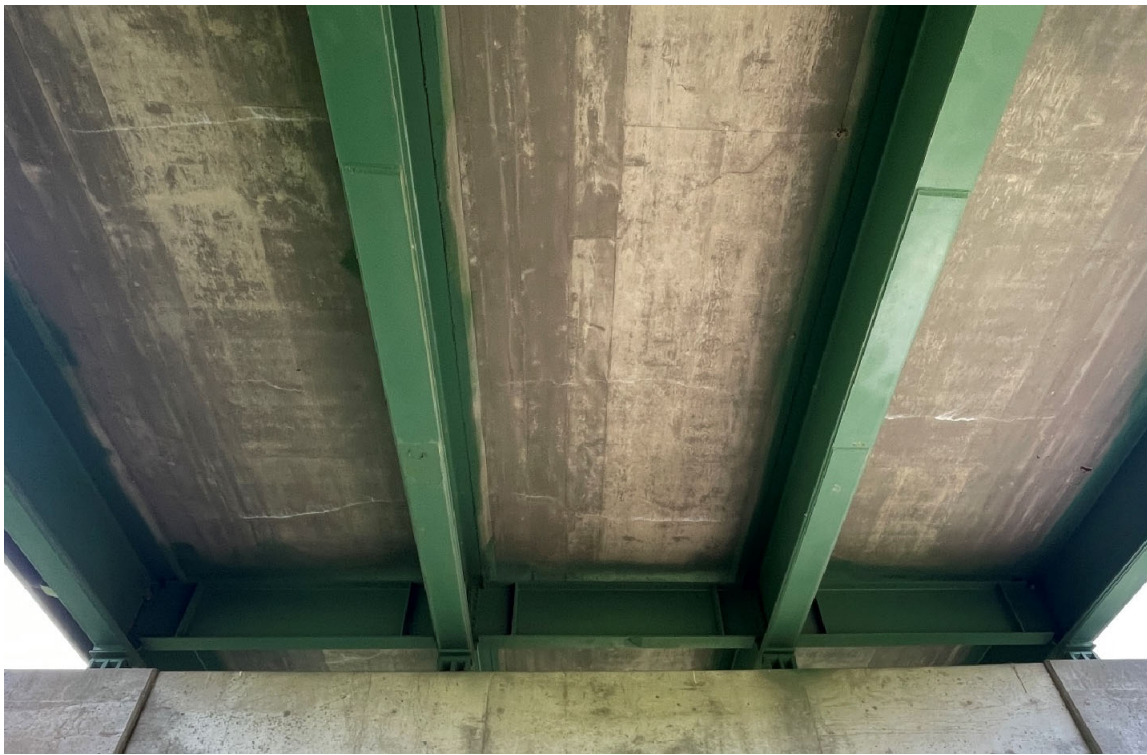
Image 21: Deck Cracking, Typ.

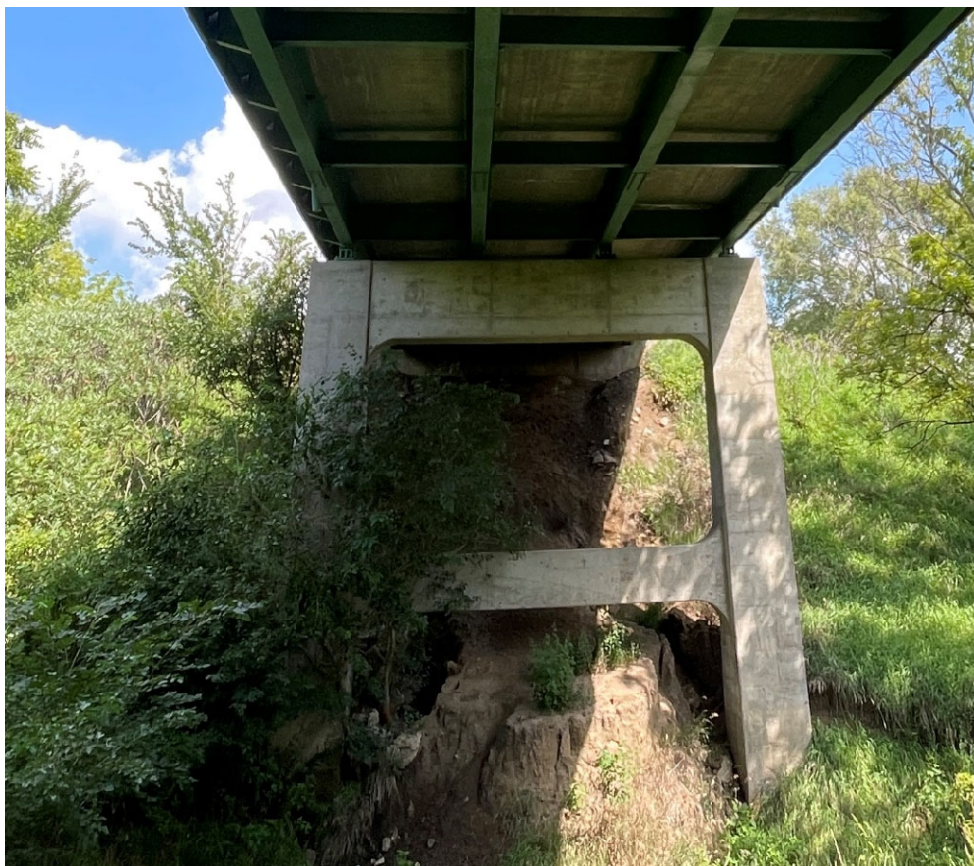
Image 22: Far Berm Erosion (Looking East)

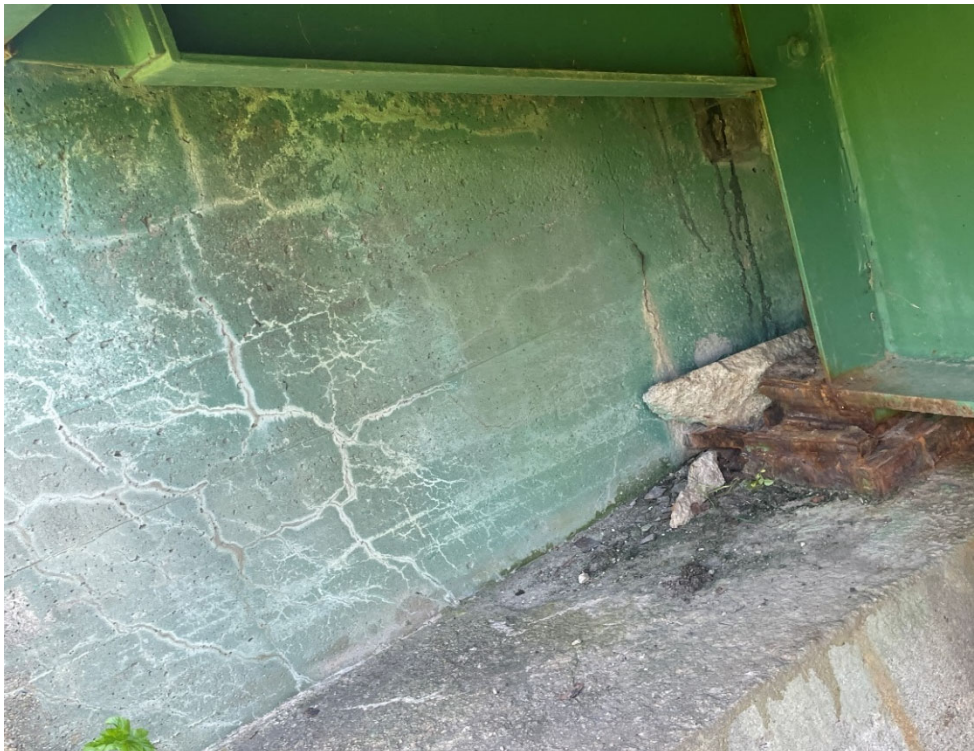
Image 24: Far Abutment Cracking (Looking East)

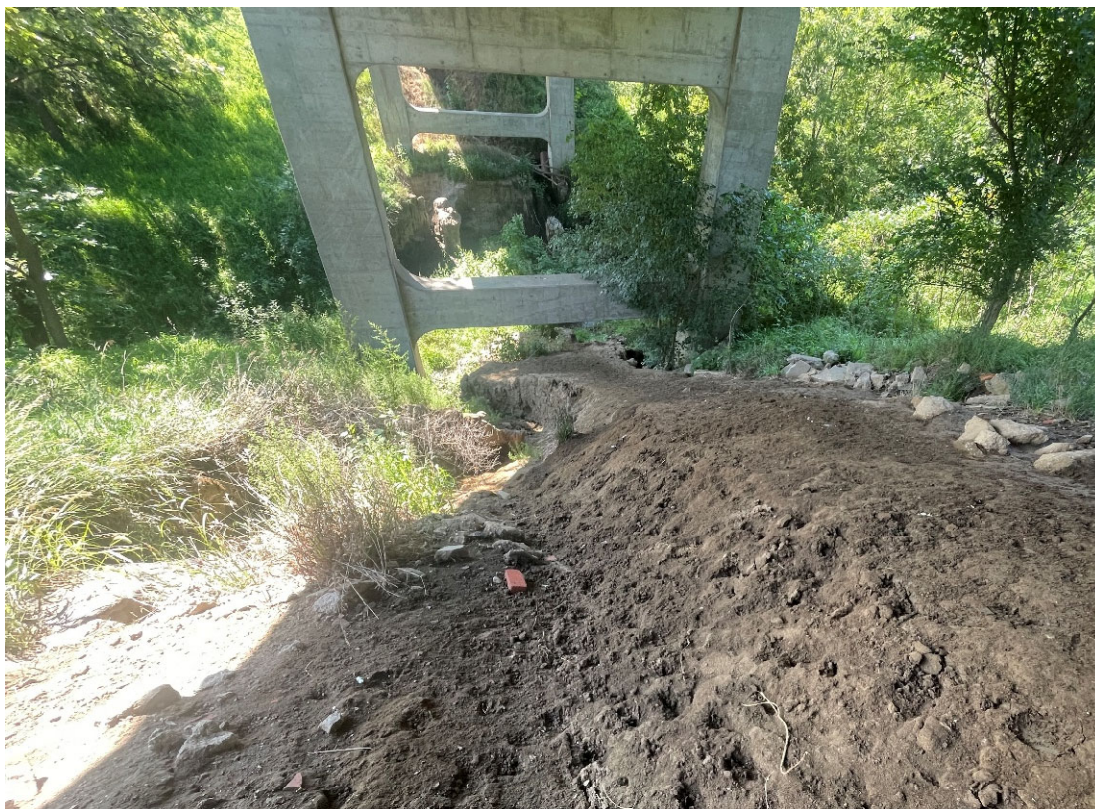
Image 25: Far Berm Erosion (Looking West)

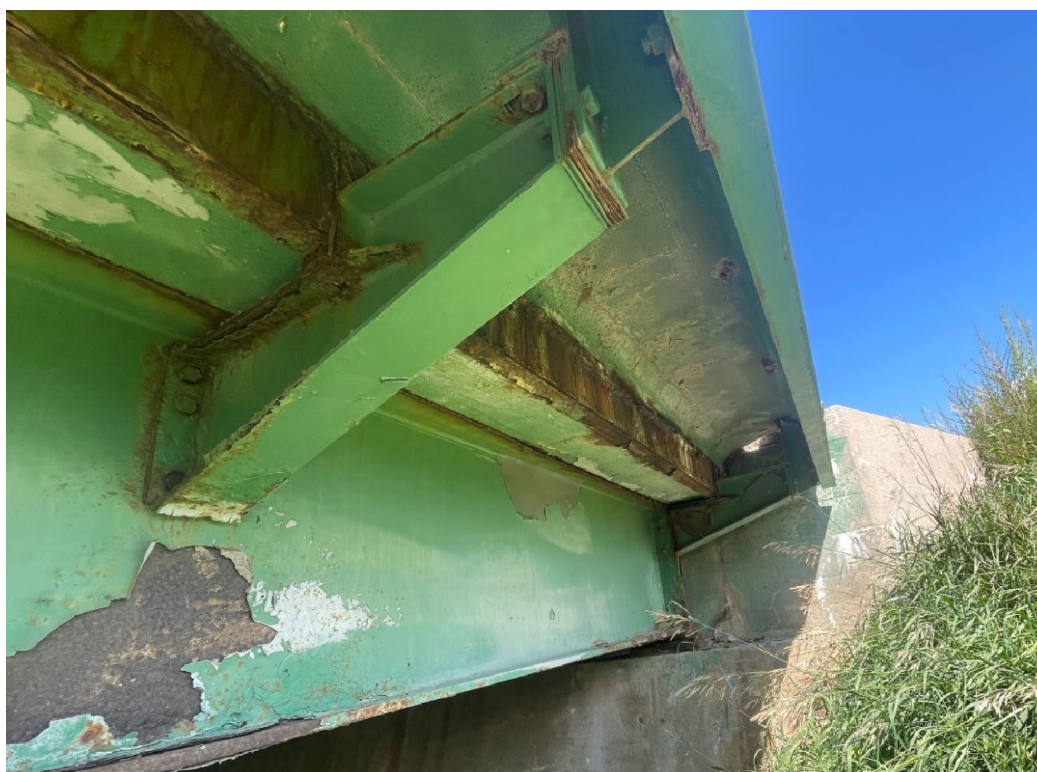
Image 26: Exterior Girder Rusting (South Side)

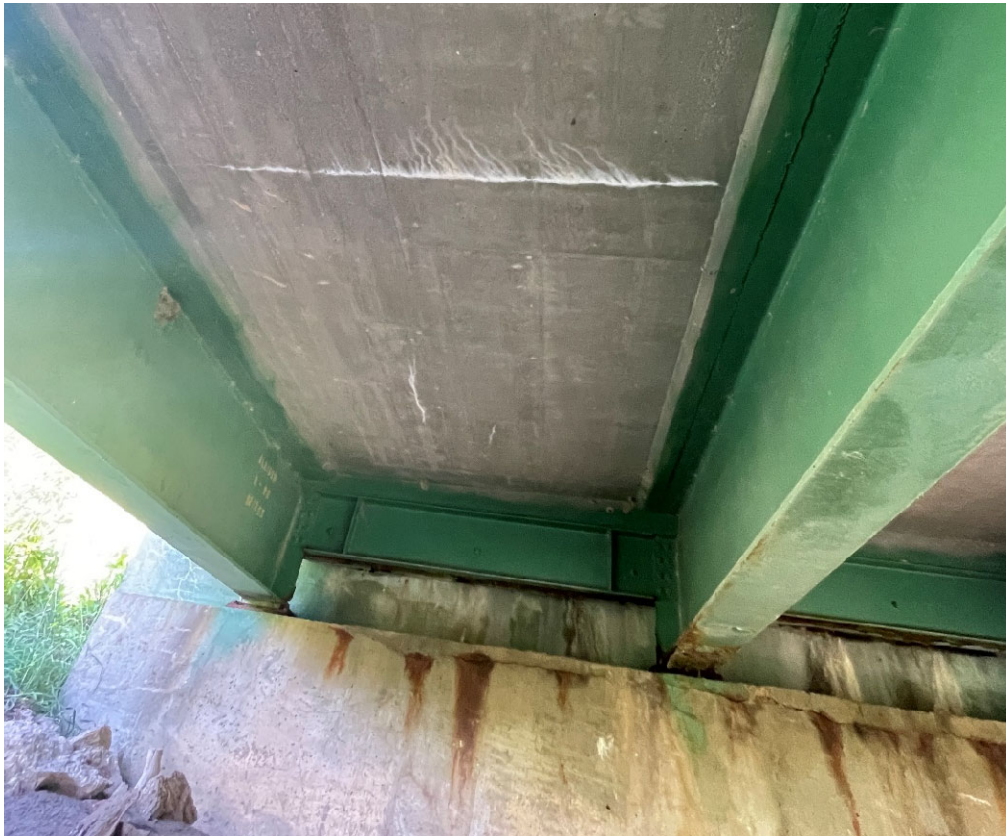
Image 27: Deck Cracking (South Side)

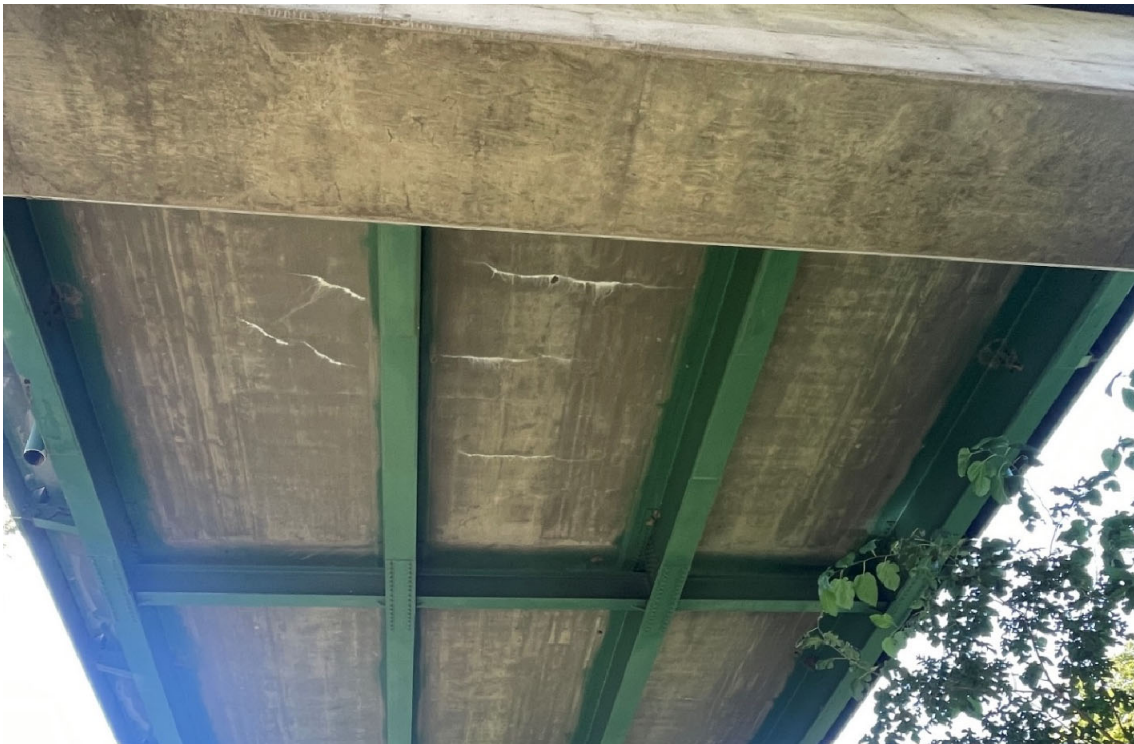
Image 28: Deck Cracking in Middle Span, Typ.

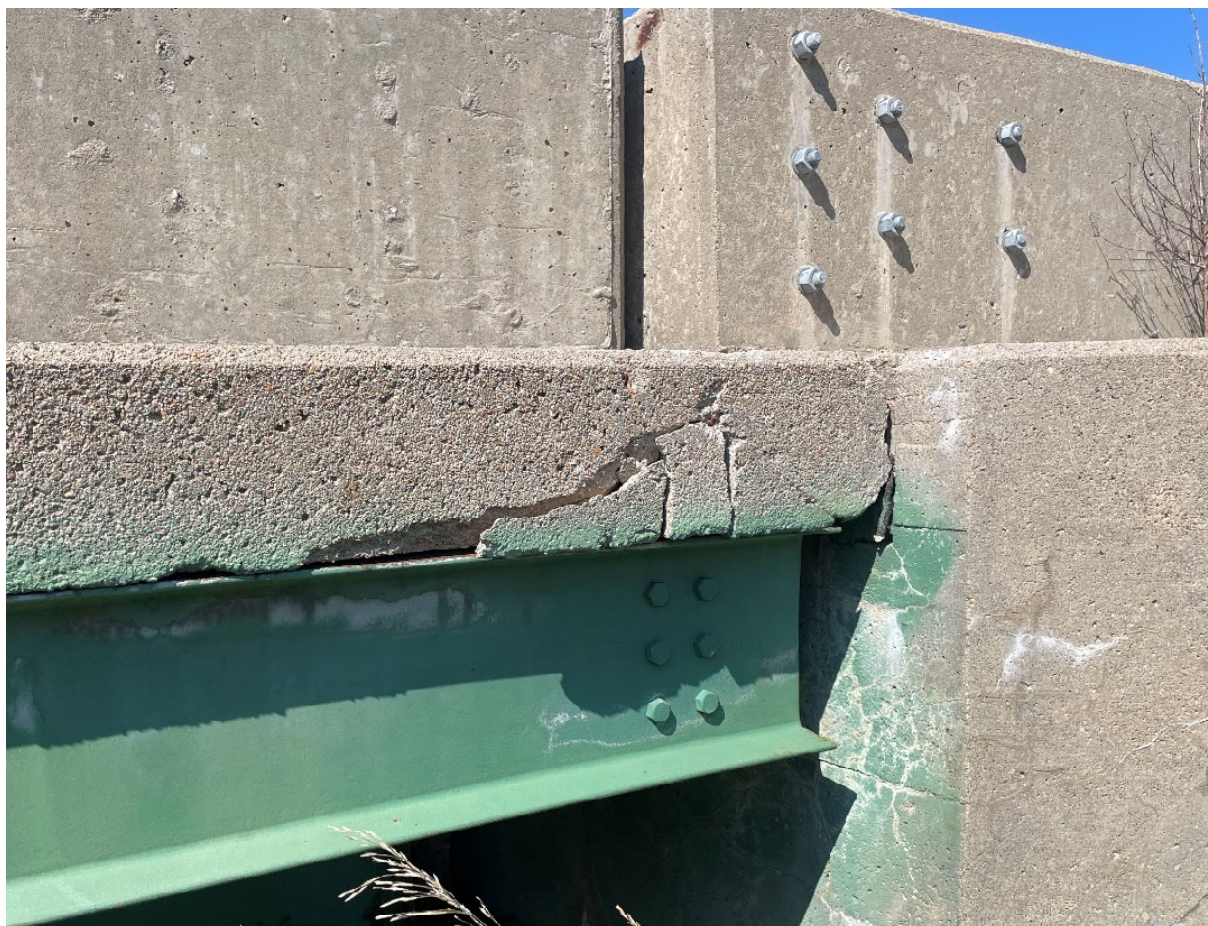
Image 29: Deck Edge Spalling (South Side)
