IOWA DEPARTMENT OF TRANSPORTATION

To Office	District 5	Date	October 22, 2020
Attention	Mark Van Dyke, Assistant District Engineer	Ref No.	Des Moines County BRFN-034-9(235)--39-29
From	Joe Stanisz/WHKS		PIN 19-29-034-020 Design No. 0124
Bureau	Bridges and Structures		File No. 31969 FHWA No. 602880
Subject	Final Concept for Bridge Rehabilitation of a 426'-5 x 54' Pretensioned Prestressed Concrete Beam Bridge. Bridge Maintenance No. 2962.00034

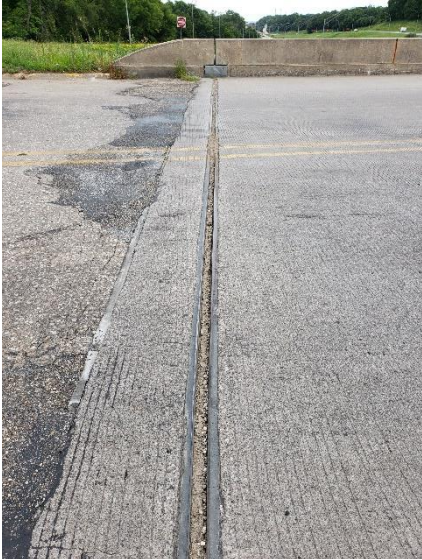
There is debris in the joints, and the north extrusion is corroded and leaking. There are cracks in the deck adjacent to extrusions. Some spalling exists at the south end of the deck.

North abutment joint

4. Remove and replace existing strip seal gland at north end.
5. Perform Class A repair adjacent to extrusions and at south end of deck adjacent to approach CF joint.

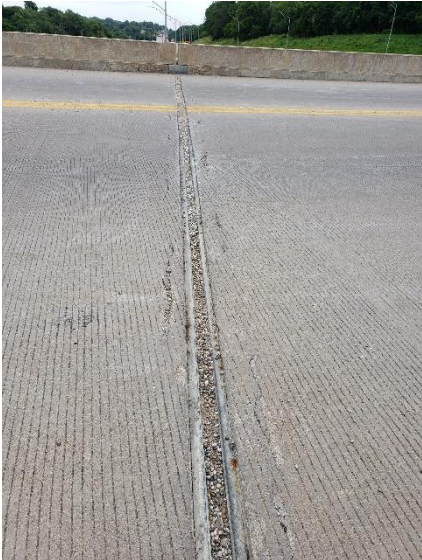
Cracking along pier joint

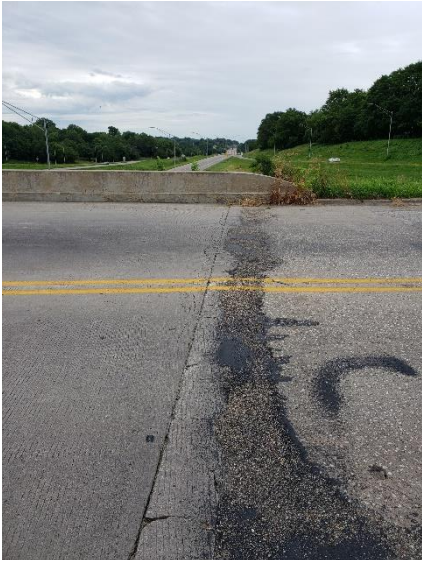
Deterioration at south end of bridge

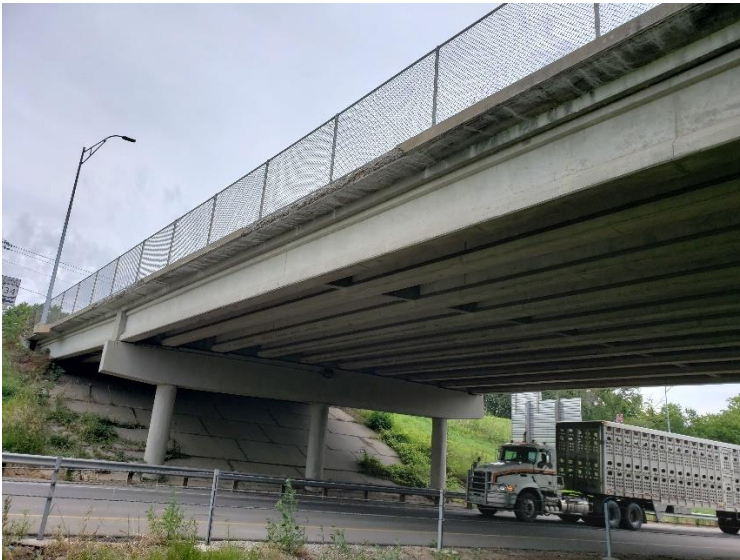
The deck is PC concrete and was overlaid in 1999 (Des. No. 198). There is some cracking in the top of the deck and patches at the south end. There is one leaching crack in the bottom of the deck between the east beams at the north abutment. The sidewalk overhang is severely deteriorated. There is a conduit in the sidewalk and a watermain is attached to the east overhang.

Leaching and spalling on west overhang

1. Replace west sidewalk overhang.
2. Remove and replace the existing chain link fence.
3. Perform concrete repairs along curbs. Clean and seal rails and curbs.

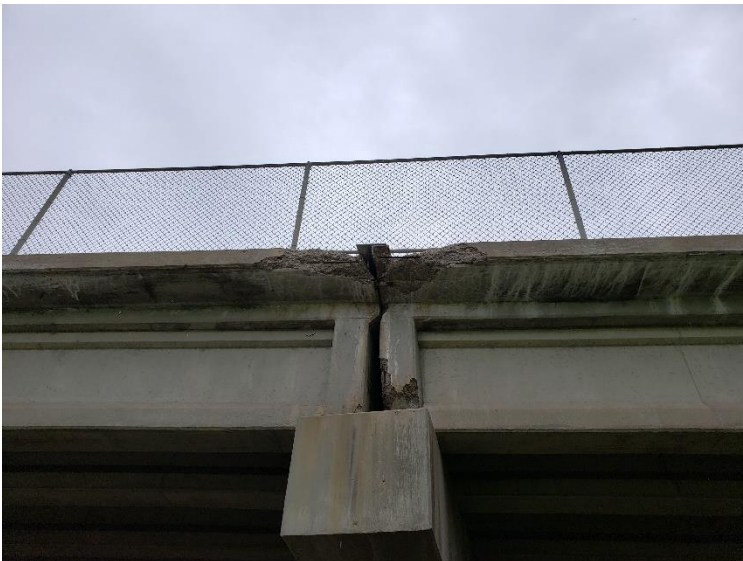
Deterioration of west overhang at pier 1

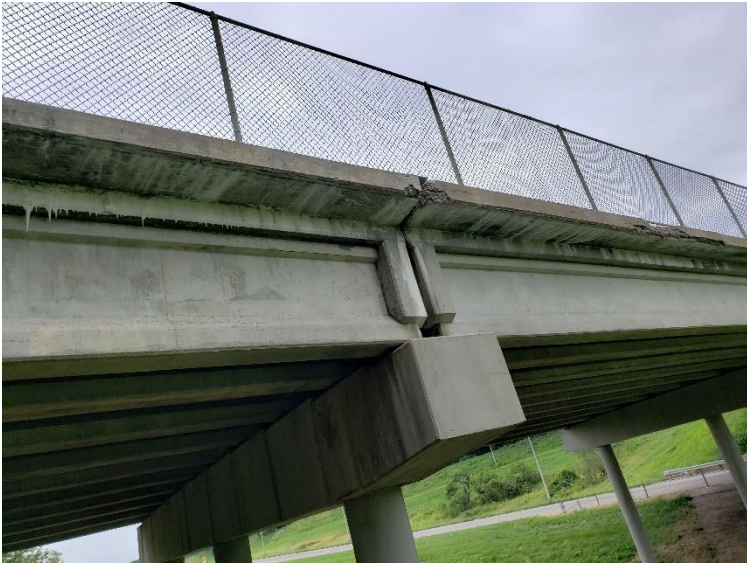
Deterioration of west overhang at pier 3

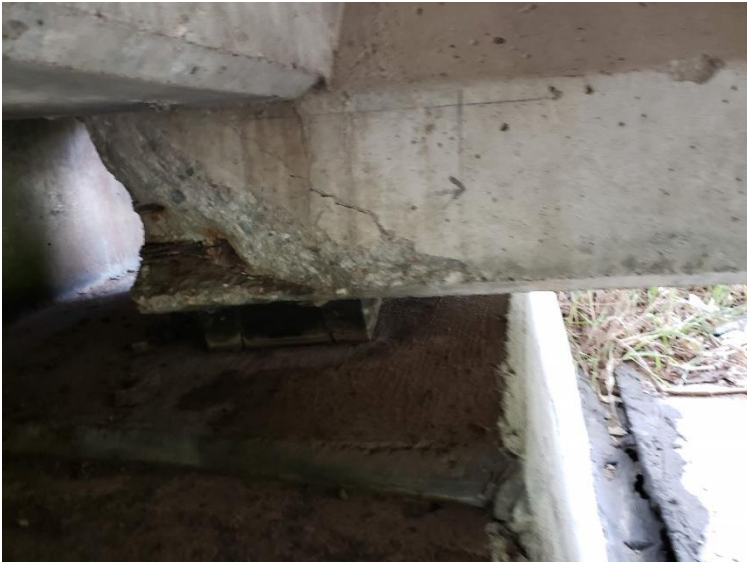
Beam end deterioration was noted at the following locations; west two beams and second beam from the east at the north abutment and the east beam and the third and fourth beams from the west at the south line at the south pier.

Spalled beam end at north abutment

6. Repair deteriorated beam ends. Clean and seal other beam ends below joints.
7. Perform concrete repairs on substructure.
8. Clean and seal backwall, bridge seats, and pier caps below joints.

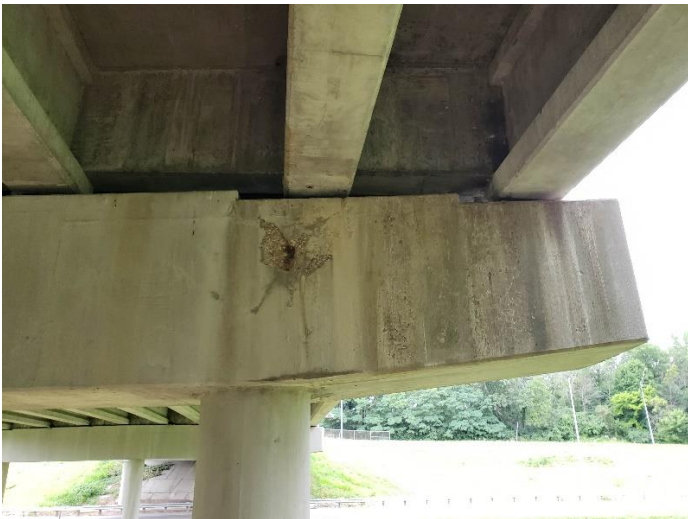
There is spalling and exposed reinforcing on the north face of the west end and the bottom of the east end of pier 3. The west mask wall at the north abutment is cracked and leaching. Concrete slope protection on the south end is shifting down the slope with some panels buckling. There is an 8" gap at the face of the abutment that has been filled with grout.

North face of west end of pier 3

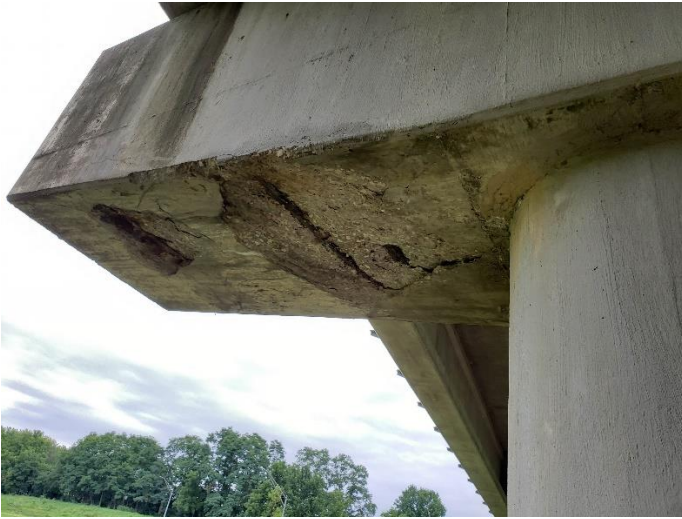
East side of pier 3 overhang

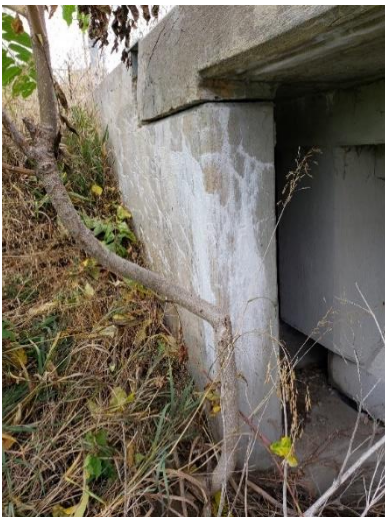
Northwest maskwall leaching

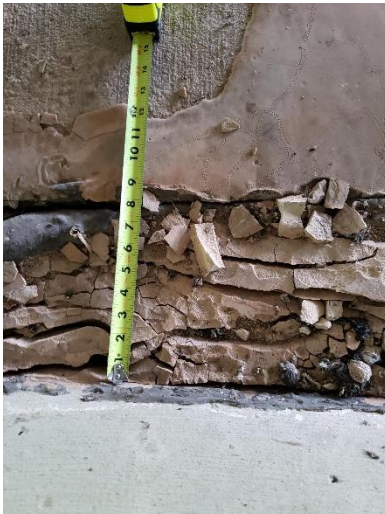
Gap at top of slope protection

9. Replace paving notches.
10. Replace concrete slope protection at south berm with macadam slope protection.
11. Remove and replace 80 ft of the south approach pavement and sidewalk ramps at all four corners of sidewalk at the south ramp intersection.

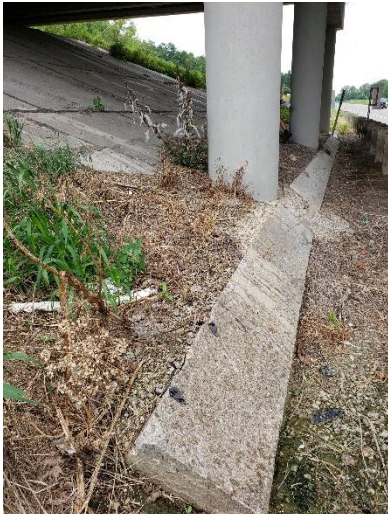
Toe of south abutment concrete slope protection

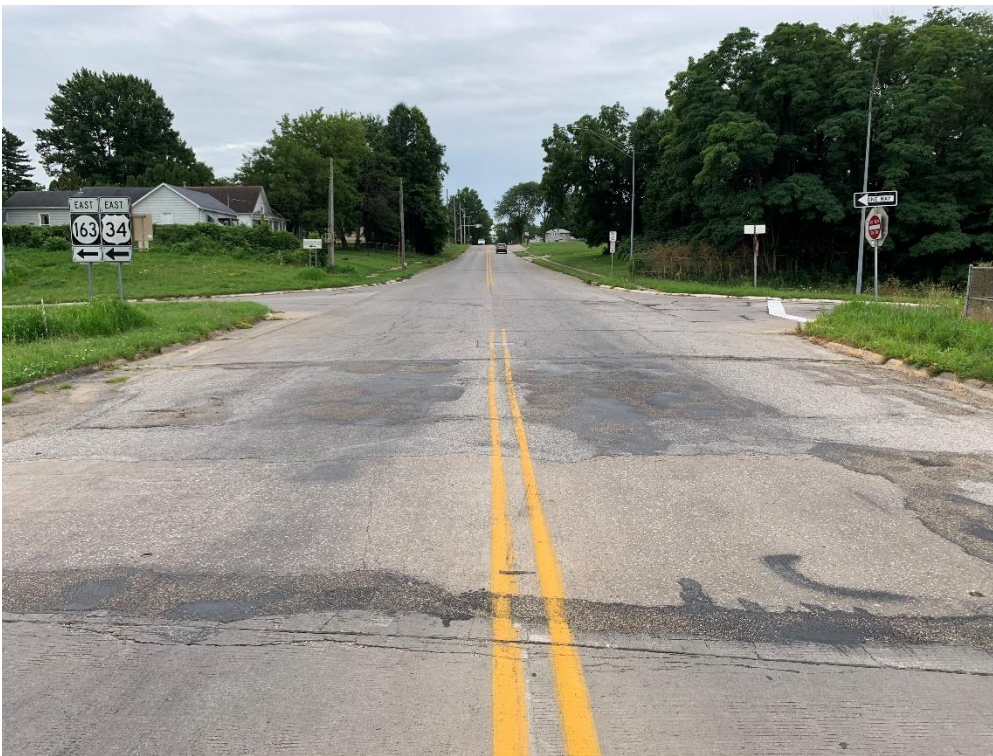
The approaches are in poor condition.

North approach looking north

12. Remove and replace 16.5' of double reinforced north bridge approach and all four corners of sidewalk at the north ramp intersection.
13. Remove and replace all sidewalk adjacent to the approach replacement and bridge rails up to the abutment.

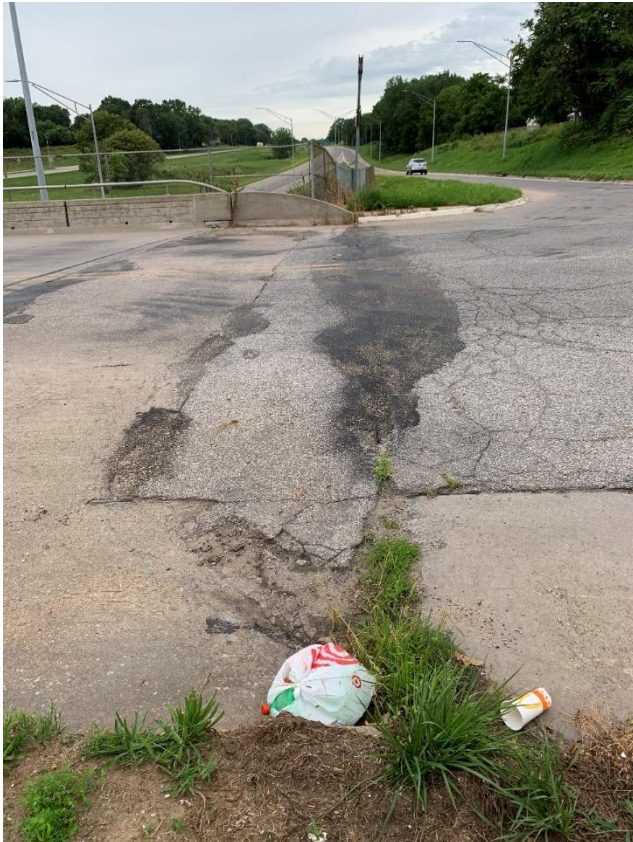
South approach looking east
