IOWA DEPARTMENT OF TRANSPORTATION

BRFN-063-1(96)--39-26

Design No. 125

Subject Final Concept for Culvert Repair of Twin 10' x 12' x 95' RCB
Bridge Maintenance No. 2622.2S063

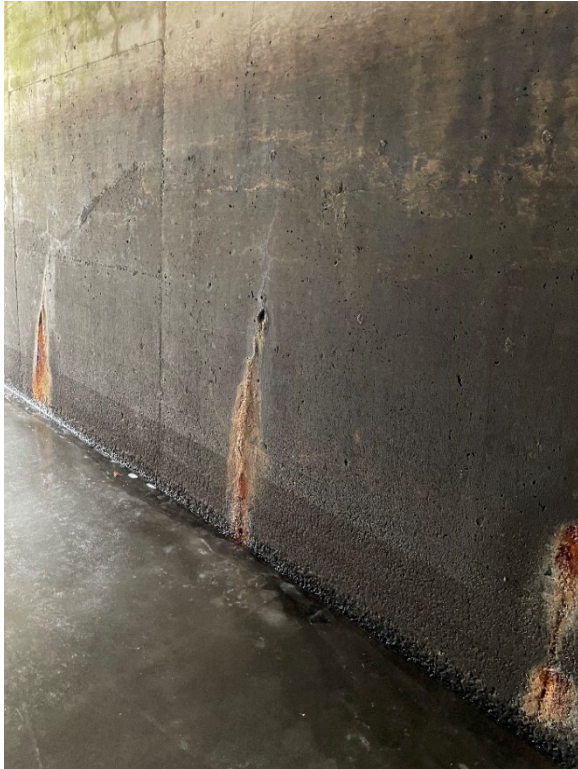
The culvert barrel sections are generally in fair to good condition. The walls have vertical hairline cracking at approximately 8'-10' cts. Several of the cracks are leaching with rust stains and a few isolated spalls. Deterioration of top slab is isolated to construction joints and includes map cracking, leaching and staining. The center construction joint of both barrels has opened, forming a 3" gap at the base of the wall (tight at top). The steel brackets across the joint are in place. The north barrel, north wall is losing fill at this joint location causing a void to form which is approximately 3' deep, 4' tall and 4' wide.

Typical Cracking in Wall

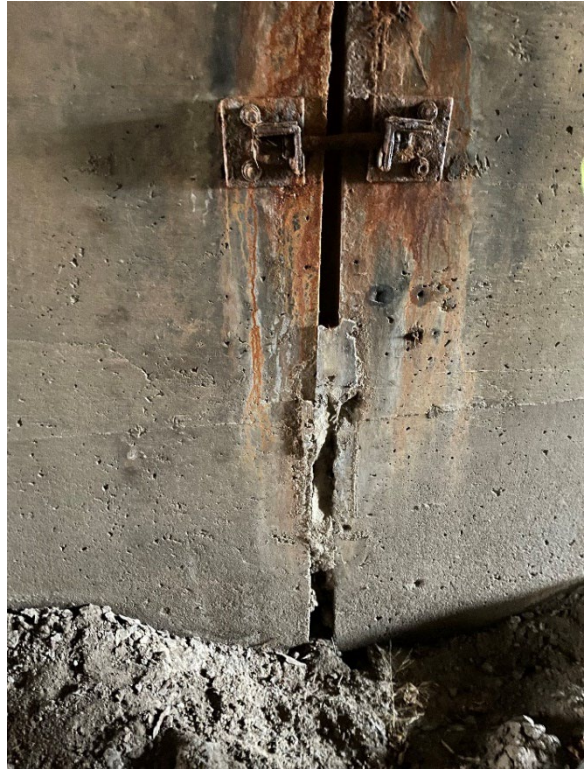
Bracket in Place in South Barrel

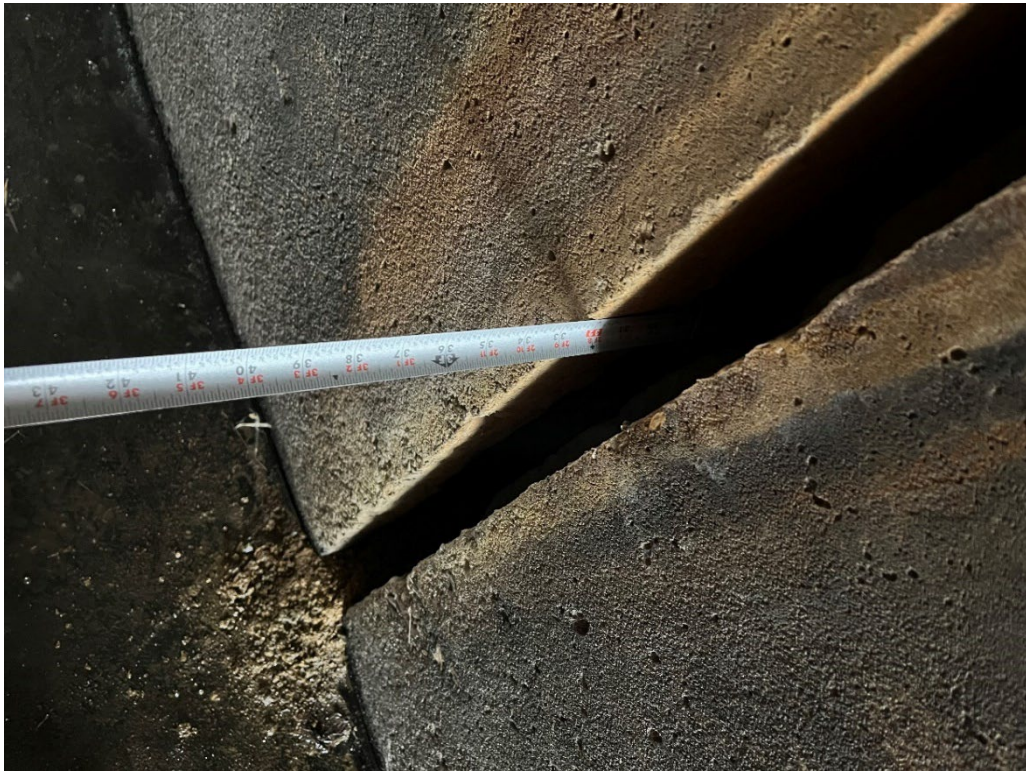
Void at Center Construction Joint of South Barrel

1. Use flowable mortar to fill void and gaps in center construction joint. (This will be performed by the District under contract work, and is not included in the Estimate.)
2. Perform concrete repairs on the wingwalls.
3. Clearing and grubbing to remove tree and other vegetation from aprons.
4. Remove sediment from the south culvert barrel and aprons.
5. Place revetment at aprons to stabilized banks and mitigate scour.

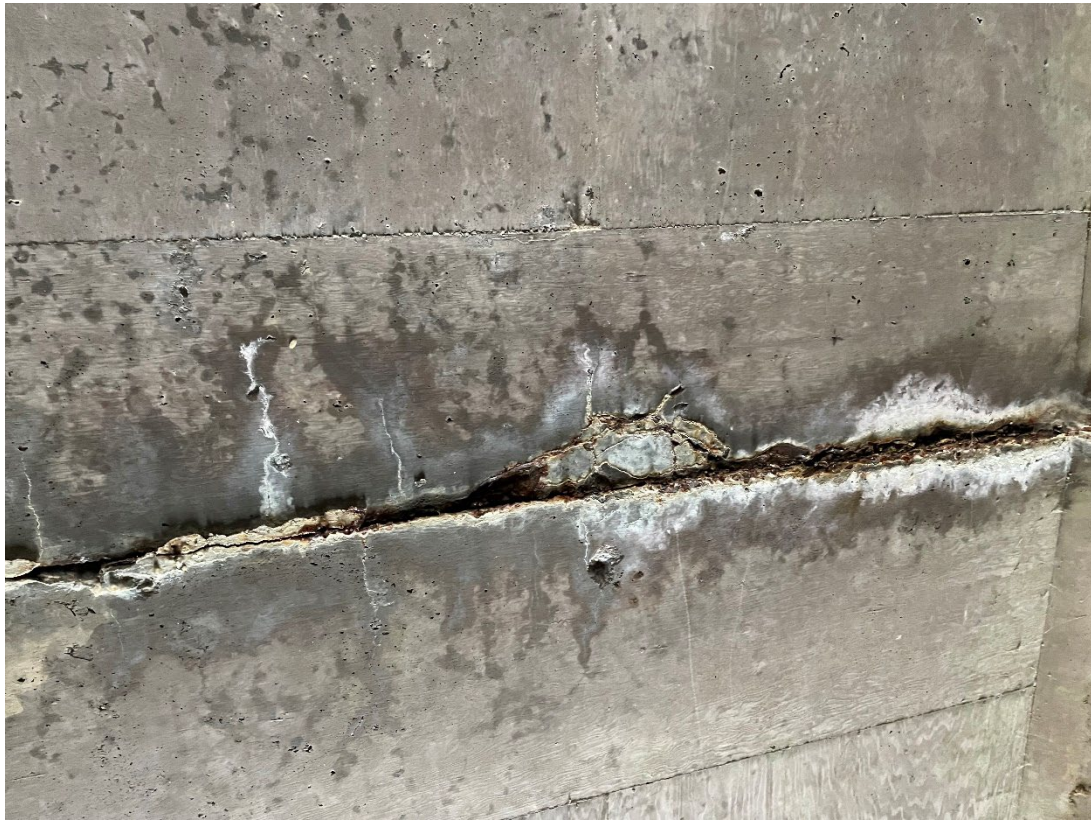
Typical Top Slab at Construction Joint

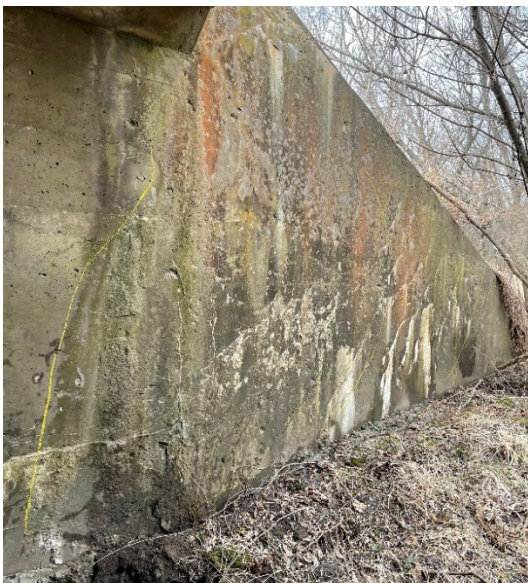
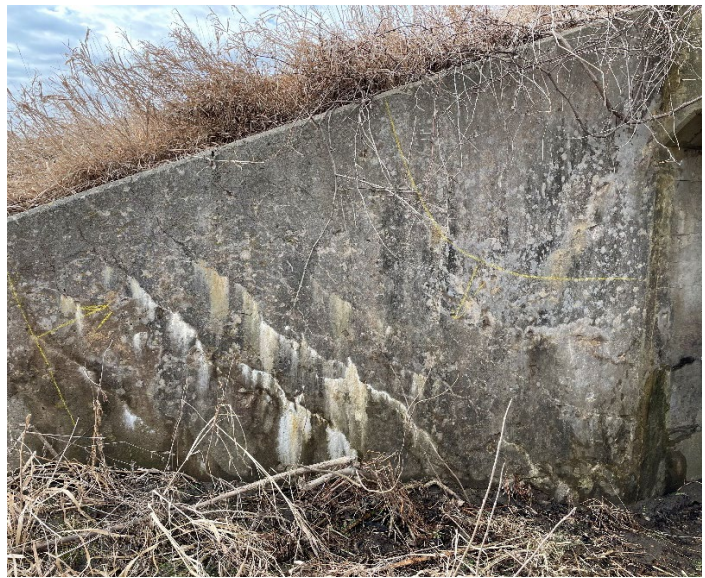
The wingwalls are in fair condition. Large areas of delamination with map-cracking, leaching and staining are typical for each wing. Approximate areas of delaminated per wing are as follows: Northwest 50 sf, Northeast 8 sf, Southwest 100 sf, and Southeast 50 sf.

Deterioration at Southwest and Southeast Wings

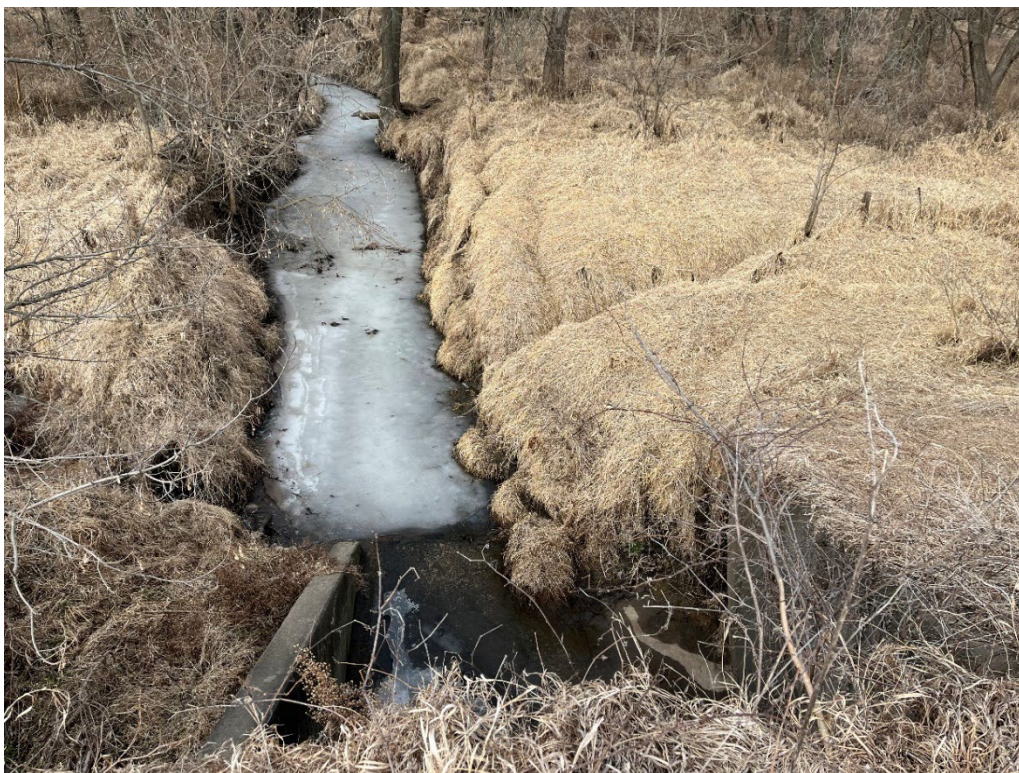
West Upstream Channel

The waterway is in fair condition. The 3'-5' of sediment has built up in the south barrel, extending the entire length of the culvert. A tree is growing in the sediment above the west apron on the south side. The bank adjacent to the north wing on the east apron is sloughing. Ice was present at time of field exam, but inspection report notes minor scour at inlet end, 0.8' deep.
