On Tuesday, June 16th, 2020 at 9:21 am a WWD was detected turning EB onto the WB exit ramp at CR-X49 and US-20.

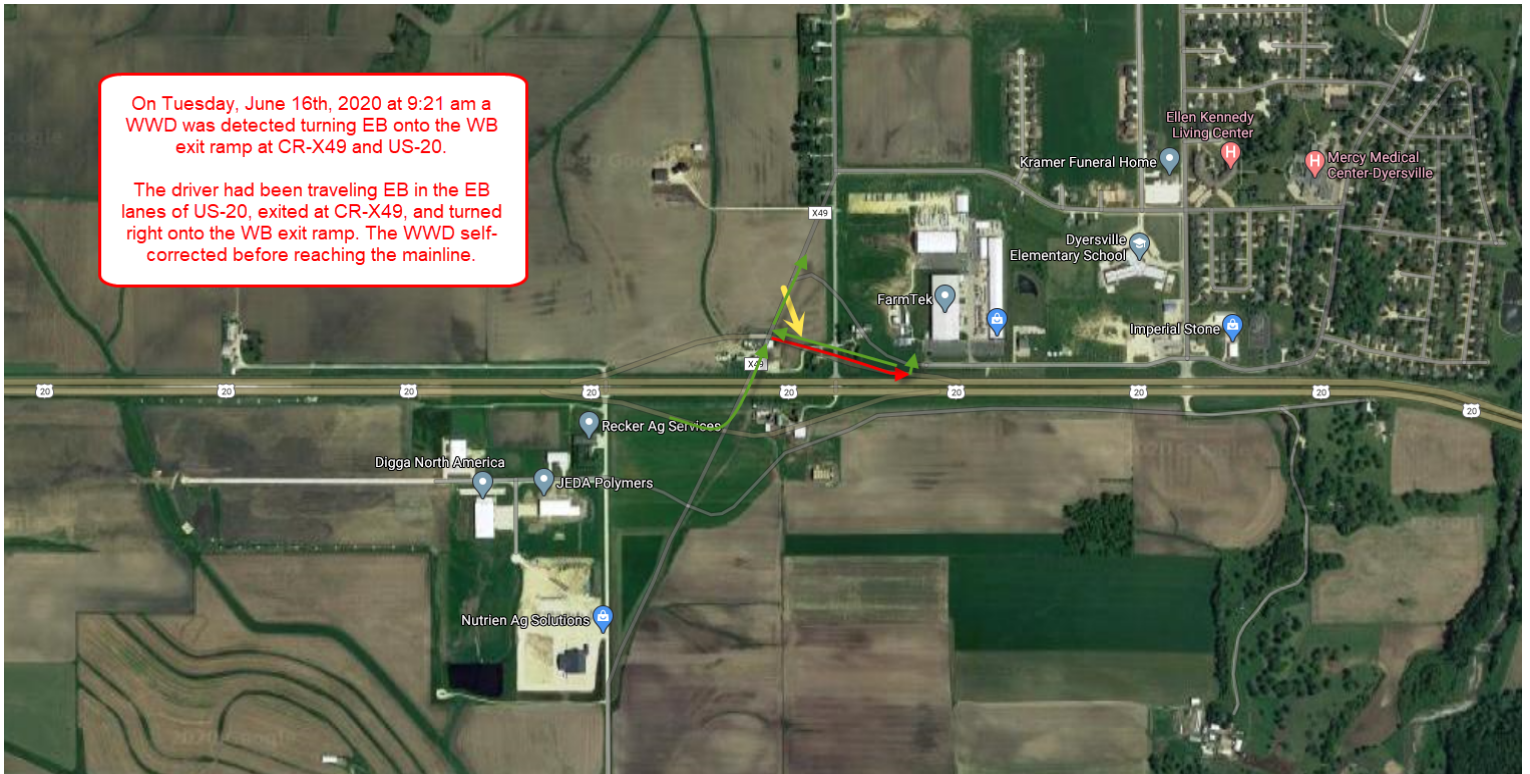
The driver had been traveling EB in the EB lanes of US-20, exited at CR-X49, and turned right onto the WB exit ramp. The WWD self-corrected before reaching the mainline.
