On Tuesday, June 16th, 2020 at 11:40 am a WWD was detected turning EB onto the WB exit ramp at CR-X49 and US-20.

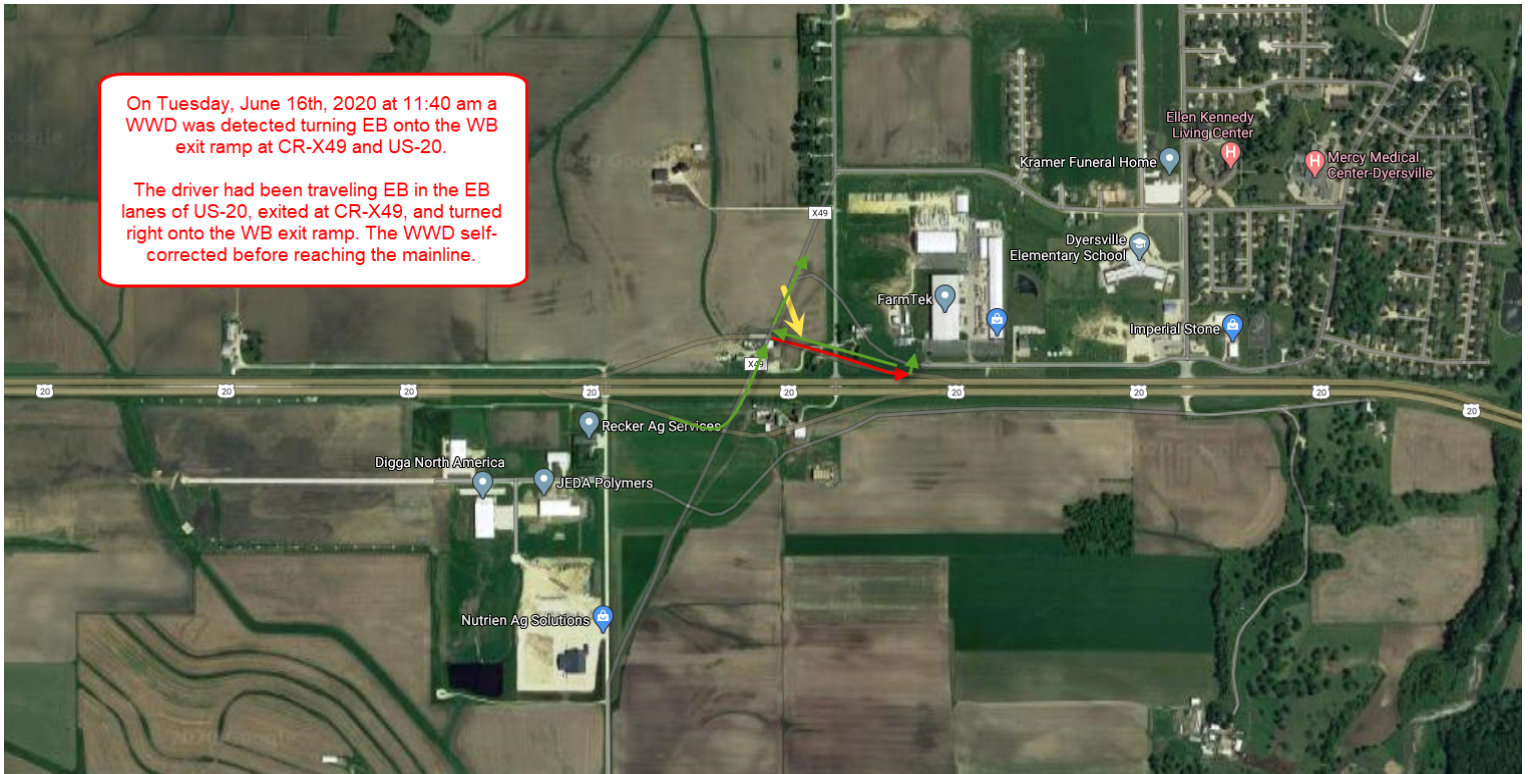
The driver had been traveling EB in the EB lanes of US-20, exited at CR-X49, and turned right onto the WB exit ramp. The WWD self-corrected before reaching the mainline.
