On Tuesday, June 23rd, 2020 at 2:30 pm a WWD was detected turning EB onto the WB exit ramp at CR-X49 and US-20.

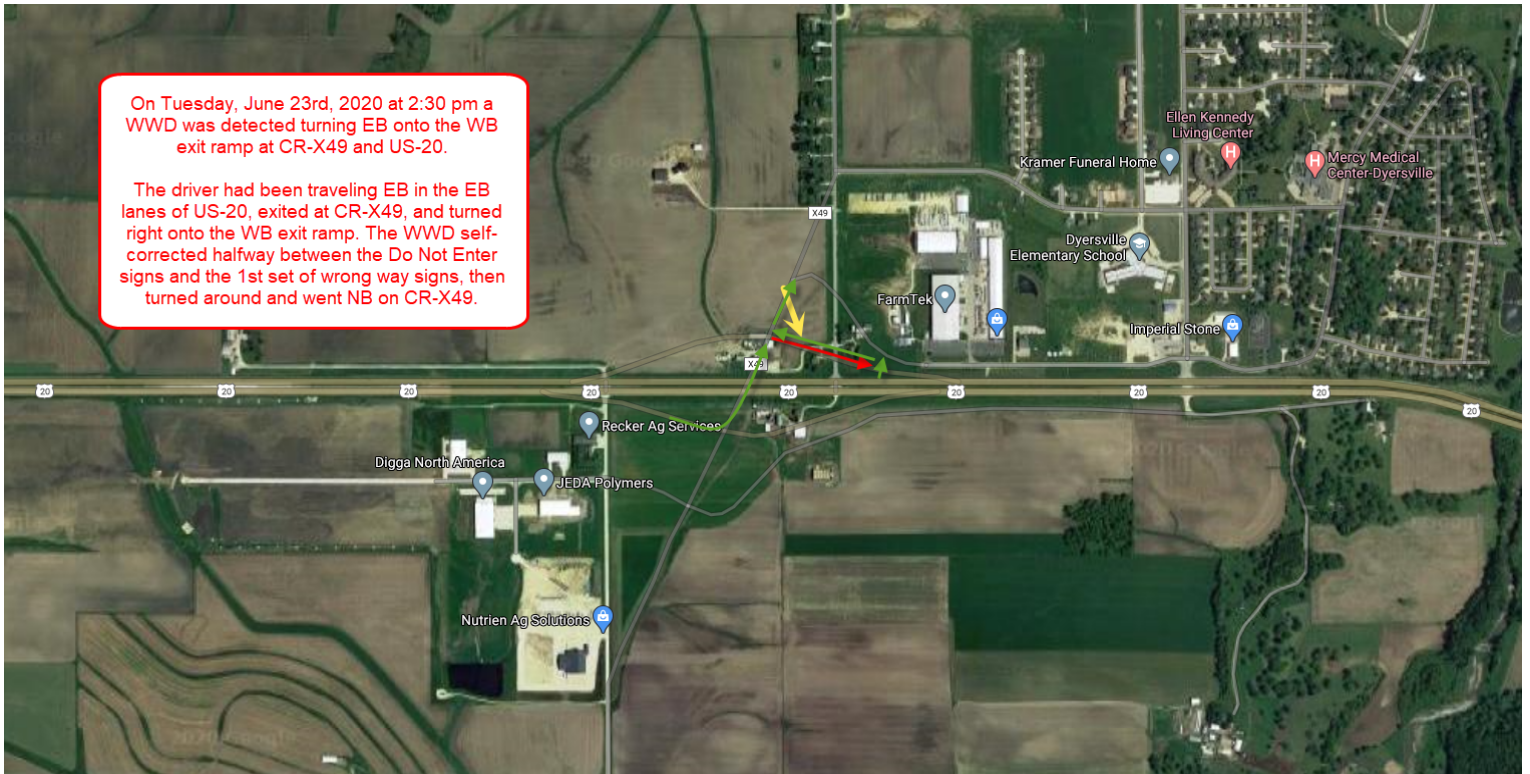
The driver had been traveling EB in the EB lanes of US-20, exited at CR-X49, and turned right onto the WB exit ramp. The WWD self-corrected halfway between the Do Not Enter signs and the 1st set of wrong way signs, then turned around and went NB on CR-X49.
