On Friday, July 10th, 2020 at 3:02 pm a WWD was detected turning EB onto the WB exit ramp at CR-X49 and US-20.

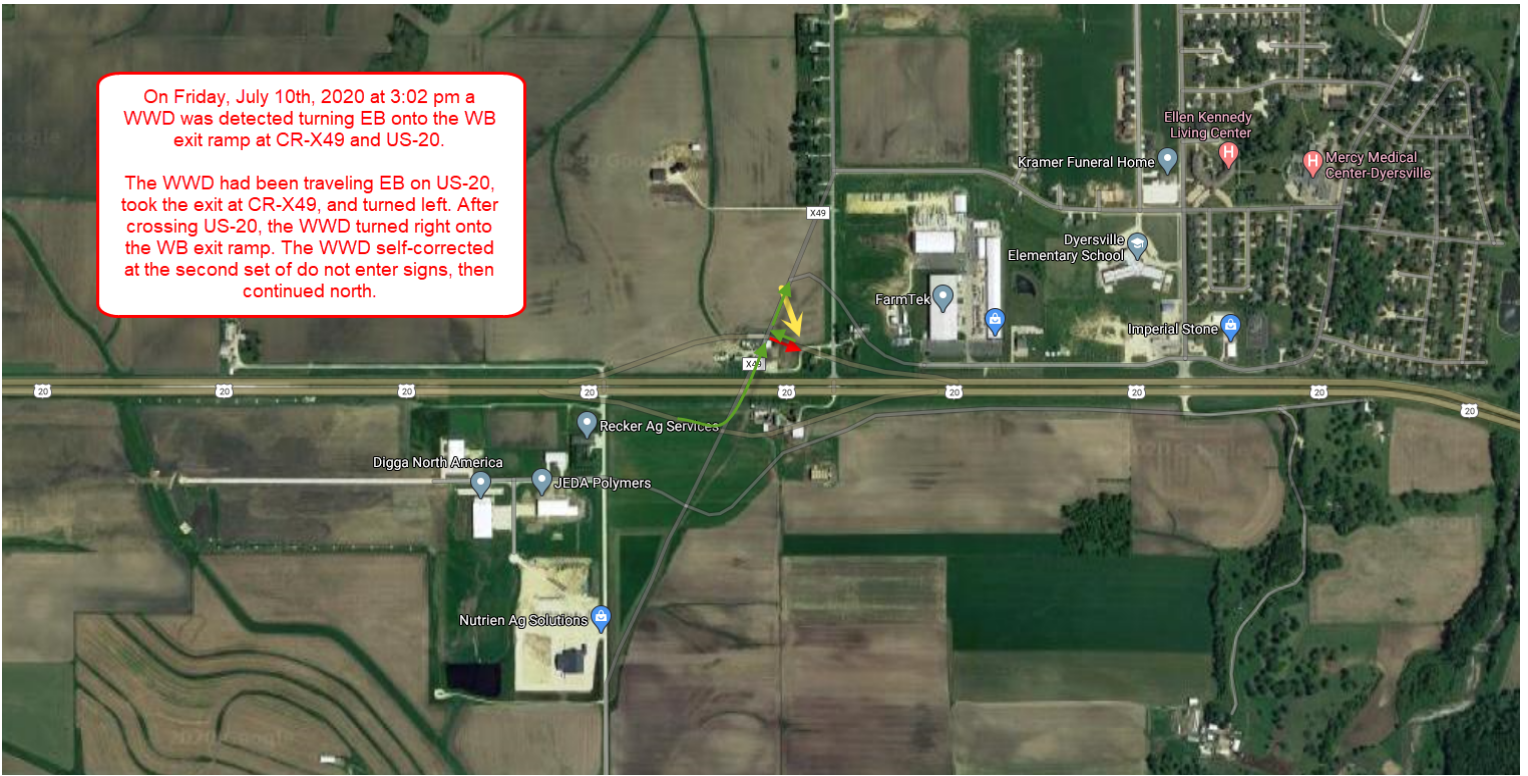
The WWD had been traveling EB on US-20, took the exit at CR-X49, and turned left. After crossing US-20, the WWD turned right onto the WB exit ramp. The WWD self-corrected at the second set of do not enter signs, then continued north.
