On Tuesday, July 21st, 2020 at 8:39 am a WWD was detected turning EB onto the WB exit ramp at CR-X49 and US-20.

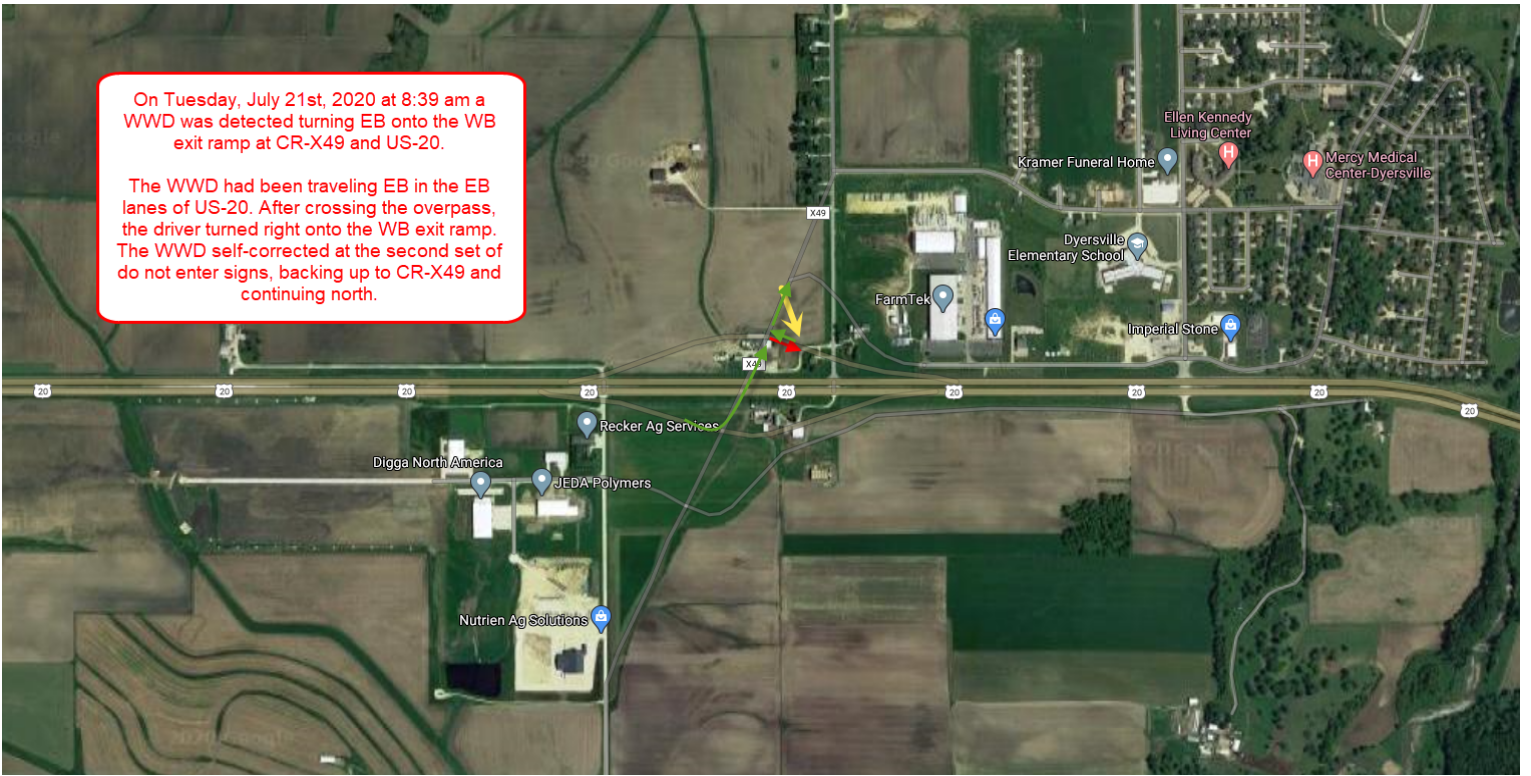
The WWD had been traveling EB in the EB lanes of US-20. After crossing the overpass, the driver turned right onto the WB exit ramp. The WWD self-corrected at the second set of do not enter signs, backing up to CR-X49 and continuing north.
