On Sunday, July 26th, 2020 at 3:13 pm a WWD was detected turning EB onto the WB exit ramp at CR-X49 and US-20.

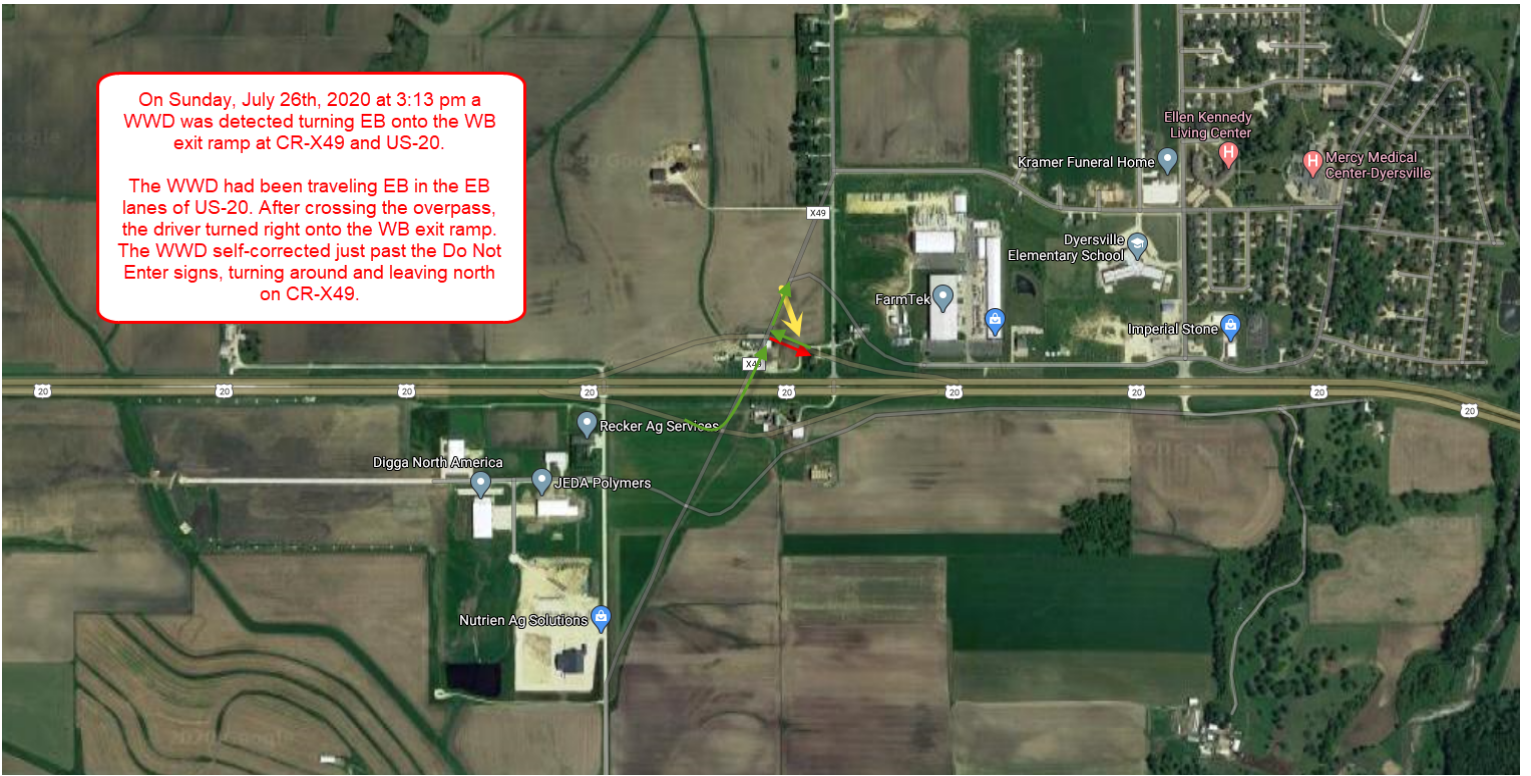
The WWD had been traveling EB in the EB lanes of US-20. After crossing the overpass, the driver turned right onto the WB exit ramp. The WWD self-corrected just past the Do Not Enter signs, turning around and leaving north on CR-X49.
