On Thursday, July 30th, 2020 at 9:08 am a WWD was detected turning EB onto the WB exit ramp at CR-X49 and US-20.

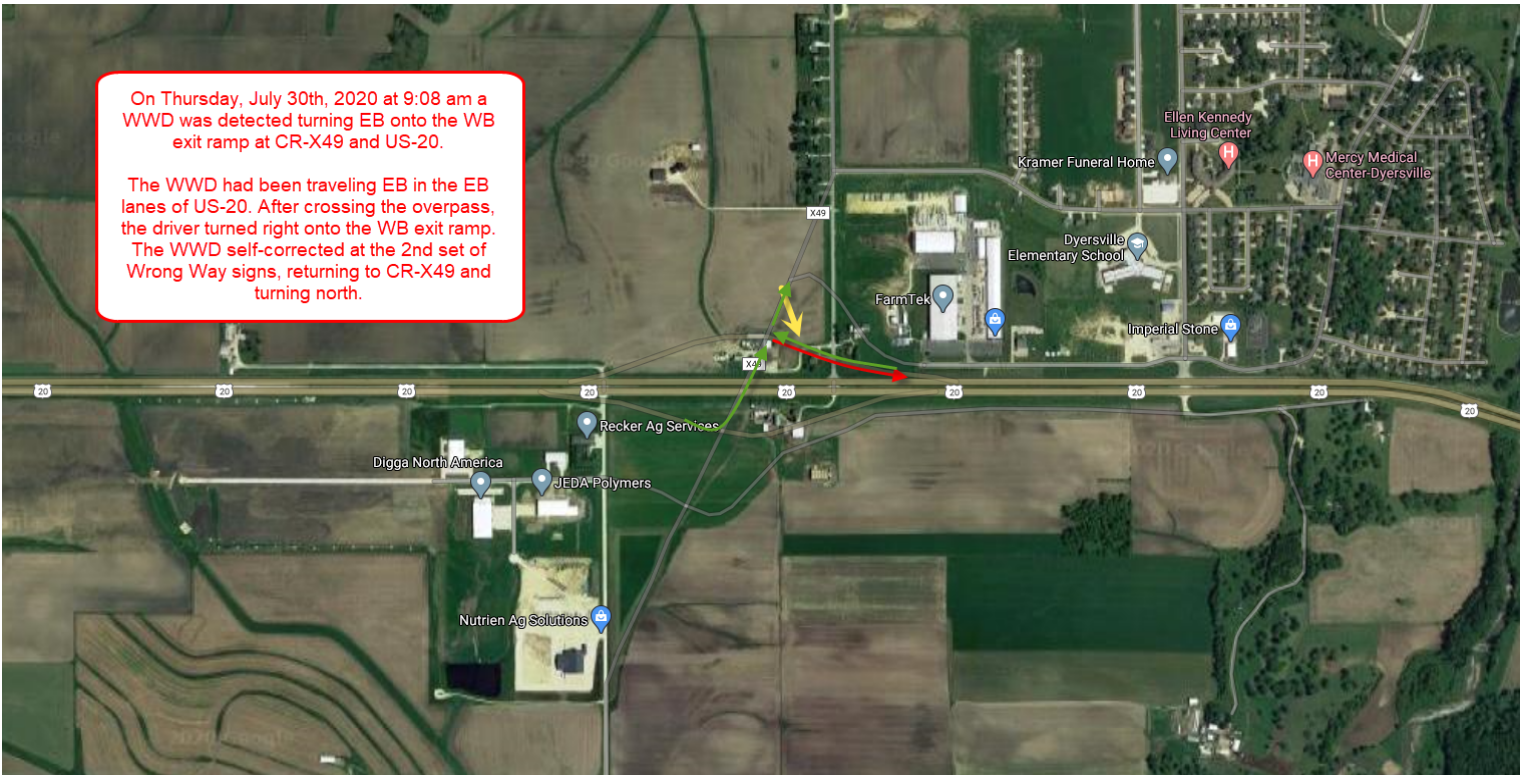
The WWD had been traveling EB in the EB lanes of US-20. After crossing the overpass, the driver turned right onto the WB exit ramp. The WWD self-corrected at the 2nd set of Wrong Way signs, returning to CR-X49 and turning north.
