On Sunday, August 2nd, 2020 at 2:56 pm a WWD was detected turning EB onto the WB exit ramp at CR-X49 and US-20.

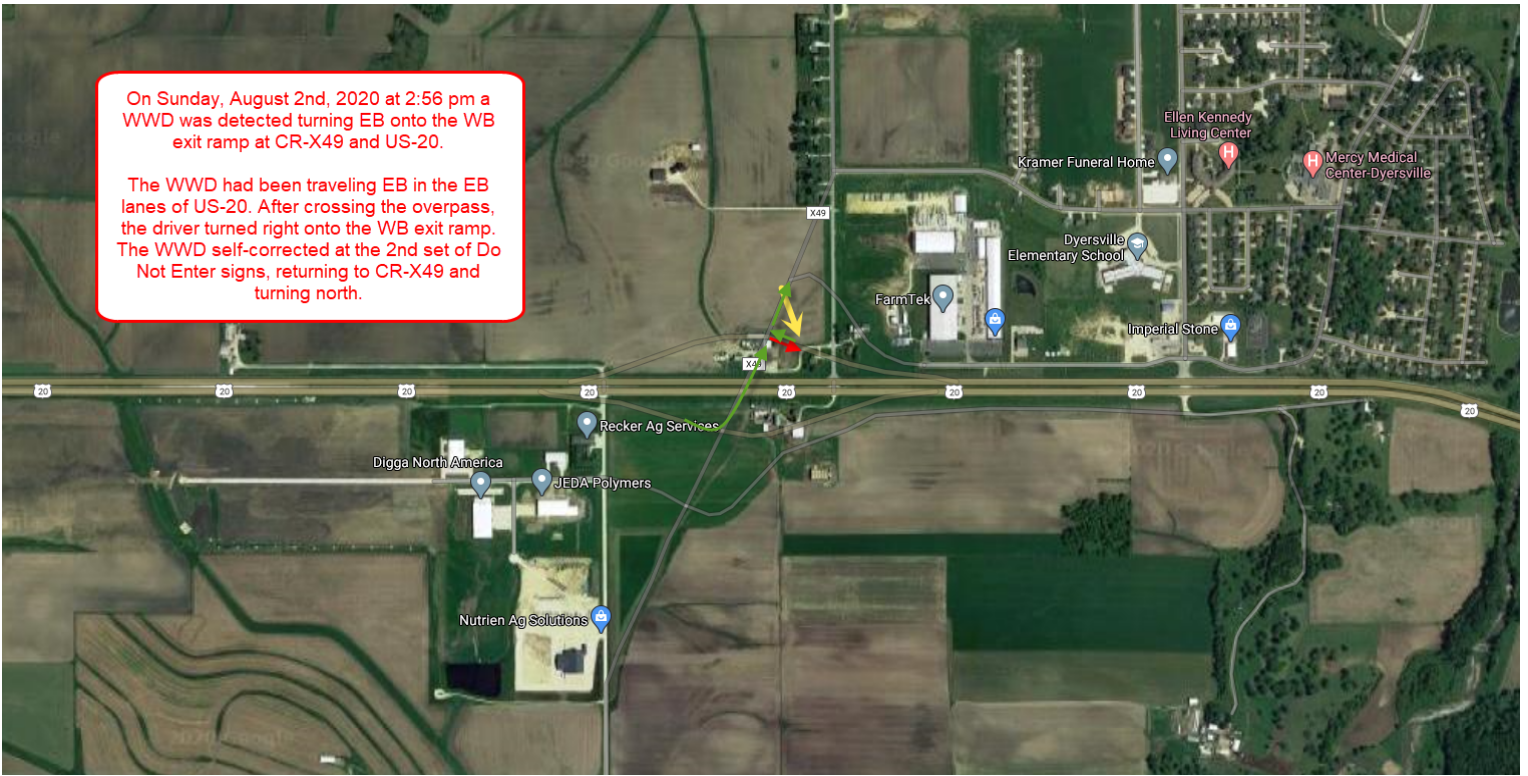
The WWD had been traveling EB in the EB lanes of US-20. After crossing the overpass, the driver turned right onto the WB exit ramp. The WWD self-corrected at the 2nd set of Do Not Enter signs, returning to CR-X49 and turning north.
