On Saturday, August 8th, 2020 at 11:01 am a WWD was detected turning EB onto the WB exit ramp at CR-X49 and US-20.

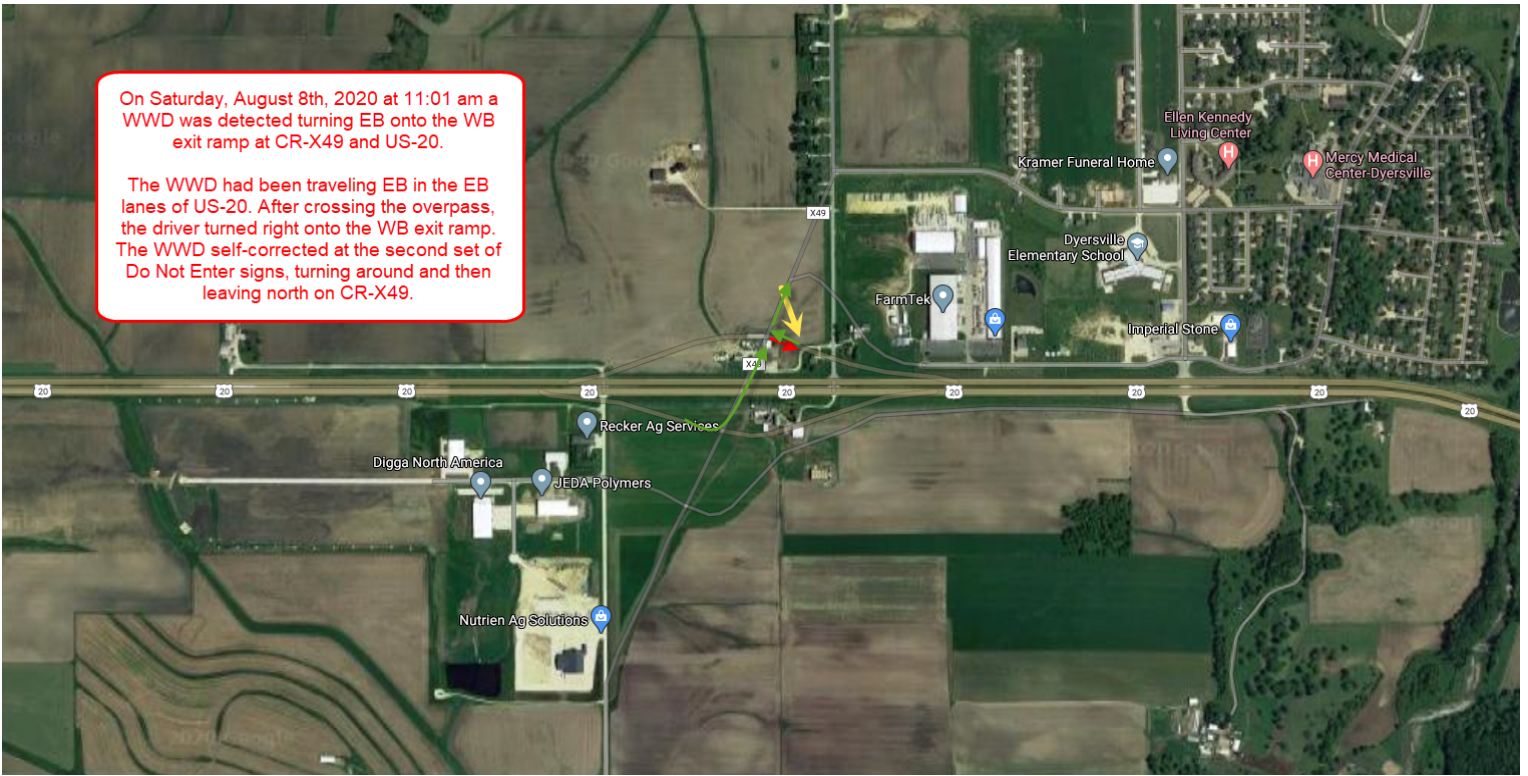
The WWD had been traveling EB in the EB lanes of US-20. After crossing the overpass, the driver turned right onto the WB exit ramp. The WWD self-corrected at the second set of Do Not Enter signs, turning around and then leaving north on CR-X49.
