On Thursday, August 13th, 2020 at 5:21 pm a WWD was detected turning EB onto the WB exit ramp at CR-X49 and US-20.

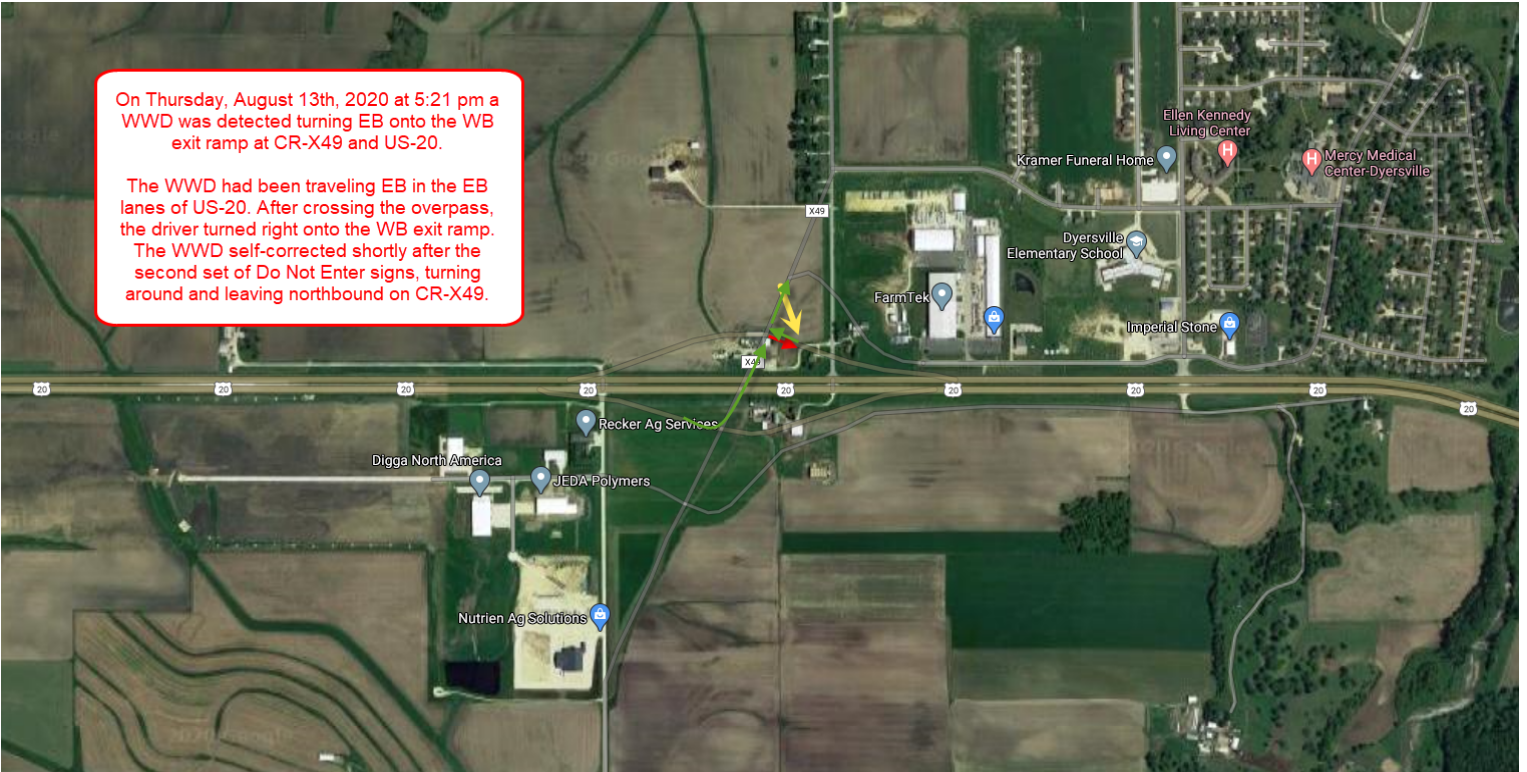
The WWD had been traveling EB in the EB lanes of US-20. After crossing the overpass, the driver turned right onto the WB exit ramp. The WWD self-corrected shortly after the second set of Do Not Enter signs, turning around and leaving northbound on CR-X49.
