On Friday, August 21st, 2020 at 1:07 pm a WWD was detected turning EB onto the WB exit ramp at CR-X49 and US-20.

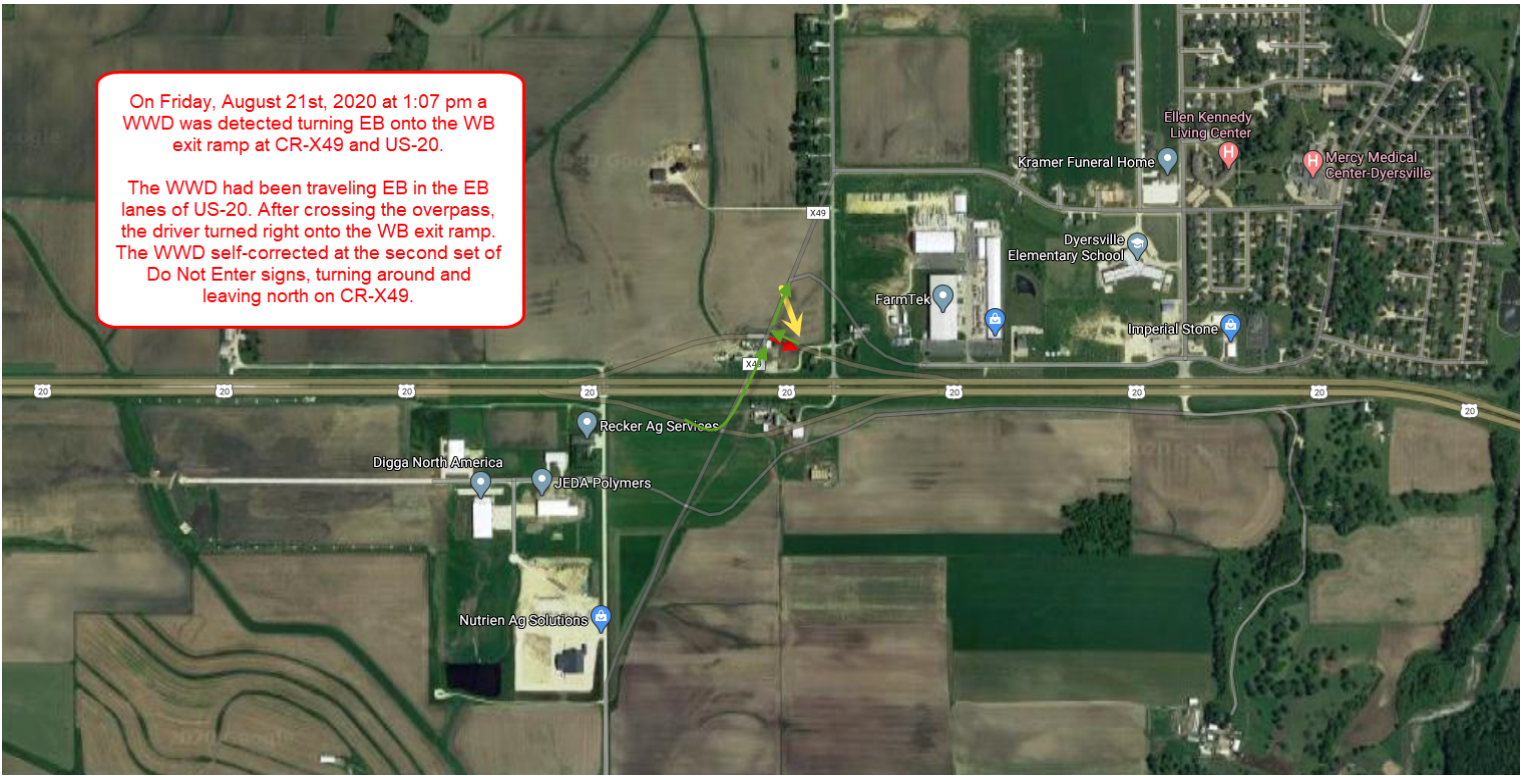
The WWD had been traveling EB in the EB lanes of US-20. After crossing the overpass, the driver turned right onto the WB exit ramp. The WWD self-corrected at the second set of Do Not Enter signs, turning around and leaving north on CR-X49.
