On Sunday, August 23rd, 2020 at 3:13 pm a WWD was detected turning EB onto the WB exit ramp at CR-X49 and US-20.

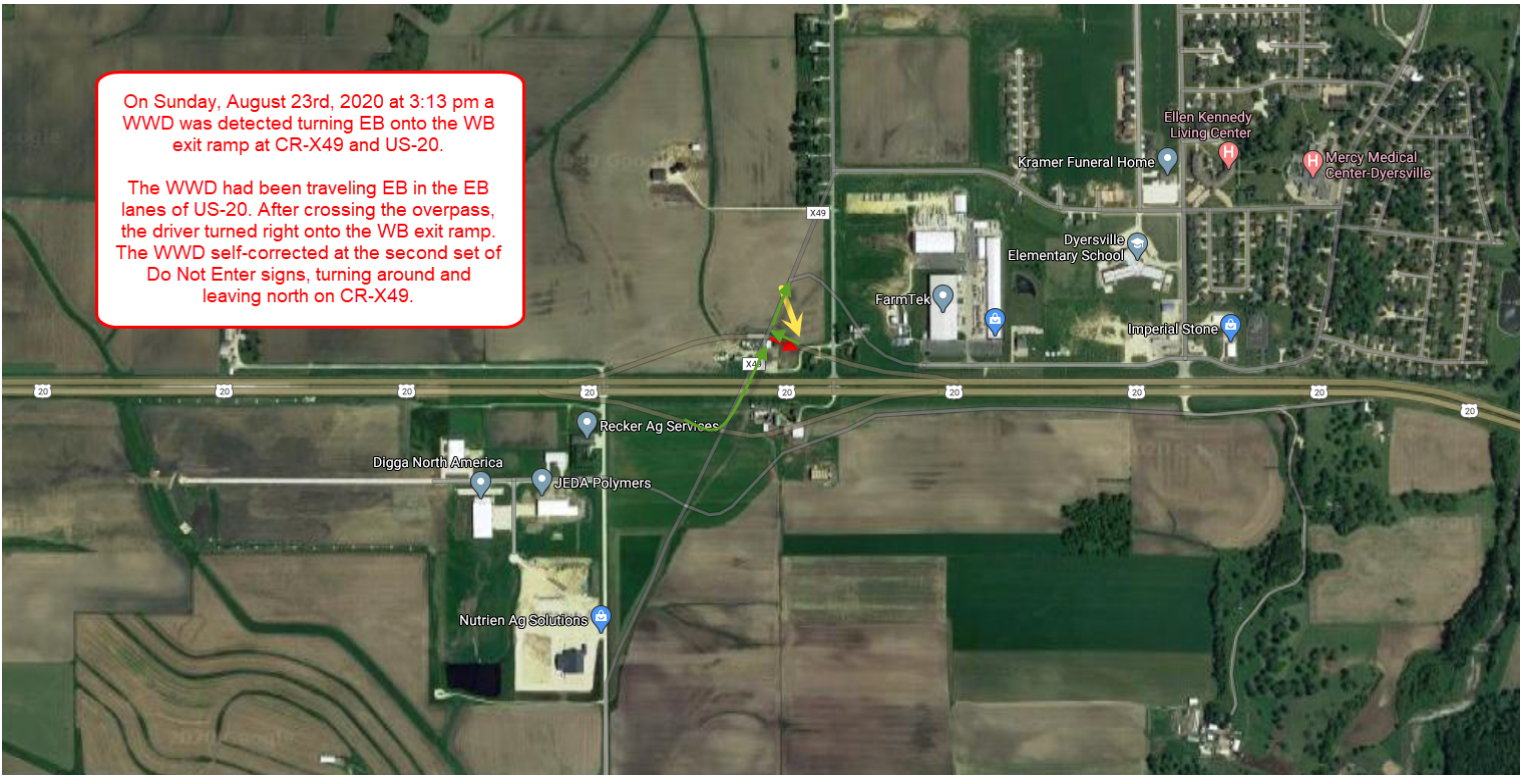
The WWD had been traveling EB in the EB lanes of US-20. After crossing the overpass, the driver turned right onto the WB exit ramp. The WWD self-corrected at the second set of Do Not Enter signs, turning around and leaving north on CR-X49.
