On Thursday, August 27th, 2020 at 3:34 pm a WWD was detected turning EB onto the WB exit ramp at CR-X49 and US-20.

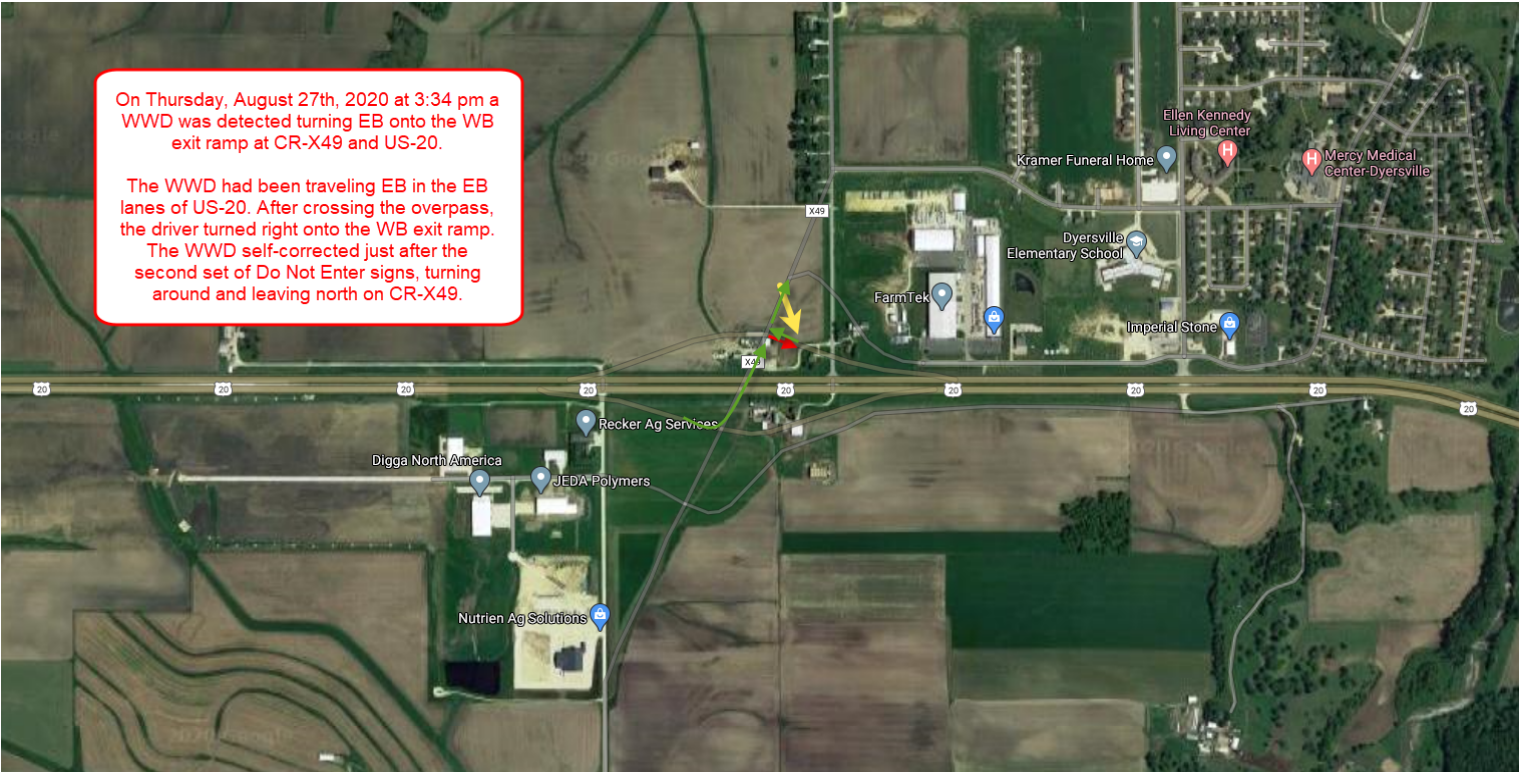
The WWD had been traveling EB in the EB lanes of US-20. After crossing the overpass, the driver turned right onto the WB exit ramp. The WWD self-corrected just after the second set of Do Not Enter signs, turning around and leaving north on CR-X49.
