On Wednesday, September 23rd, 2020 at 4:42 pm a WWD was detected turning EB onto the WB exit ramp at CR-X49 and US-20.

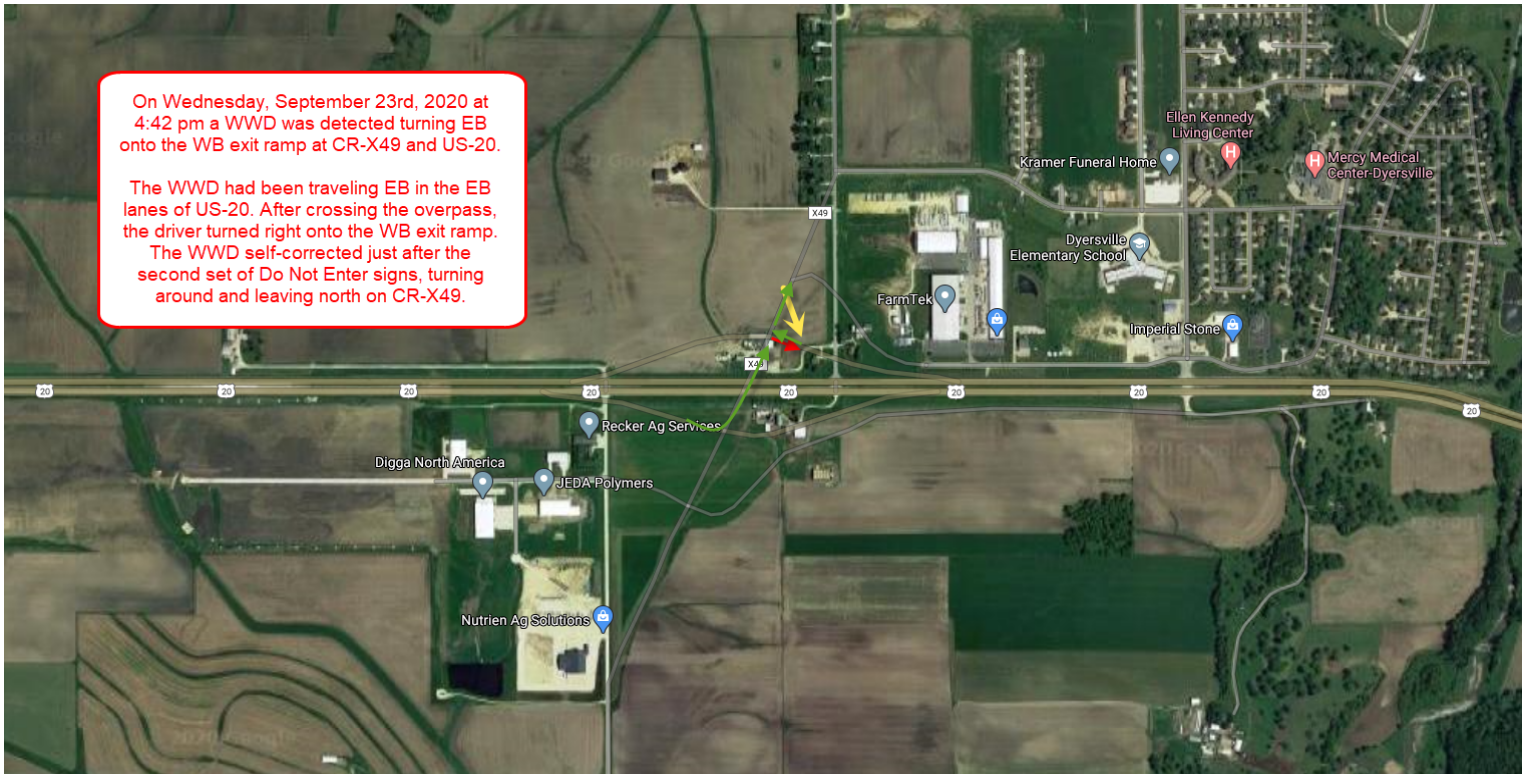
The WWD had been traveling EB in the EB lanes of US-20. After crossing the overpass, the driver turned right onto the WB exit ramp. The WWD self-corrected just after the second set of Do Not Enter signs, turning around and leaving north on CR-X49.
