On Thursday, October 1st, 2020 at 8:12 am a WWD was detected turning EB onto the WB exit ramp at CR-X49 and US-20.

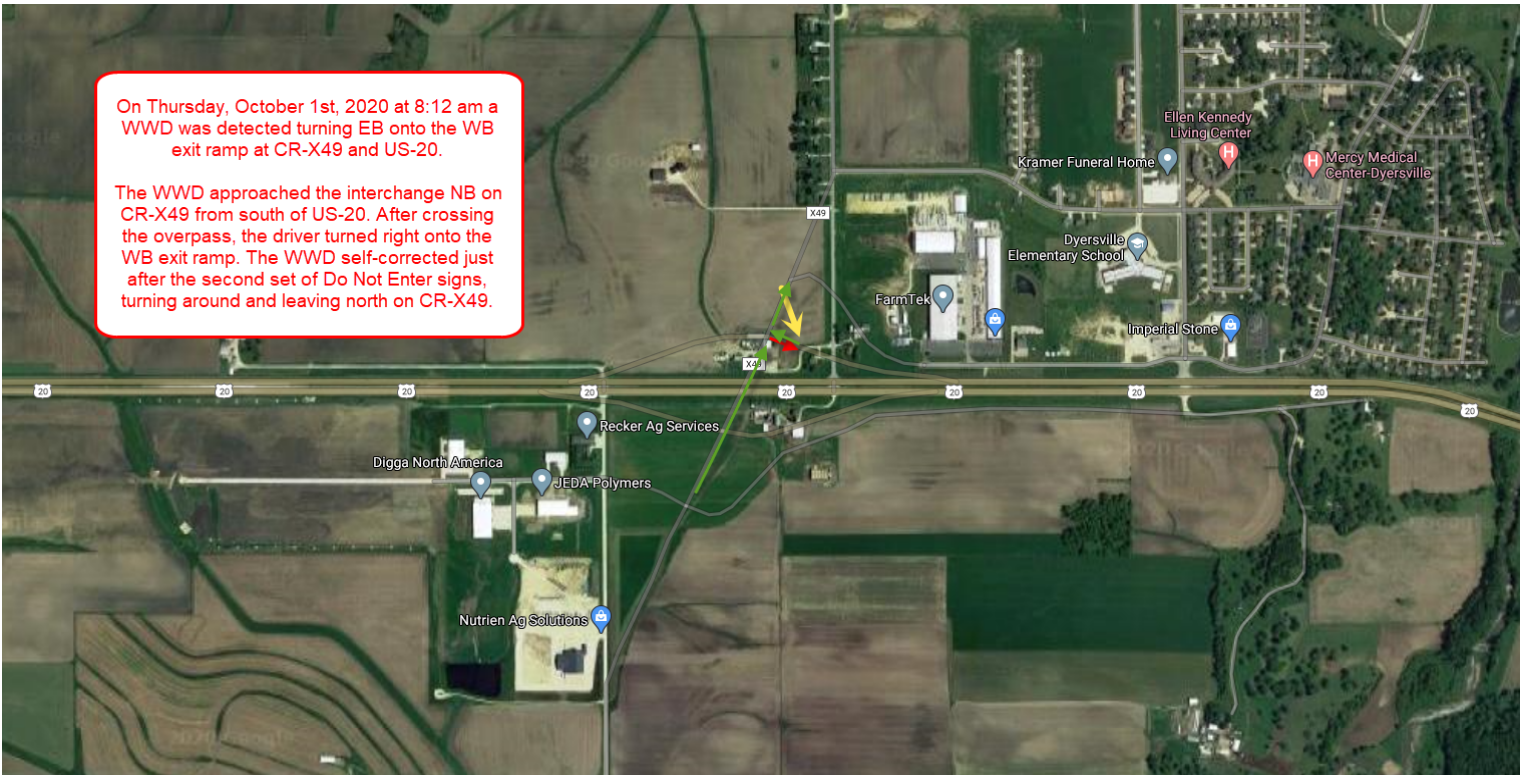
The WWD approached the interchange NB on CR-X49 from south of US-20. After crossing the overpass, the driver turned right onto the WB exit ramp. The WWD self-corrected just after the second set of Do Not Enter signs, turning around and leaving north on CR-X49.
