On Wednesday, October 21st, 2020 at 3:31 pm a WWD was detected turning EB onto the WB exit ramp at CR-X49 and US-20.

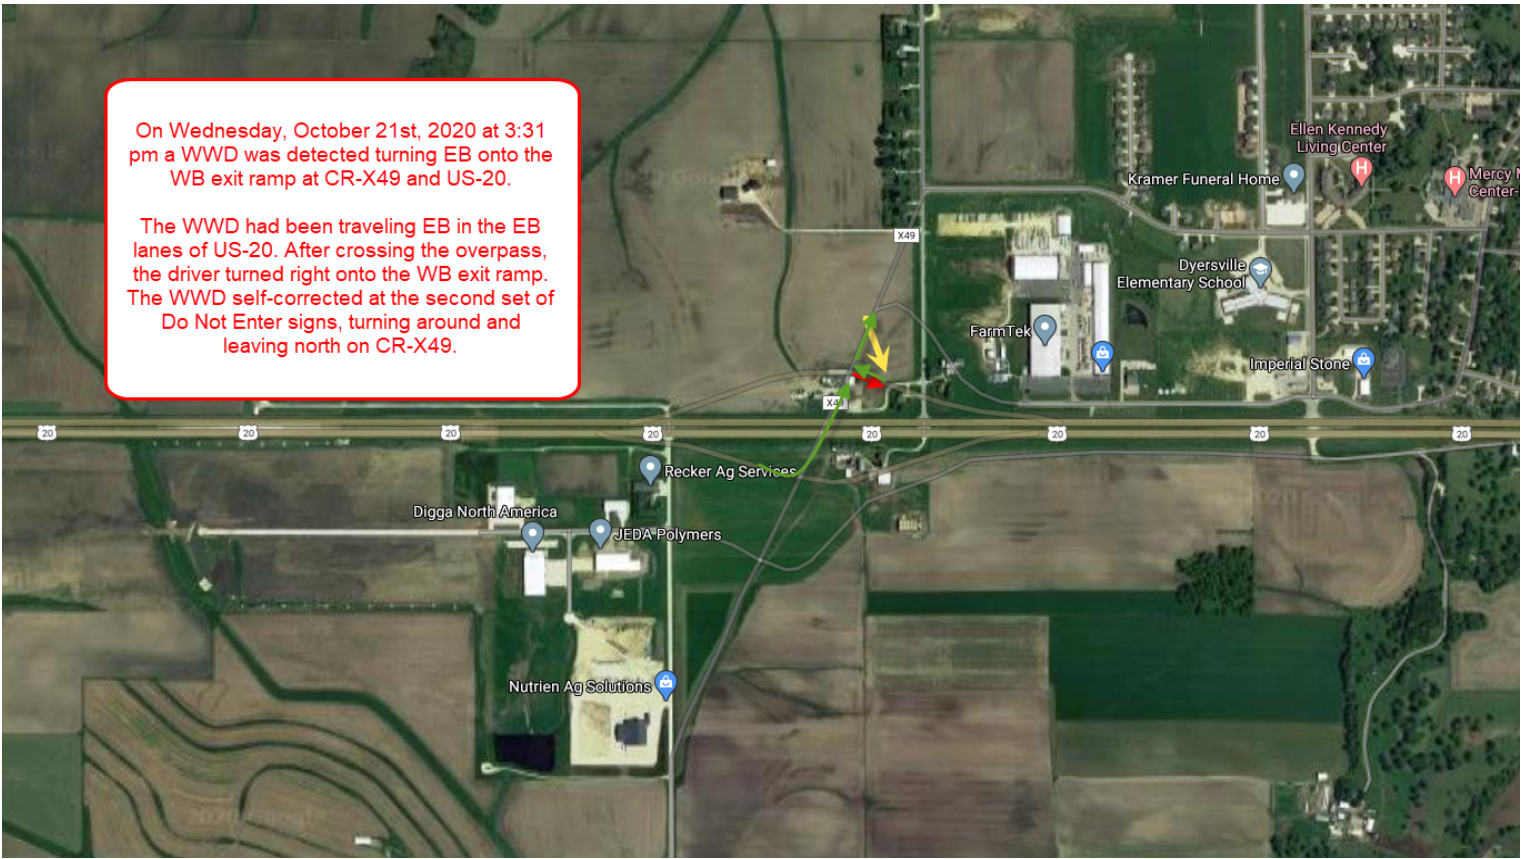
The WWD had been traveling EB in the EB lanes of US-20. After crossing the overpass, the driver turned right onto the WB exit ramp. The WWD self-corrected at the second set of Do Not Enter signs, turning around and leaving north on CR-X49.
