On Tuesday, October 27th, 2020 at 1:03 pm a WWD was detected turning EB onto the WB exit ramp at CR-X49 and US-20.

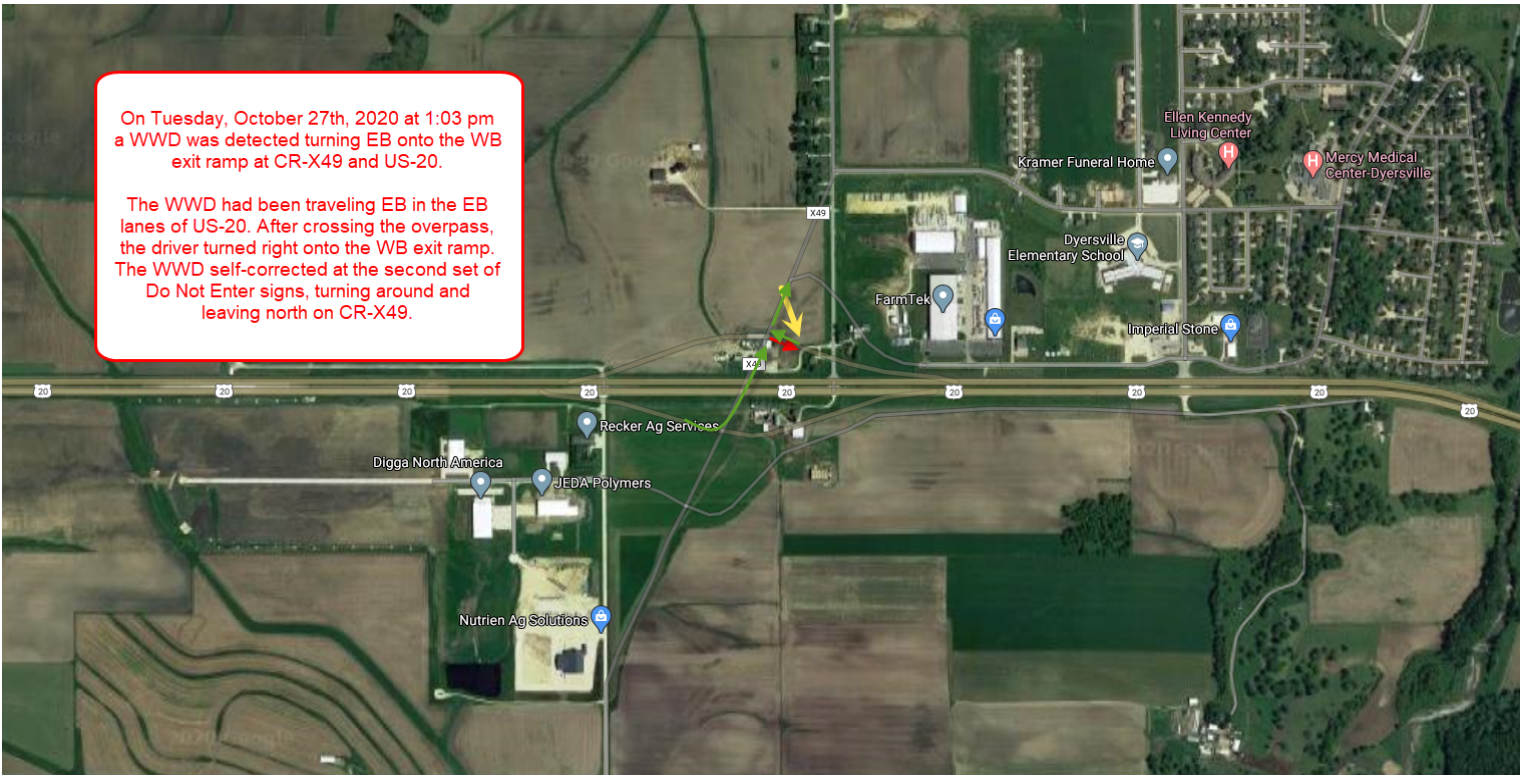
The WWD had been traveling EB in the EB lanes of US-20. After crossing the overpass, the driver turned right onto the WB exit ramp. The WWD self-corrected at the second set of Do Not Enter signs, turning around and leaving north on CR-X49.
