On Wednesday, October 28th, 2020 at 4:41 pm a WWD was detected turning EB onto the WB exit ramp at CR-X49 and US-20.

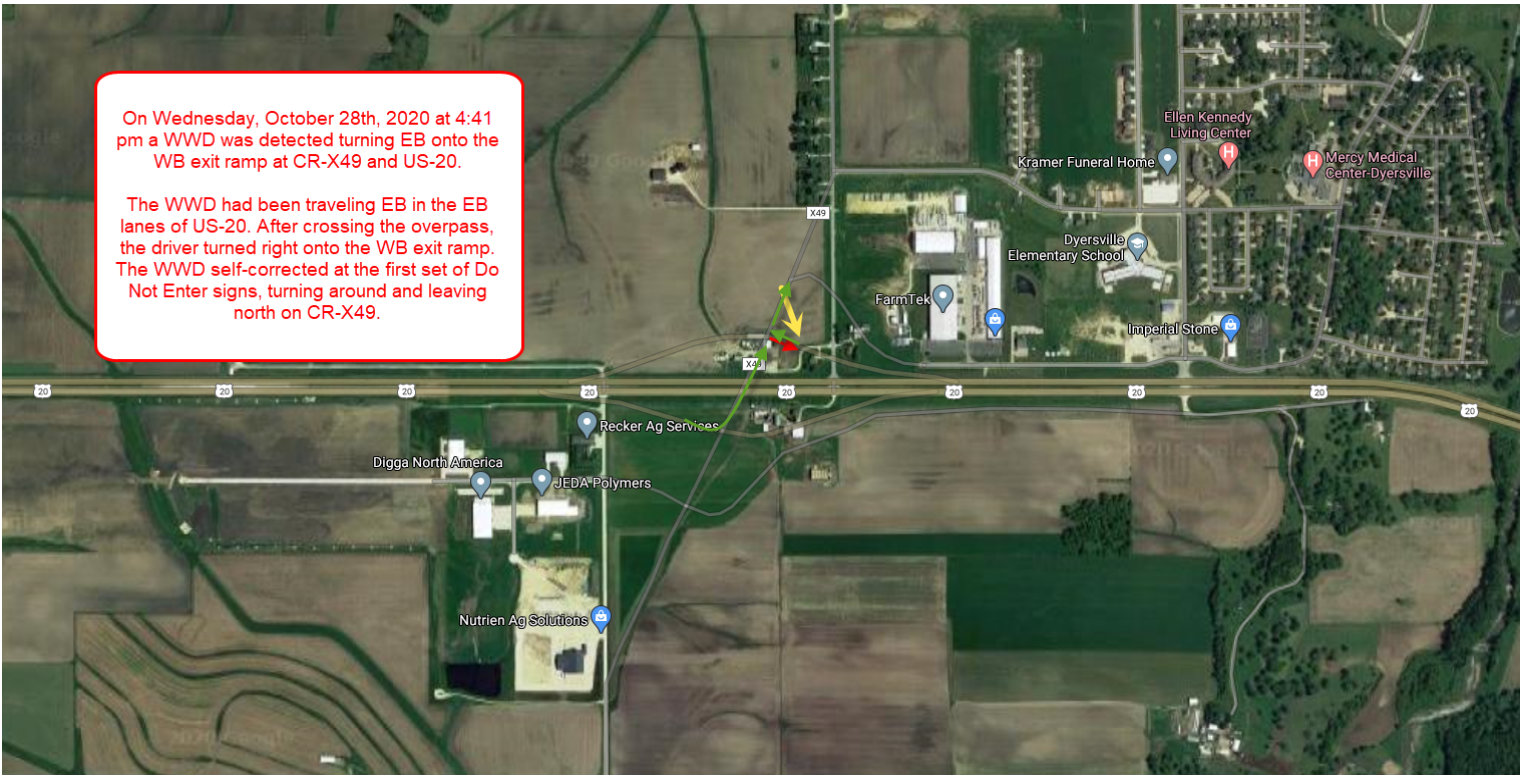
The WWD had been traveling EB in the EB lanes of US-20. After crossing the overpass, the driver turned right onto the WB exit ramp. The WWD self-corrected at the first set of Do Not Enter signs, turning around and leaving north on CR-X49.
