On Tuesday, July 21st, 2020 at 5:27 pm a WWD was detected turning EB onto the WB exit ramp at CR-X49 and US-20.

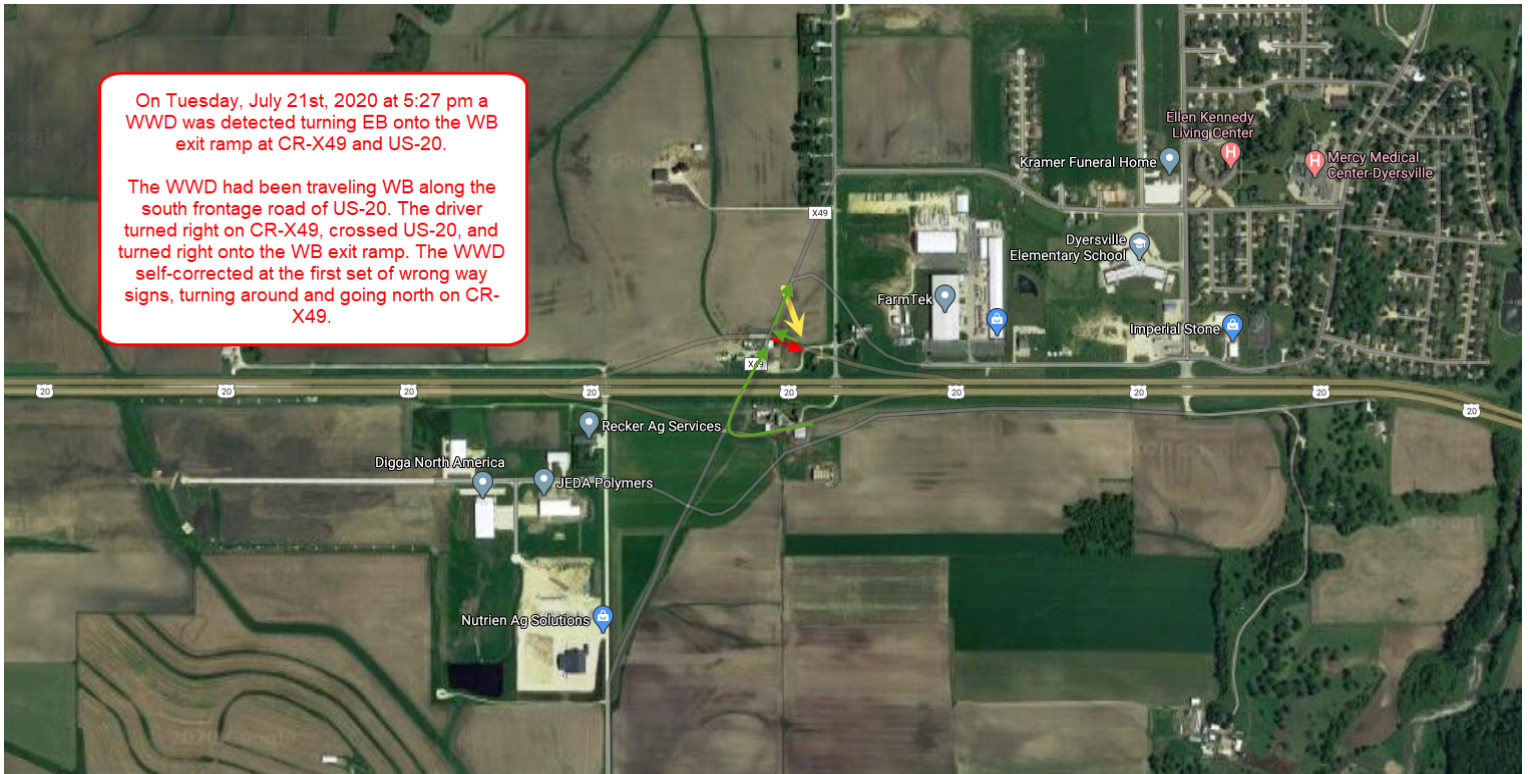
The WWD had been traveling WB along the south frontage road of US-20. The driver turned right on CR-X49, crossed US-20, and turned right onto the WB exit ramp. The WWD self-corrected at the first set of wrong way signs, turning around and going north on CR-X49.
