On Sunday, July 26th, 2020 at 10:36 am a WWD was detected turning EB onto the WB exit ramp at CR-X49 and US-20.

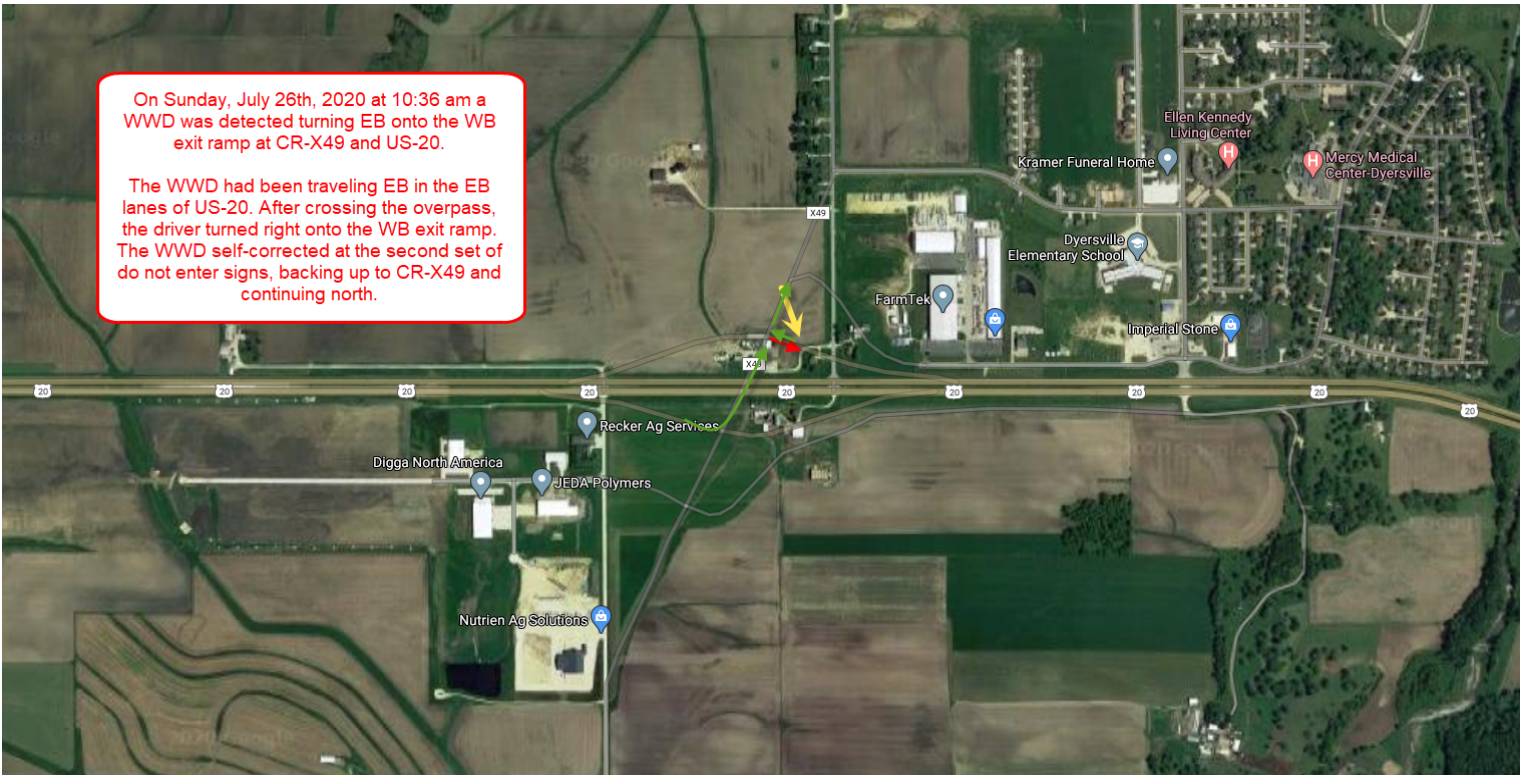
The WWD had been traveling EB in the EB lanes of US-20. After crossing the overpass, the driver turned right onto the WB exit ramp. The WWD self-corrected at the second set of do not enter signs, backing up to CR-X49 and continuing north.
