On Sunday, July 26th, 2020 at 6:29 pm a WWD was detected turning EB onto the WB exit ramp at CR-X49 and US-20.

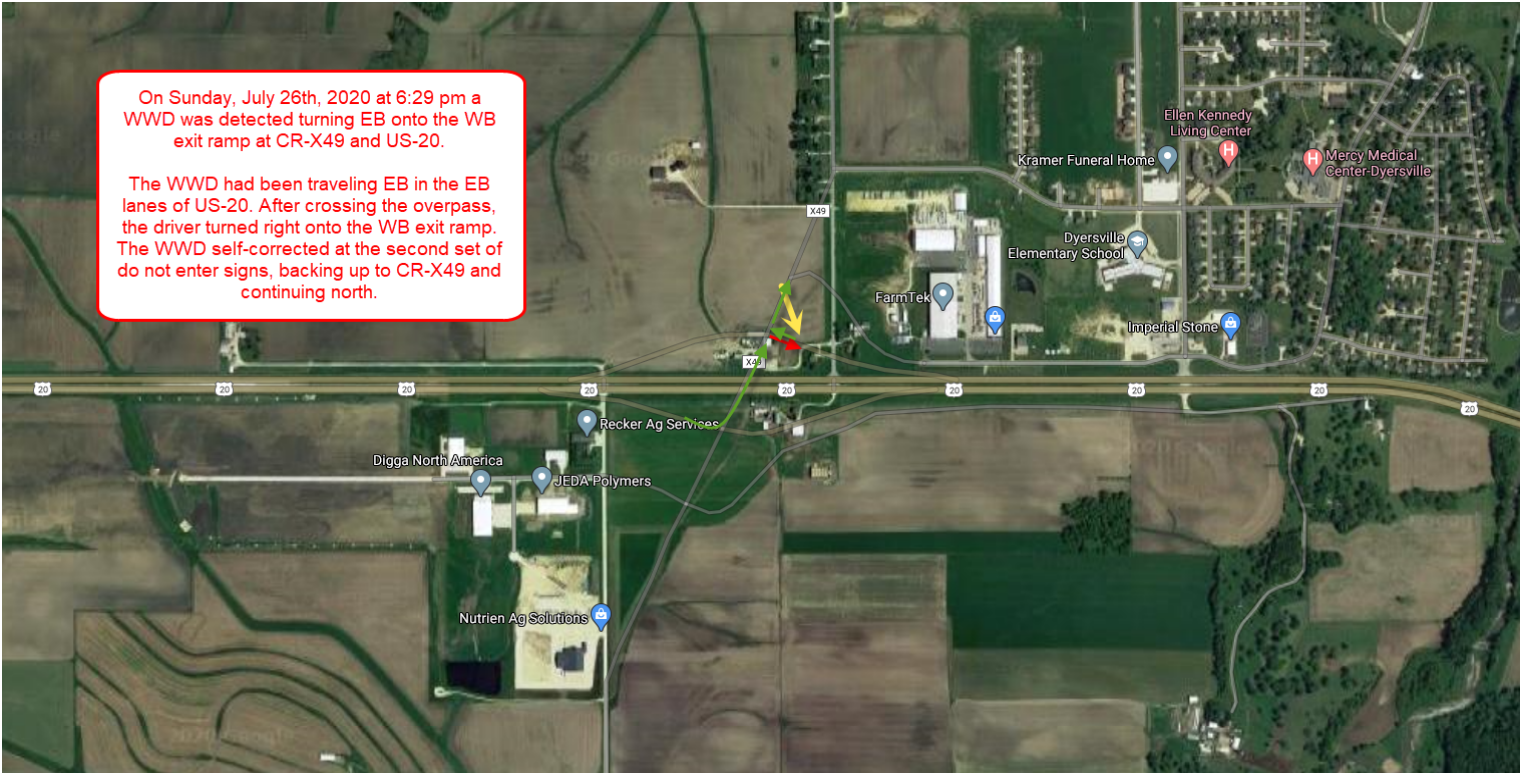
The WWD had been traveling EB in the EB lanes of US-20. After crossing the overpass, the driver turned right onto the WB exit ramp. The WWD self-corrected at the second set of do not enter signs, backing up to CR-X49 and continuing north.
