On Saturday, September 5th, 2020 at 10:31 am a WWD was detected turning EB onto the WB exit ramp at CR-X49 and US-20.

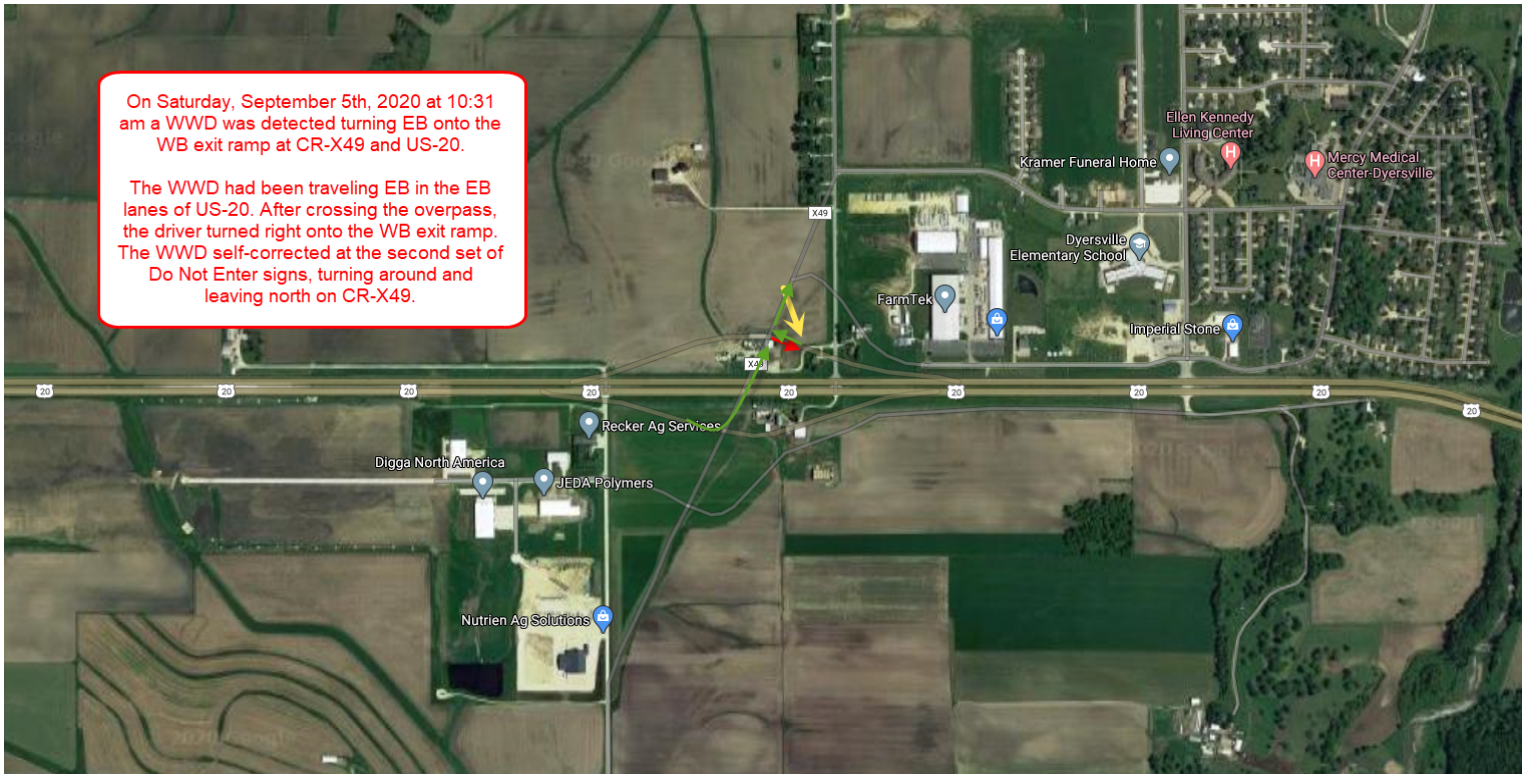
The WWD had been traveling EB in the EB lanes of US-20. After crossing the overpass, the driver turned right onto the WB exit ramp. The WWD self-corrected at the second set of Do Not Enter signs, turning around and leaving north on CR-X49.
