On Saturday, September 5th, 2020 at 6:11 pm a WWD was detected turning EB onto the WB exit ramp at CR-X49 and US-20.

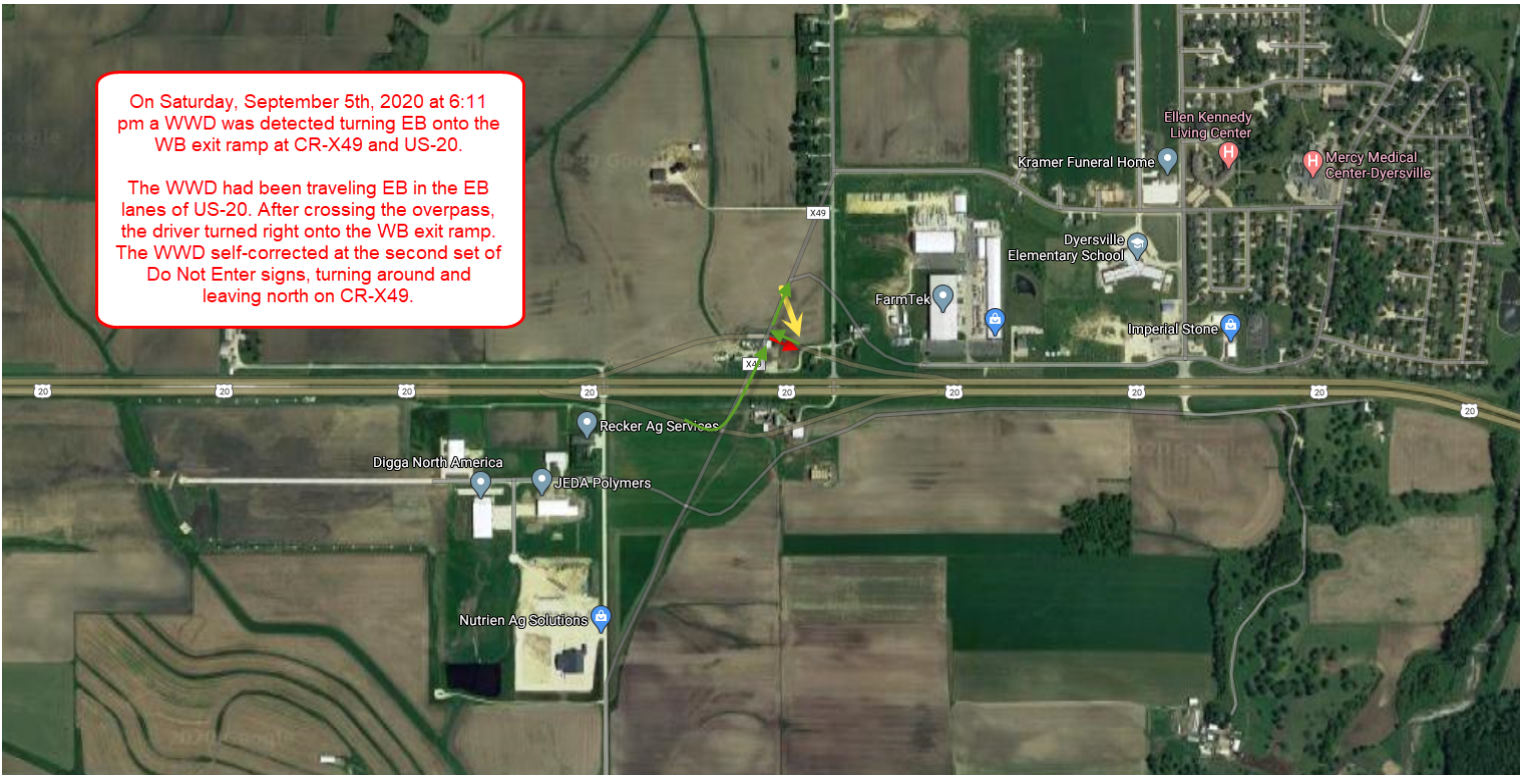
The WWD had been traveling EB in the EB lanes of US-20. After crossing the overpass, the driver turned right onto the WB exit ramp. The WWD self-corrected at the second set of Do Not Enter signs, turning around and leaving north on CR-X49.
