On Thursday, September 17th, 2020 at 4:36 pm a WWD was detected turning EB onto the WB exit ramp at CR-X49 and US-20.

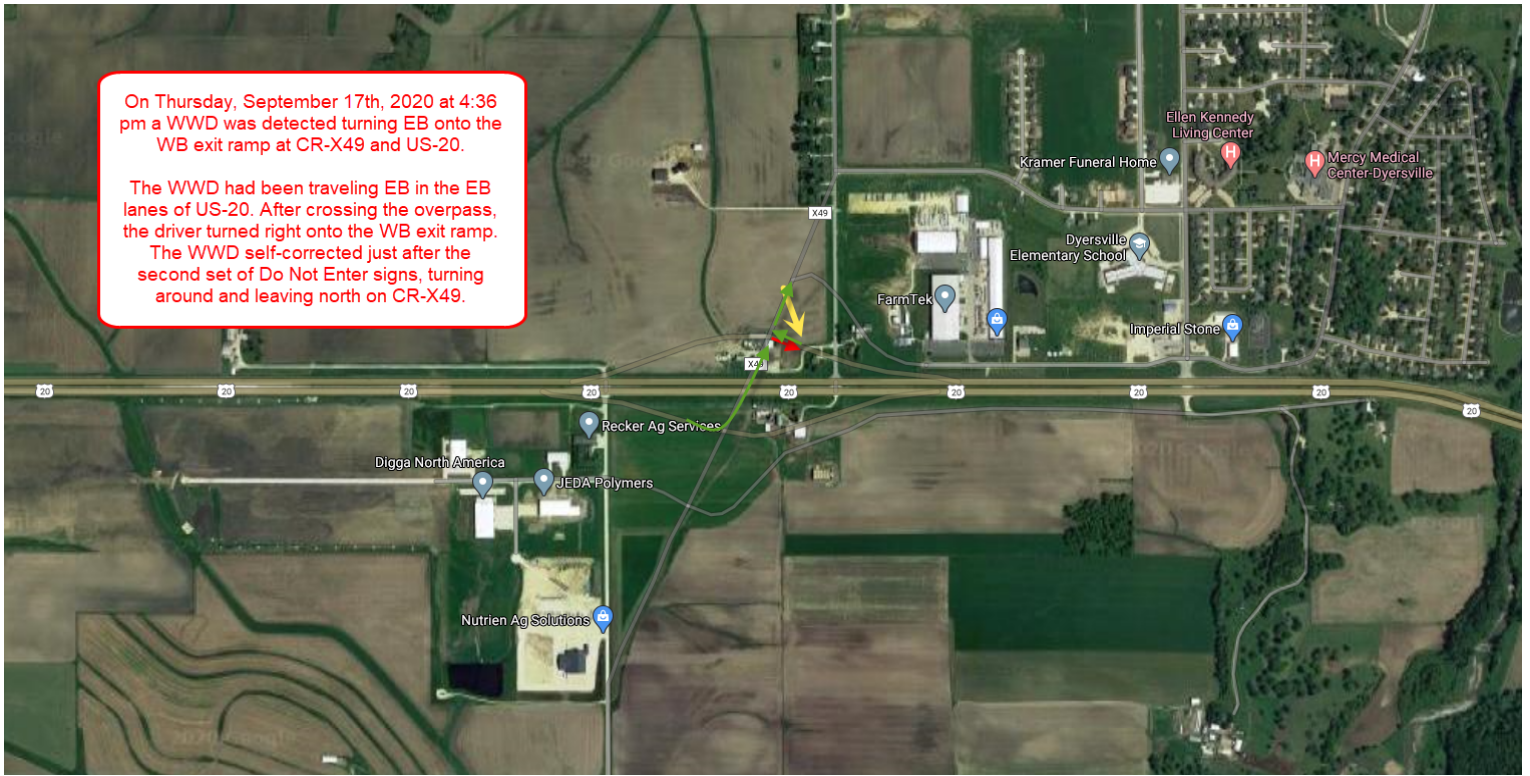
The WWD had been traveling EB in the EB lanes of US-20. After crossing the overpass, the driver turned right onto the WB exit ramp. The WWD self-corrected just after the second set of Do Not Enter signs, turning around and leaving north on CR-X49.
