On Friday, October 2nd, 2020 at 5:30 pm a WWD was detected turning EB onto the WB exit ramp at CR-X49 and US-20.

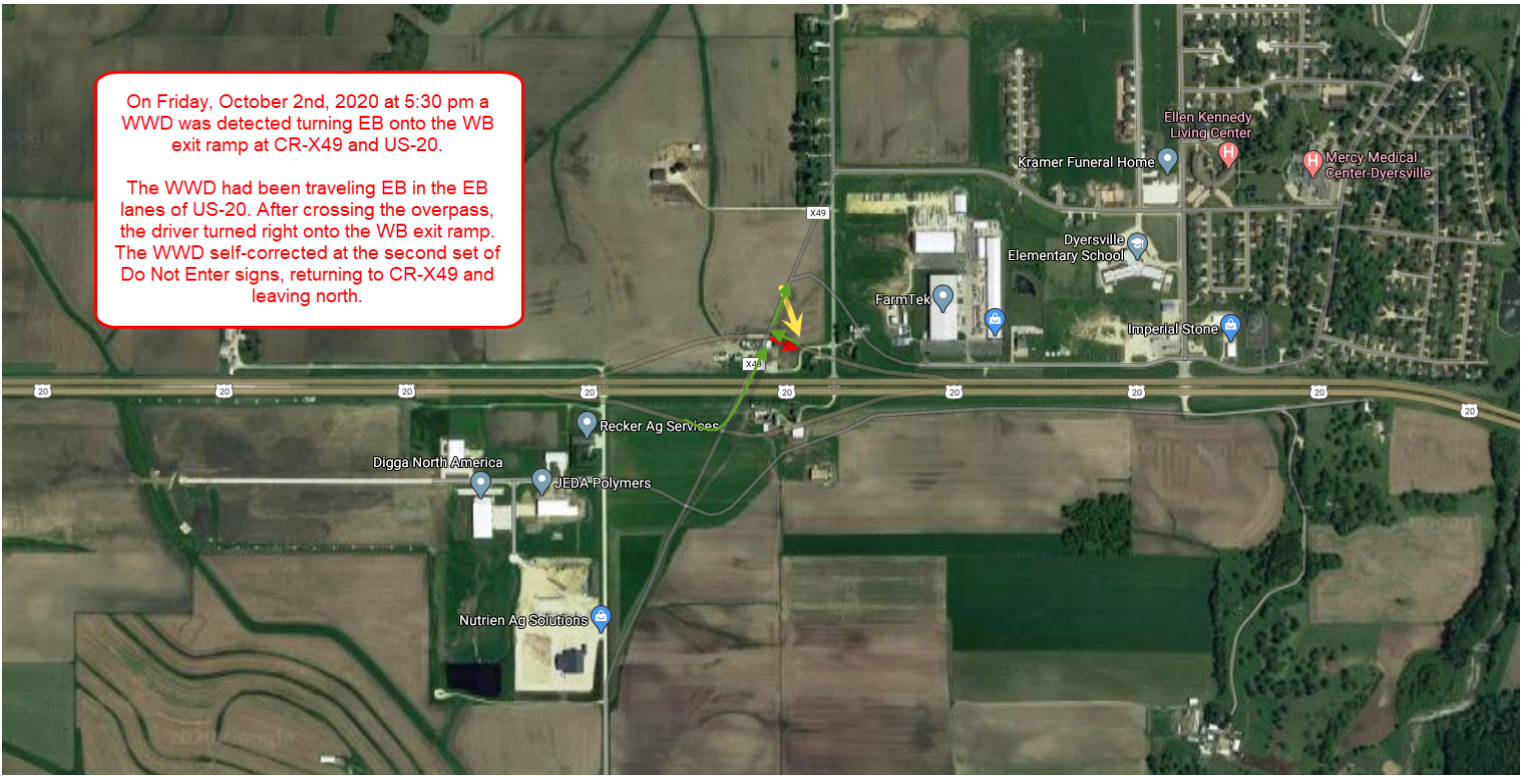
The WWD had been traveling EB in the EB lanes of US-20. After crossing the overpass, the driver turned right onto the WB exit ramp. The WWD self-corrected at the second set of Do Not Enter signs, returning to CR-X49 and leaving north.
