LUCAS COUNTY

SLIDE REPAIR
ER-014-2(42)--28-59

PLANS OF PROPOSED IMPROVEMENT ON THE
**PRIMARY ROAD SYSTEM
LUCAS COUNTY
SLIDE REPAIR**

2.1 mi S of US 34 to 3.6 mi N of Co Rd J22 - 7 Locations

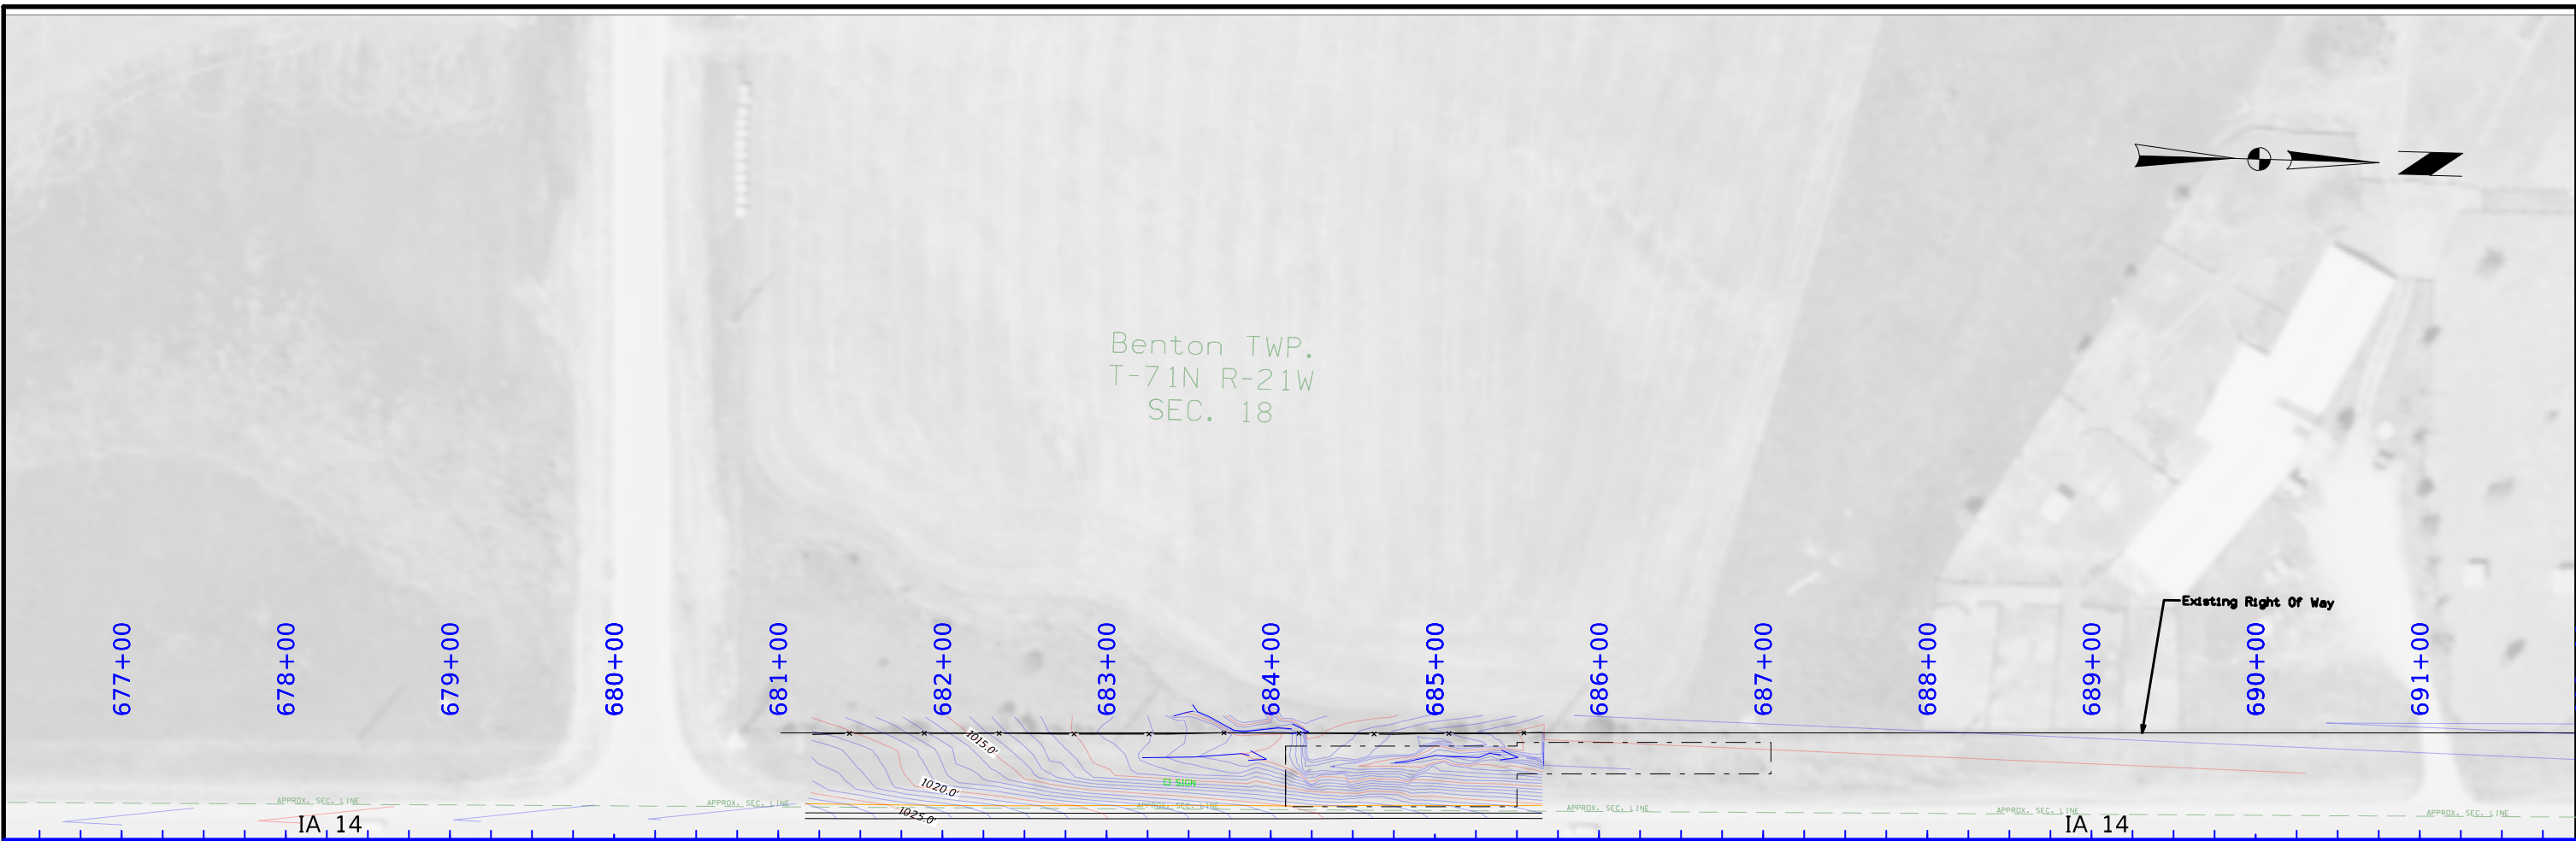
IA 14
 Area 4

FILE NO.	ENGLISH	DESIGN TEAM HOLST/TAMRAKAR/ACKERMAN	LUCAS COUNTY	PROJECT NUMBER ER-014-2(42)--28-59	SHEET NUMBER D.6
----------	---------	-------------------------------------	--------------	------------------------------------	------------------

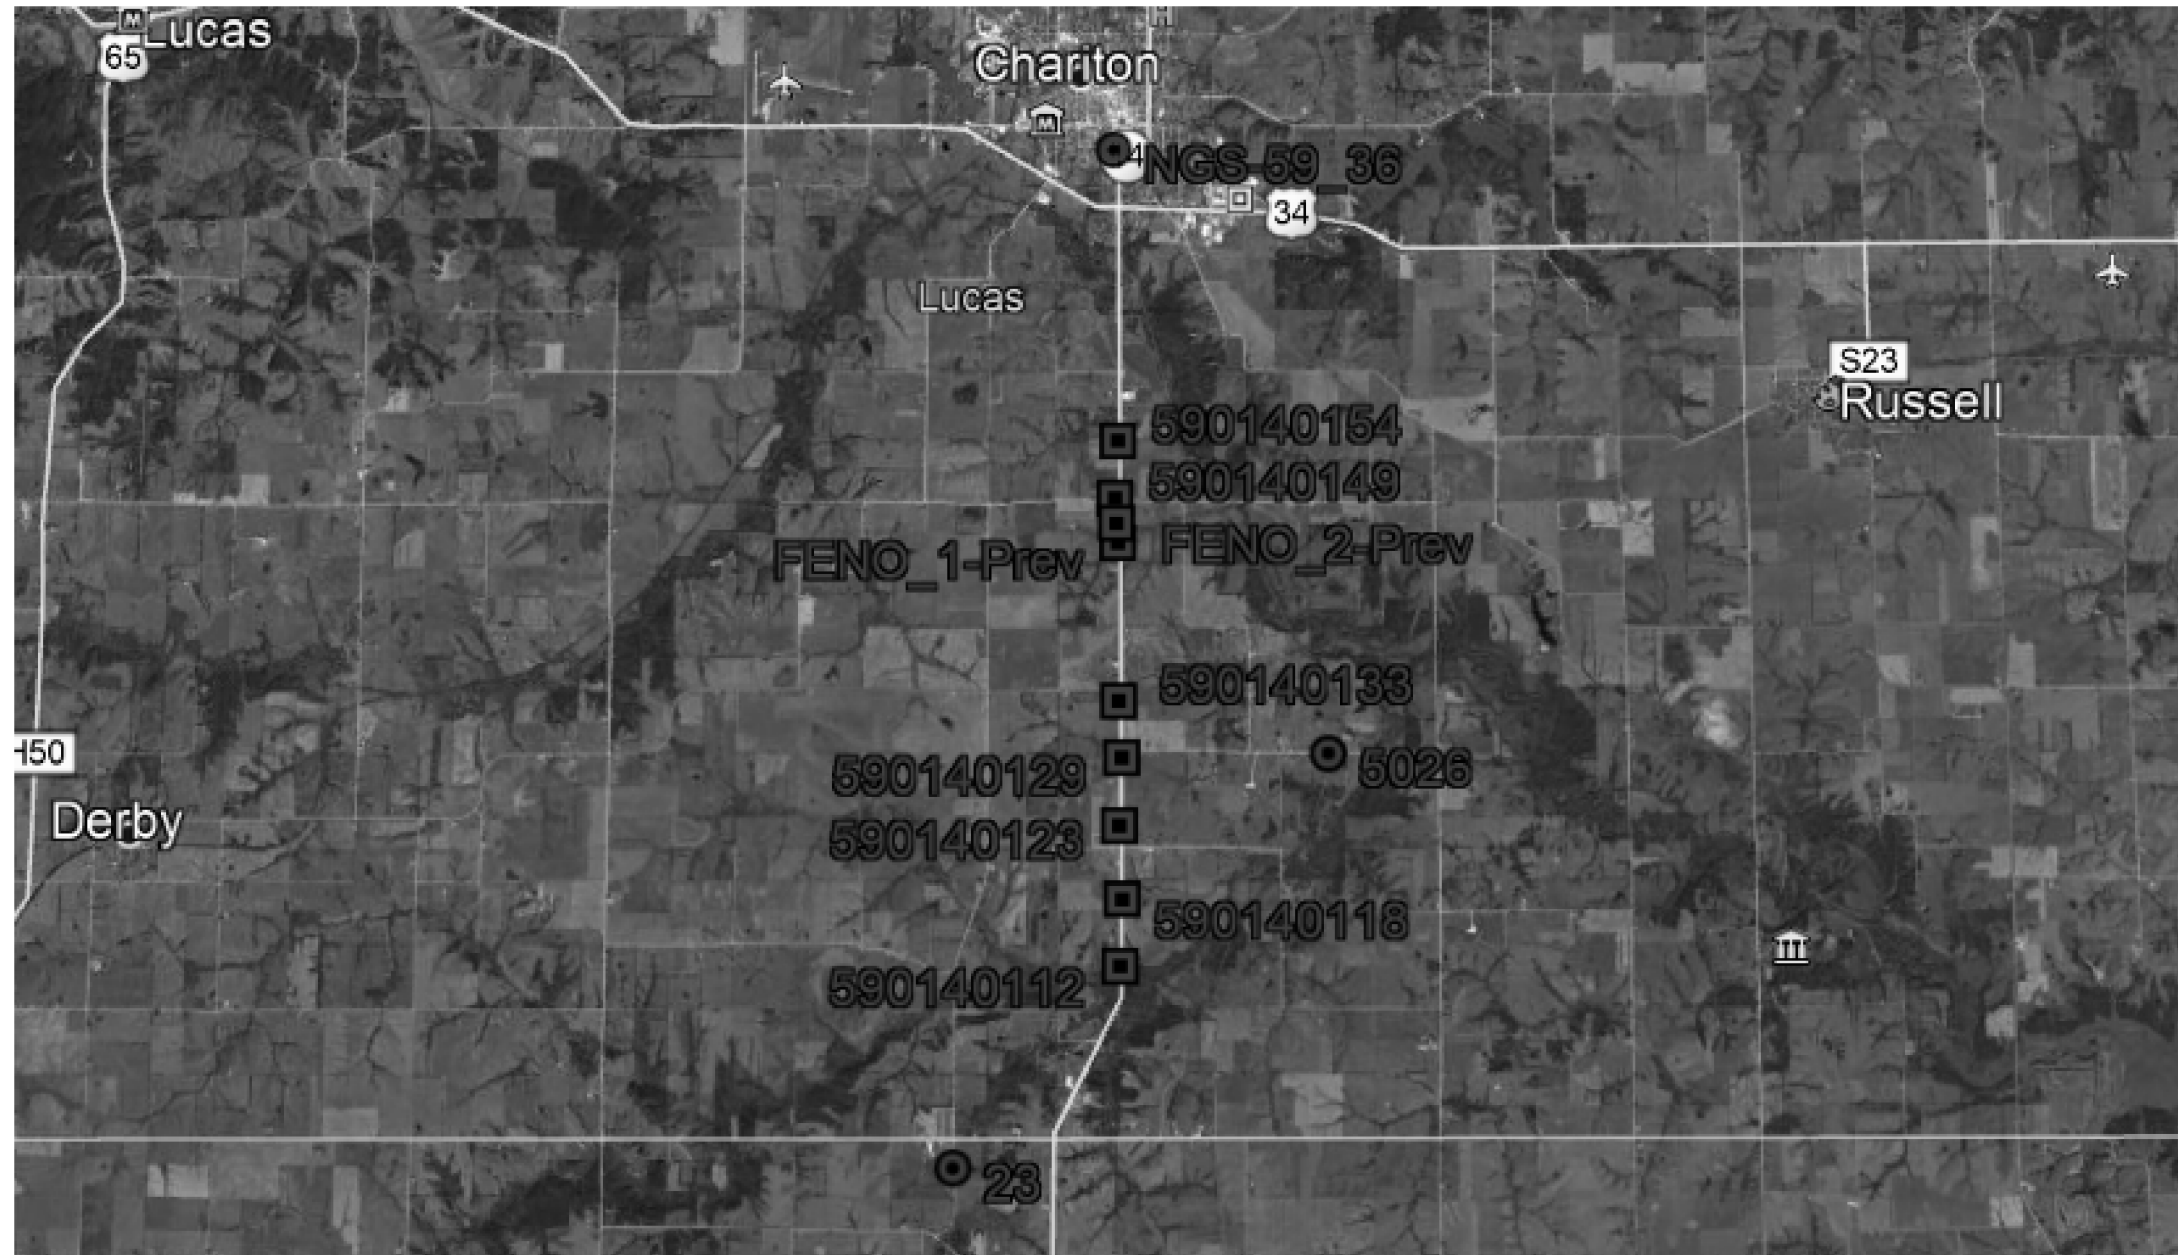
CONTROL POINT VICINITY MAP

This map is a guide to the vicinity of the primary project control points. Primary control is for use with RTK base stations and for RTN validation. Future surveys will use primary project control to establish temporary control as needed for construction or other surveying applications.
