LUCAS COUNTY

SLIDE REPAIR
ER-014-2(42)--28-59

PLANS OF PROPOSED IMPROVEMENT ON THE
**PRIMARY ROAD SYSTEM
LUCAS COUNTY
SLIDE REPAIR**

2.1 mi S of US 34 to 3.6 mi N of Co Rd J22 - 7 Locations

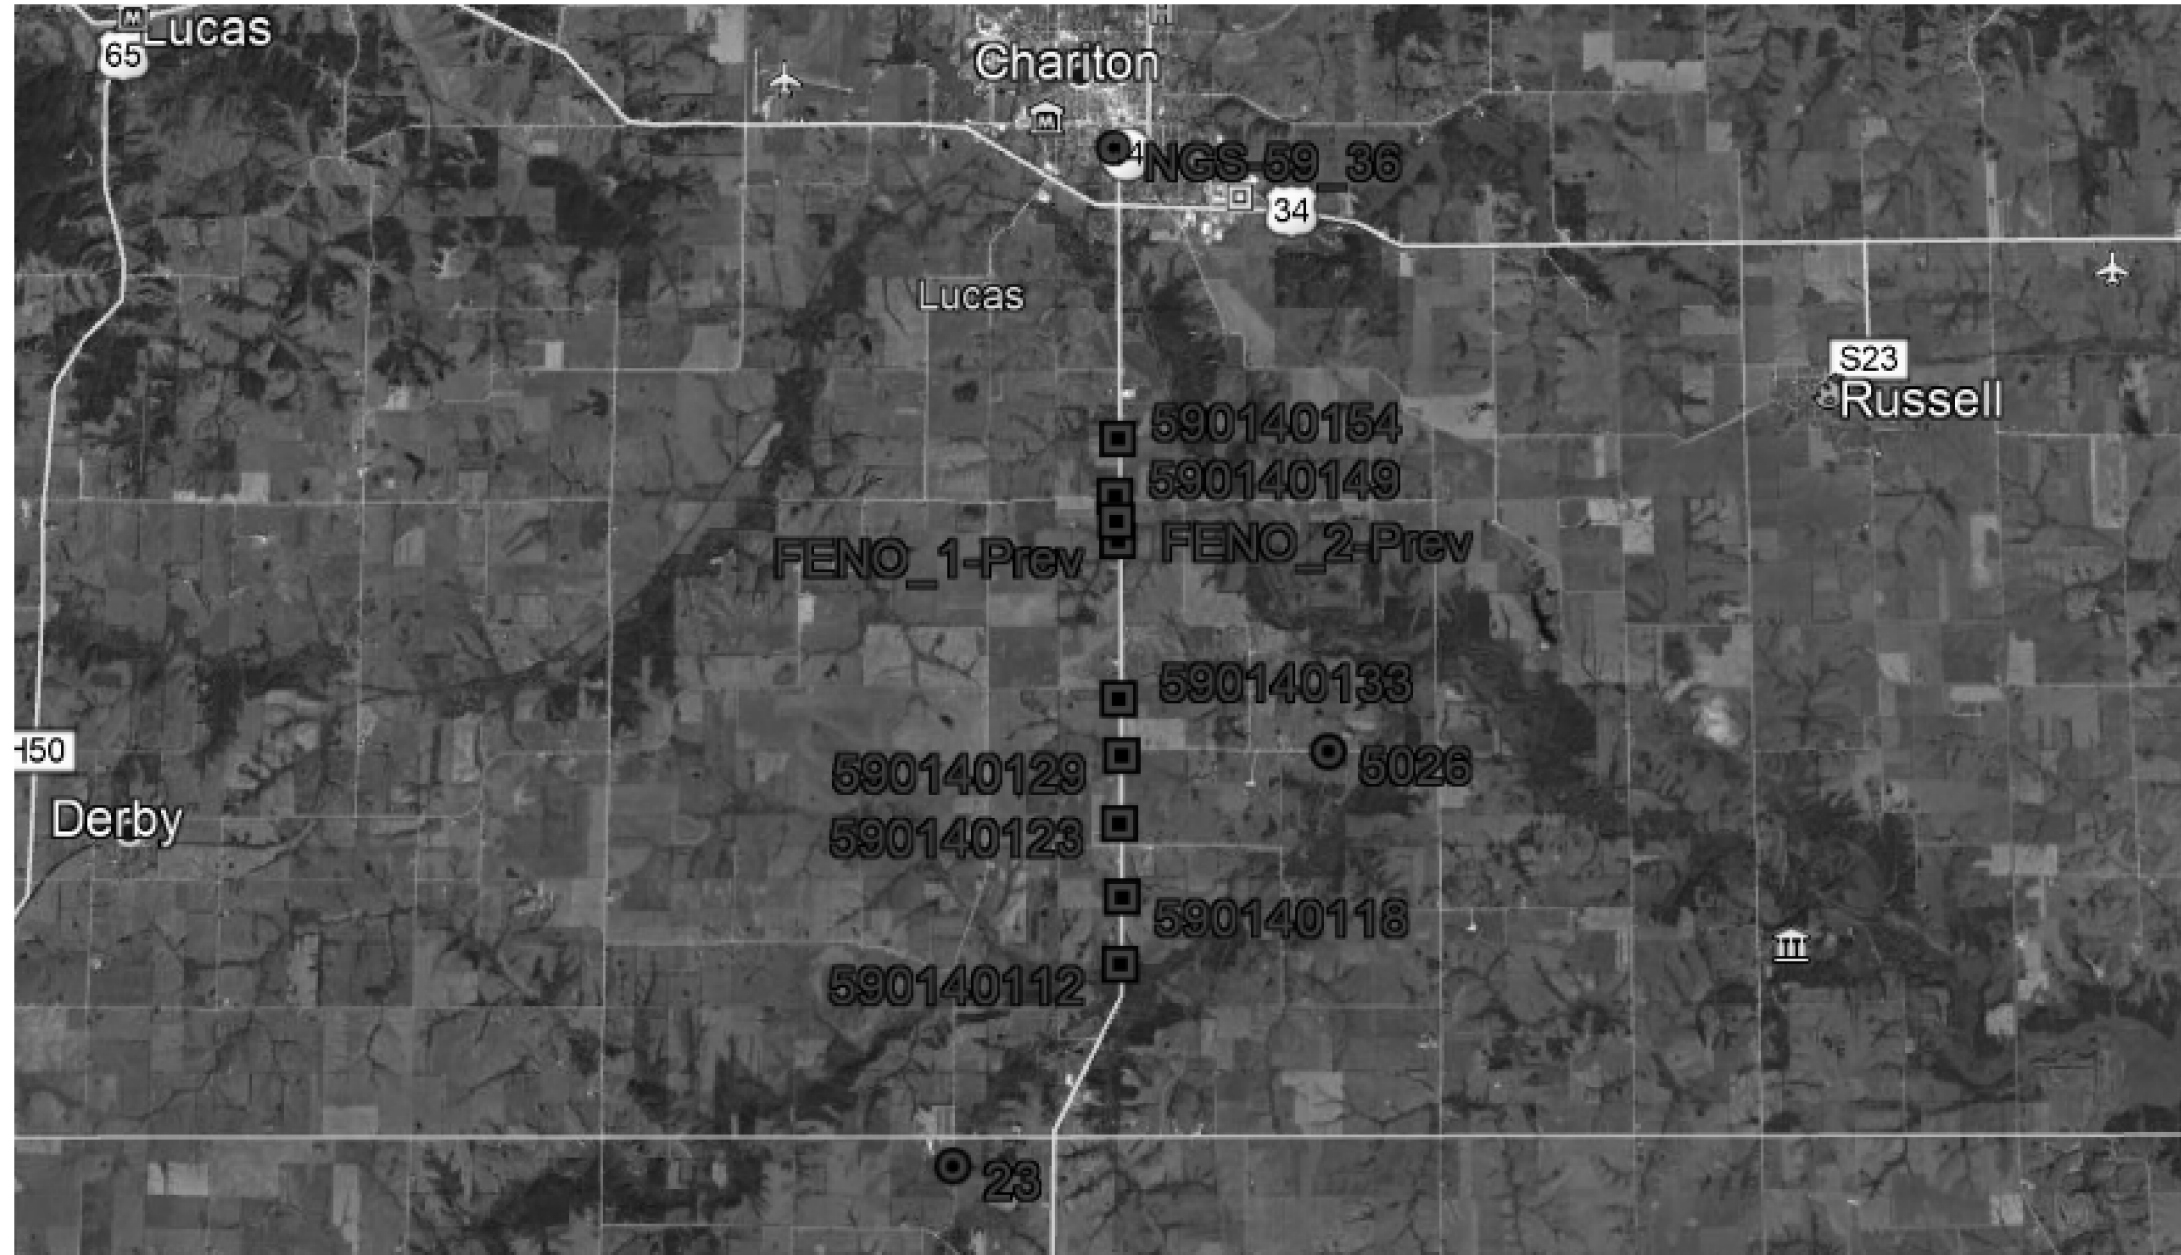
CONTROL POINT VICINITY MAP

This map is a guide to the vicinity of the primary project control points. Primary control is for use with RTK base stations and for RTN validation. Future surveys will use primary project control to establish temporary control as needed for construction or other surveying applications.

HORIZ. DATUM: NAD83(2011) EPOCH 2010.00

VERT. DATUM: NAVD88
