SLIDE REPAIR
NHSN-034-8(159)--2R-51

PLANS OF PROPOSED IMPROVEMENT ON THE

SLIDE REPAIR

0.3 mi E of Bus 34 Interchange to 0.4 mi E of Umber Ave (5 Locations)

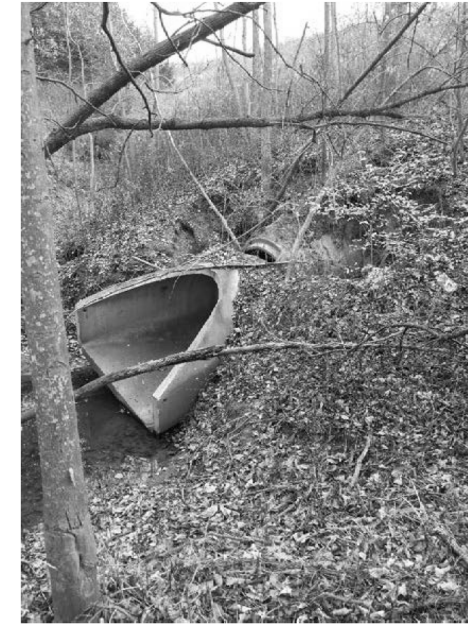
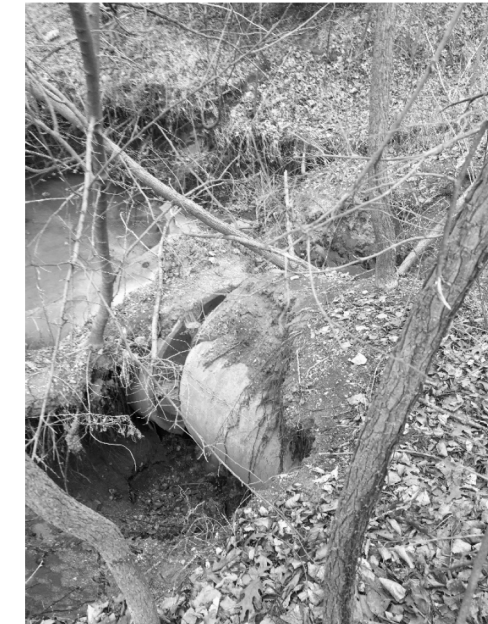
Bench and rebuild the foreslope to pre-existing conditions starting near Station 193+81.3 and then extending east to about Station 194+16.4. It is recommended that the backfill material consist of cohesive furnished embankment and that a subdrain system be installed to more efficiently move water away from the rebuilt foreslope. The repair shall start at the toe of the existing foreslope and then extend up-slope to within about 10 feet from the outside edge of the gravel shoulder. The rebuilt slope shall be covered with an 8-inch thick layer of furnished topsoil. Fill the scour hole located at the outlet end of the culvert with Class E Revetment underlain with Engineering Fabric. Some relatively small amount of Clearing and Grubbing will be necessary in the area around the culvert outlet. Regrade/backfill the roadside ditch within the limits of degradation with suitable cohesive furnished embankment. After regrading/backfilling the roadside ditch, install a rock-lined ditch within the limits of previous degradation. Construct the rock-lined ditch with Class E Revetment underlain with Engineering Fabric. The existing 1350 mm RCP culvert barrel appears to be in good shape under the roadway. The flared end section has separated and

erosion has occurred around the outlet. The end section needs reset and regraded to match the original conditions.

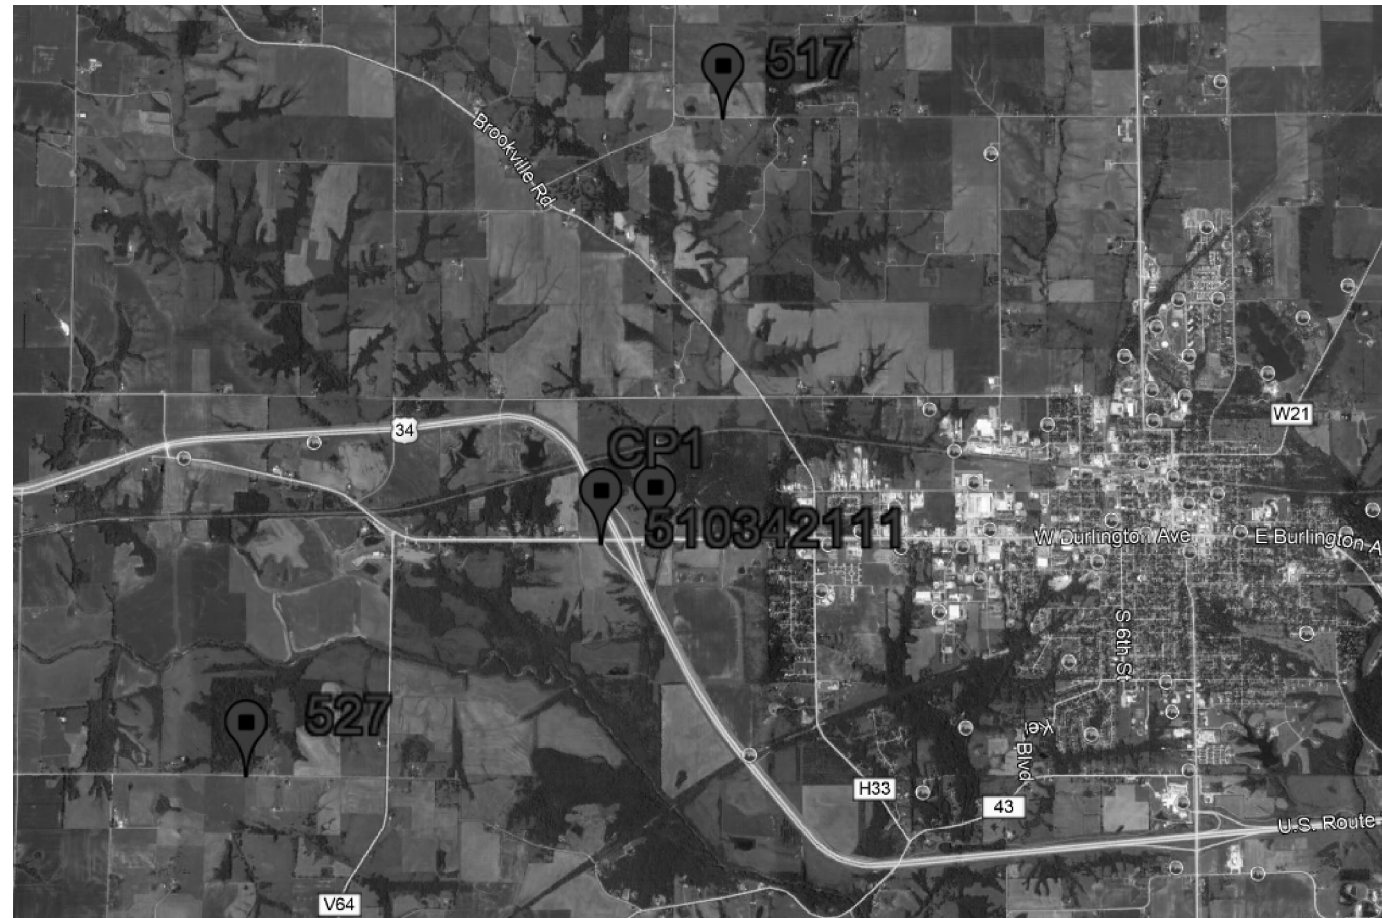
CONTROL POINT VICINITY MAP

This map is a guide to the vicinity of the primary project control points
Primary control is for use with RTK base stations and for RTN validation.
Future surveys will use primary project control to establish temporary
control as needed for construction or other surveying applications.

HORIZ. DATUM: NAD83(2011) EPOCH 2010.00

VERT. DATUM: NAVD88
